Research paper

Settlement of a historic building due to seepage-induced soil deformation

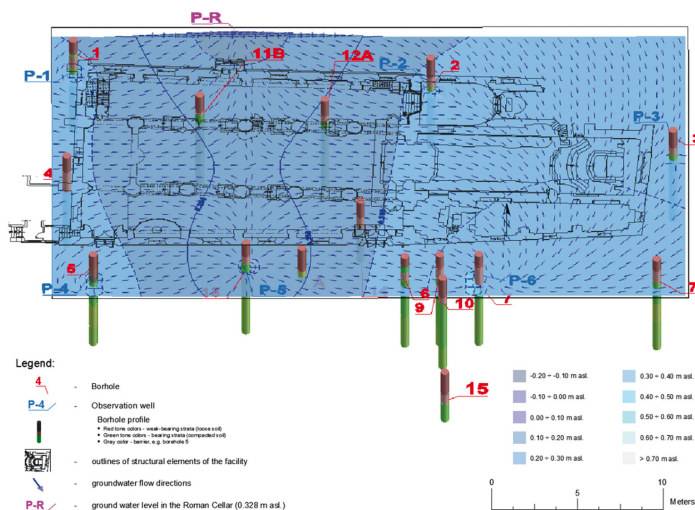
Fig. 5. Groundwater table level map with marked soil profiles at the borehole and piezometer location, with seepage directions for 31/7/2019, against the background of the Basilica basement level plan

31/7/2019, against the background of the Basilica basement level plan, with marked soil profiles in test boreholes and piezometers. Fig. 5 also shows water seepage directions resulting from piezometer groundwater levels. The analysis covered changing water levels on individual piezometers, as well as varying water seepage directions and seepage gradient values. Gradient values were analysed both along the entire length between the piezometers and locally, e.g., in the area of the pillars that experienced the greatest settlement.

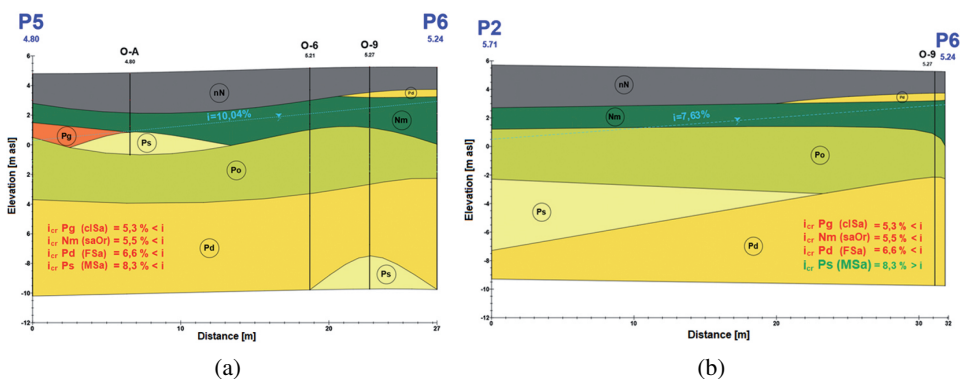
Fig. 7a shows the P5-P6 longitudinal profile and the position of the groundwater table curve position on 2/12/2019, and Fig. 7b shows the P2-P6 longitudinal profile and the position of the groundwater table curve position on 2/12/2019. Fig. 8 shows the P5-P2 longitudinal profile and the position of the groundwater table mean curve position and the local mean curve on 12/7/2019, as well as a diagram of pillar foundation level. Fig. 7–8 also show determined mean gradients between piezometers, relative to the critical gradients for

Fig. 7. Averaged groundwater table position within the Basilica area for 2/12/2019:
 a) P5-P6 longitudinal profile, b) P2-P6 longitudinal profile

given soil types. Red colour marks the soils with exceeded critical gradient values (Bligh criterion) [37].

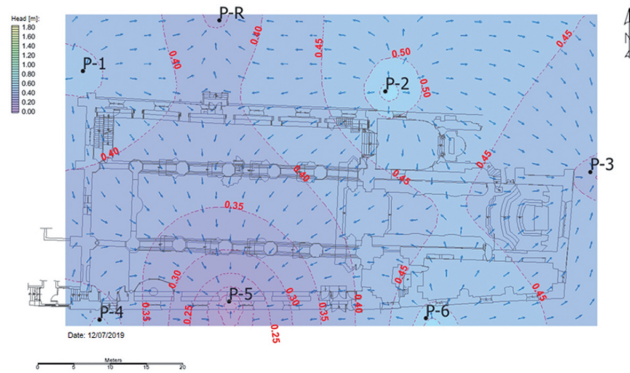
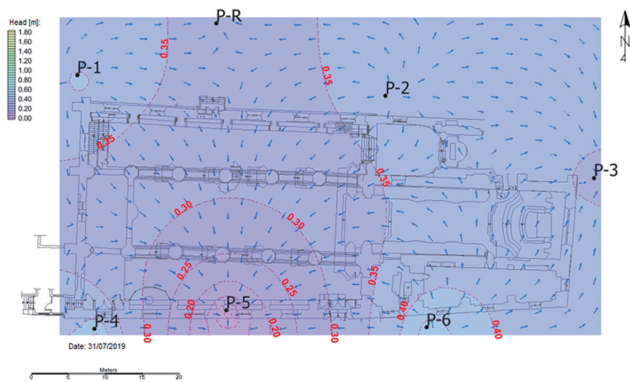
Fig. 9. Groundwater table level map with seepage directions for a) 12/7/2019 and b) 31/7/2019, against the background of the Basilica basement level plan

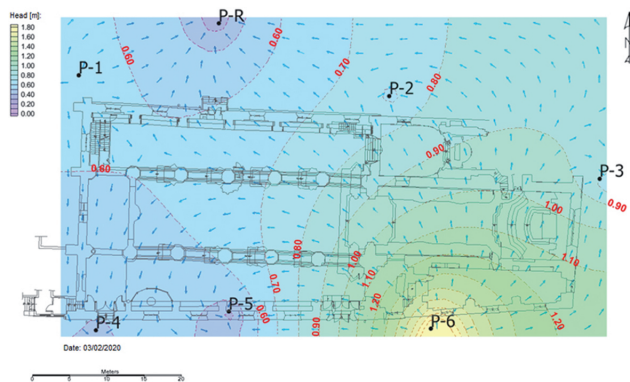
Fig. 10. Groundwater table level map with seepage directions for 3/2/2020, against the background of the Basilica basement level plan

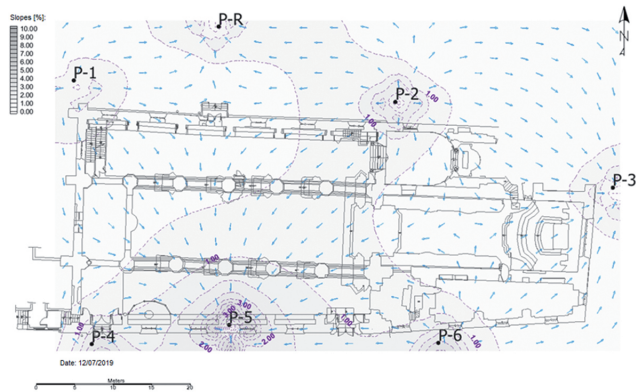
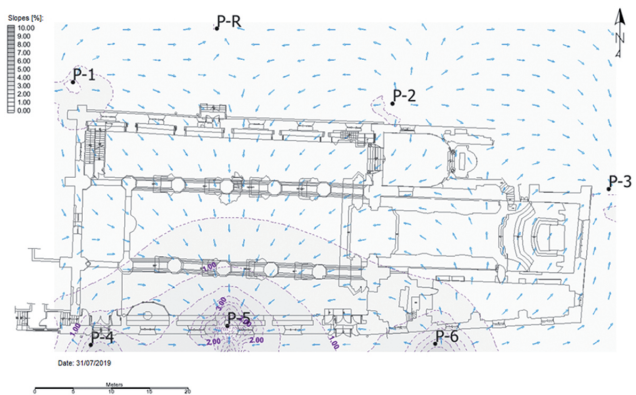
Fig. 11. Map of local groundwater table declines with seepage directions for a) 12/7/2019 and b) 31/7/2020, against the background of the Basilica basement level plan

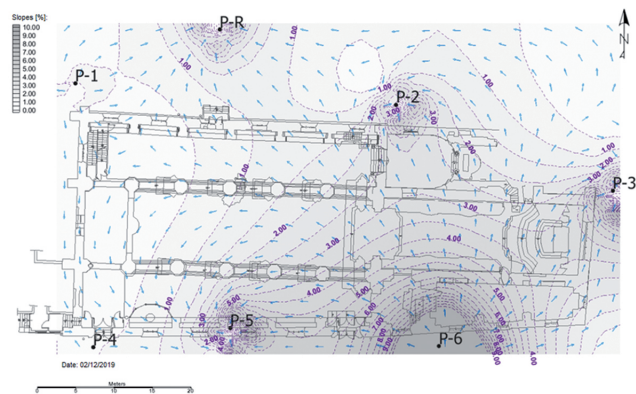
Fig. 12. Map of local groundwater table declines with seepage directions for 2/12/2019, against the background of the Basilica basement level plan
