SOME ADJUSTMENT AND EXPLOITATION PROBLEMS OF THE CONTROLLABLE PITCH PROPELLER PNEUMATIC AND HYDRAULIC CONTROL SYSTEMS

Czesław Dymarski

*Gdansk University of Technology
Faculty of Ocean Engineering and Ship Technology
11/12 G. Narutowicza Str., 80-233 Gdańsk, POLAND*

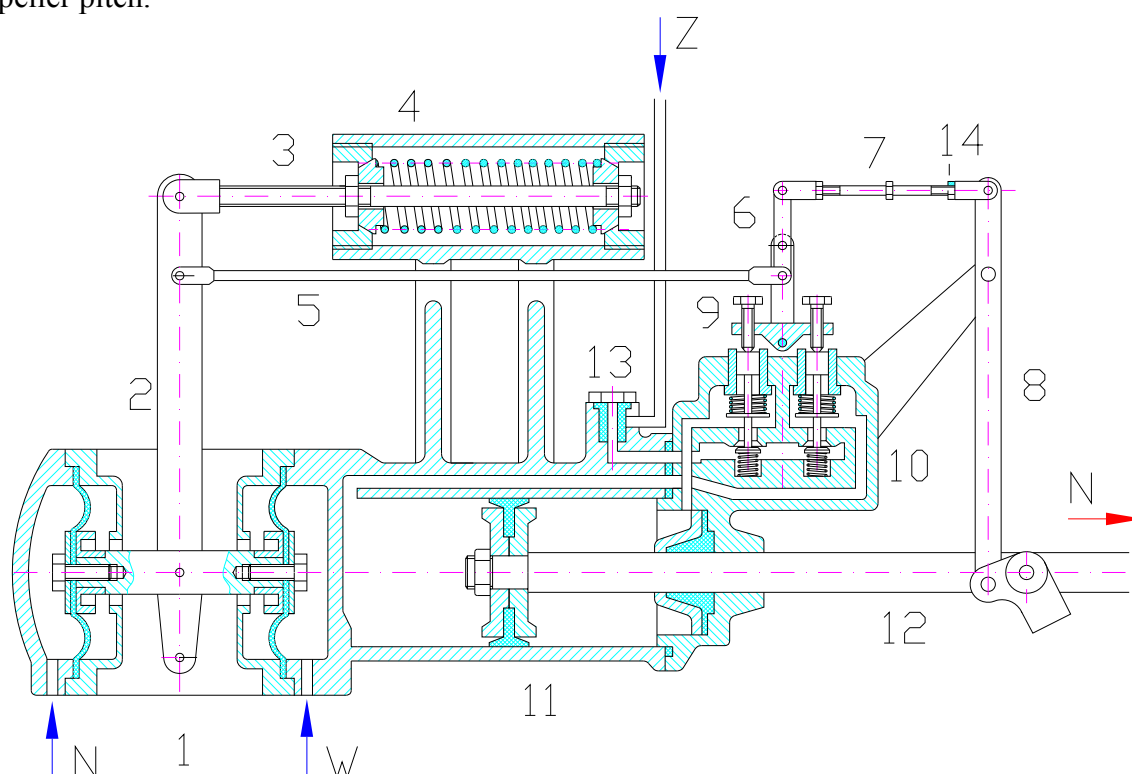
Fig. 4. A simplified drawing of the pneumatic servomotor of the controllable pitch propeller remote control system. Letter nomenclature: N – „ahead” direction, W – „astern” direction, Z – air supply.

Two hours after collision during the engine room machinery inspection the ship's engineer spotted the broken connecting link (item 7 on fig. 4). A break intersection was at a fore face plain of a left lock-nut, which is shown on fig. 5. No other damages were found.

The remote pneumatic control system without broken connecting link was also tested. Even by very light finger pushing on the upper end of the lever 6 (on fig.4) the piston rod 12 moved in one or another direction according to direction of finger pushing. In full range of control it worked correctly. During this test I have noticed one characteristic feature of the pneumatic servomotor. It was that from each set position of the piston rod after stopping pushing on lever 6, it automatically moved to “full ahead” position.

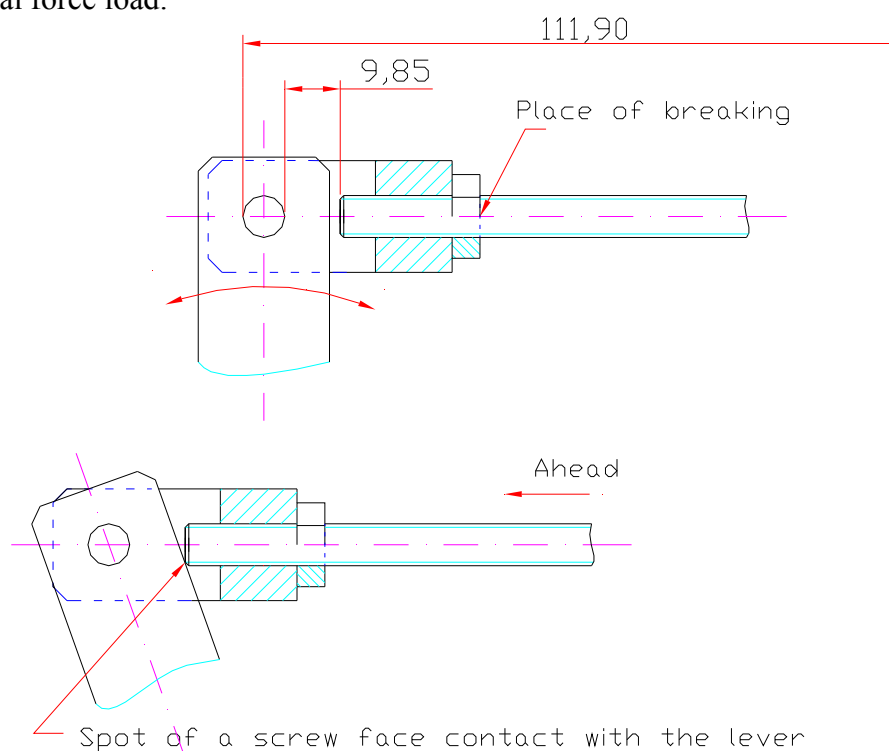
Fig. 5. An articulated joint of the connecting link with the lever in “zero” and “full ahead” positions with shown two dimensions checked in front of the commission

would be exactly the same as in the damaged one. Conformity of two most significant dimensions, namely a distance between outer surfaces of botch pins of connecting link and distance between the pin and face surface of the connecting link screw, which are shown on fig. 5, was checked in front of the commission.

The following tests were conducted with using the remote pneumatic control system and checking conformity of the set values with real values of the propeller pitch during a few full cycles of the pitch changing. Also this time the system worked correctly. In this situation I have decided to repeat last test changing gradually, step by step the propeller pitch and each time observing and touching the connecting link 7, gently pressing it by finger. In almost all steps the pressing connector displaced slightly crosswise in a clearance range, but just in positions “full ahead” and close to it the connector tensed and stiffened. Precise observation of this connection unit revealed a reason of this stiffness. Just in mentioned above position close to „full ahead”, a face surface of the connector link screw rested against the lever 6 in such way, as is shown on fig. 5. Because of it, a bending moment in the screw was generated. This additional bending moment load was undoubtedly many times bigger than a nominal axial force load.

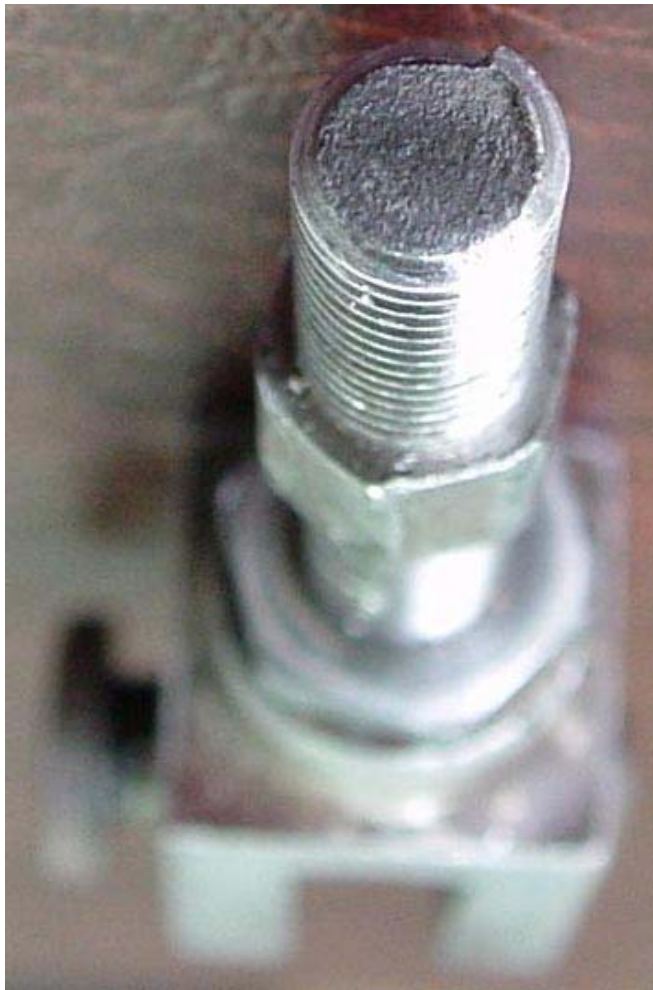
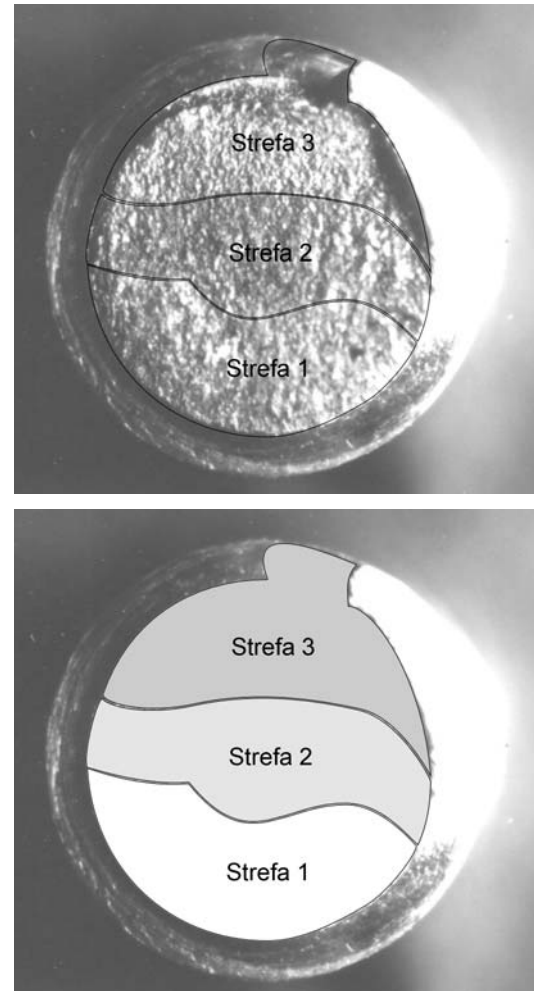
Fig. 3. A view of the fatigue fracture with marked zones of conducted fatigue damage

Apart from described works a metallographic examination of a broken screw surface was conducted at the Faculty of Ocean Engineering and Ship Technology of Gdansk University of Technology Laboratory. The results of the examination shown that the connecting link breaking was caused by material fatigue under influence of changing bending moment loads in a long period of time.

Photographs of the screw fatigue fracture with marked zones of conducting fatigue damages are presented on fig. 6. A fatigue crack was a result of acting in the first area a parallel but displaced in comparison with a screw axe force in long period of time, what generated a bending moment. This kind of load caused sequential “opening” and “closing the fatigue crack which propagated in the zone”2” direction. With the passage of time the crack was slowly increasing and after reaching the zone “2” the increase was successively faster because of a more significant decreasing of a loaded cross-section area and growing value of stresses. When the crack reached zone “3” about 60% of a screw cross-section area was lost and stresses excided strength of the material what caused final breaking

The above presented analytical works and inspections as well as the CPP control system tests and a metallographic examination of the fatigue fracture enabled to find a real reason of the collision. It was an incorrect adjustment of the feedback elements connection in the pneumatic servomotor unit. More precisely speaking the screw of the connecting link 7 was too deep screwed in the lug at the side of lever 6 (fig. 4 and fig. 5). Because of it, every time in the “full ahead” propeller pitch position the screw face contact with the lever occurred. It caused an additional load of the bending moment on both these elements. The moment was acting at a vertical surface of their movement. The effects of such loads were most unfortunate for this screw, because its cross-section area was the smallest and the thread was a significant notch. It should be marked that during the nominal work the load of the screw, that is – axial force being very small, about 1 N, the generated stresses could not cause such damage. But the additional periodic bending moment loads were multiply bigger and generated much higher stresses. Value of these stresses was lower than static strength so did not caused short term breaking, but repeating continuously in long period of time led to fatigue breaking. Mechanism of this kind of damage was explained in the metallographic examination of a broken screw surface report [1].

It is worth mention that there is conformity of the damage area propagation direction with the bending moment acting surface, what is noticeable on fig.6
