SOME ADJUSTMENT AND EXPLOITATION PROBLEMS OF THE CONTROLLABLE PITCH PROPELLER PNEUMATIC AND HYDRAULIC CONTROL SYSTEMS

Czesław Dymarski

Abstract

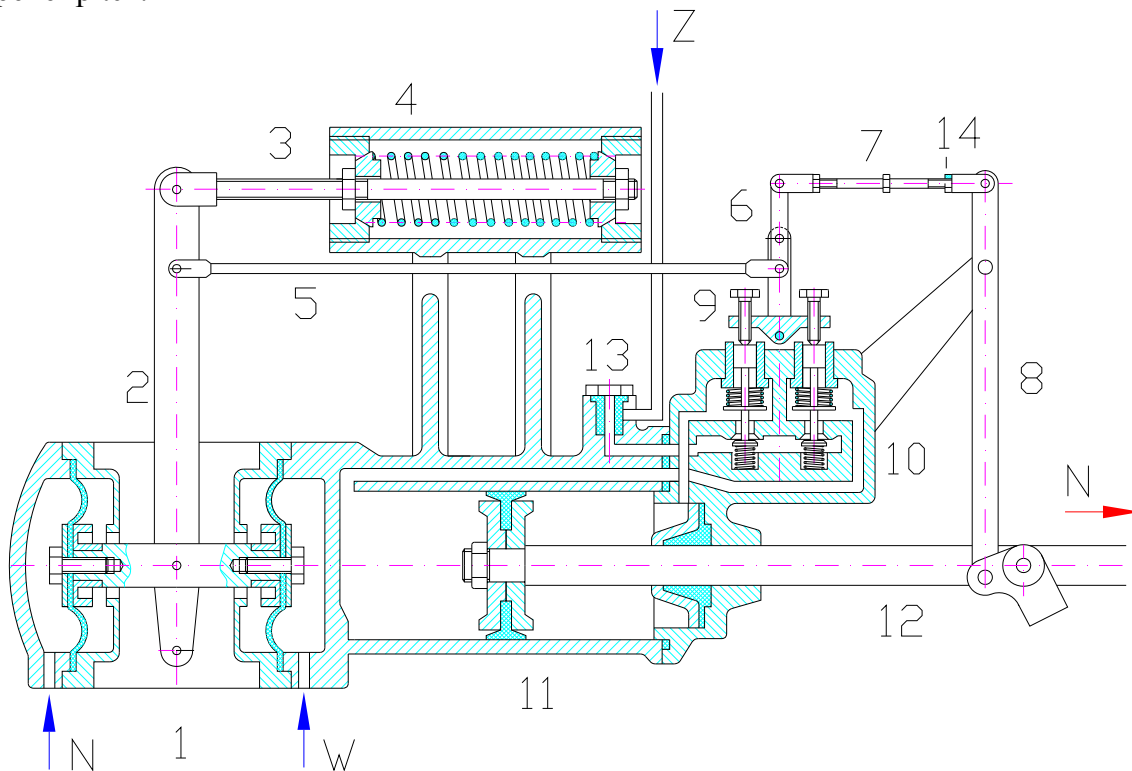
Fig. 4. A simplified drawing of the pneumatic servomotor of the controllable pitch propeller remote control system. Letter nomenclature: N – „ahead” direction, W – „astern” direction, Z – air supply.

Two hours after collision during the engine room machinery inspection the ship’s engineer spotted the broken connecting link (item 7 on fig. 4). A break intersection was at a fore face plain of a left lock-nut, which is shown on fig. 5. No other damages were found.

The remote pneumatic control system without broken connecting link was also tested. Even by very light finger pushing on the upper end of the lever 6 (on fig.4) the piston rod 12 moved in one or another direction according to direction of finger pushing. In full range of control it worked correctly. During this test I have noticed one characteristic feature of the pneumatic servomotor. It was that from each set position of the piston rod after stopping pushing on lever 6, it automatically moved to “full ahead” position.
