The Impact of Material Selection on Durability of Exhaust Valve Faces of a Ship Engine – A Case Study

Hanna Smoleńska¹, Włodzimierz Kończewicz², Sylwia Bazychowska^{2*}

ABSTRACT

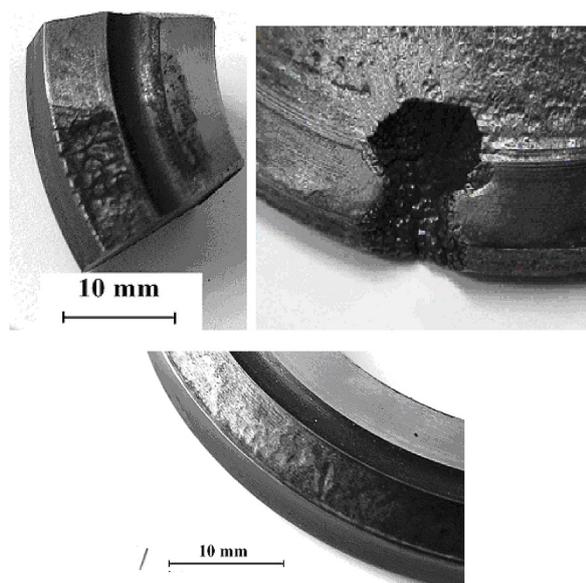
- loss of tightness caused by corrosion pits resulting from erosive exhaust fumes (Fig. 1b),
- over burning of the valve head edges caused by the flow of extremely hot gases through the leaks (Fig. 1a),
- cracks, scratches and splinters caused by fatigue of the face layer (Fig. 1c).

Fig. 1. Examples of damaged exhaust valve of the marine engine: (a) corrosion of the face – “pavement”; (b) destruction of the face and substrate due to valve leaks – irreparable; (c) face wear – repairable

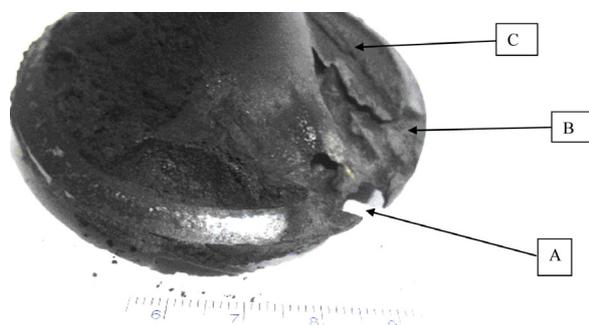
After 2000 hours of service valve L12 was still intact without of any traces of serious failure but valve N was completely destroyed. Figure 2 presented the state of the valve N after operation. On the right side of the figure there is visible broken (A) part of the valve and the layer of surfacing (B) has practically disappeared. The damage also applies to the valve plug (C). The L12 valve

Fig. 2. N valve after 2000 hours of operation

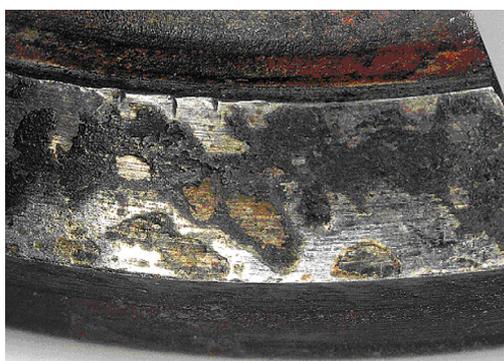
Fig. 3. L12 valve after 3000 hours of operation. Magnification 10x

after 3000 hours of operation did not show any significant signs of wear or damage (Fig. 3).

The L12 valve shows little signs of degradation after a longer operating time. Some regions of the scale are visible however some of the face is still shiny and smooth. Detailed investigations were carried out on the face surfaces of both valves and microstructures on the cross-section of the analyzed valves. In addition, hardness measurements were carried out to assess the degree of material degradation. During the operation and heat interaction, diffusion processes occur in the surfacing material leading to changes in the structure. Mainly the formation of oxides on the surface causes the decomposition of carbides and a decrease in the hardness of the material. Microhardness tests are very sensitive to microstructure changes.

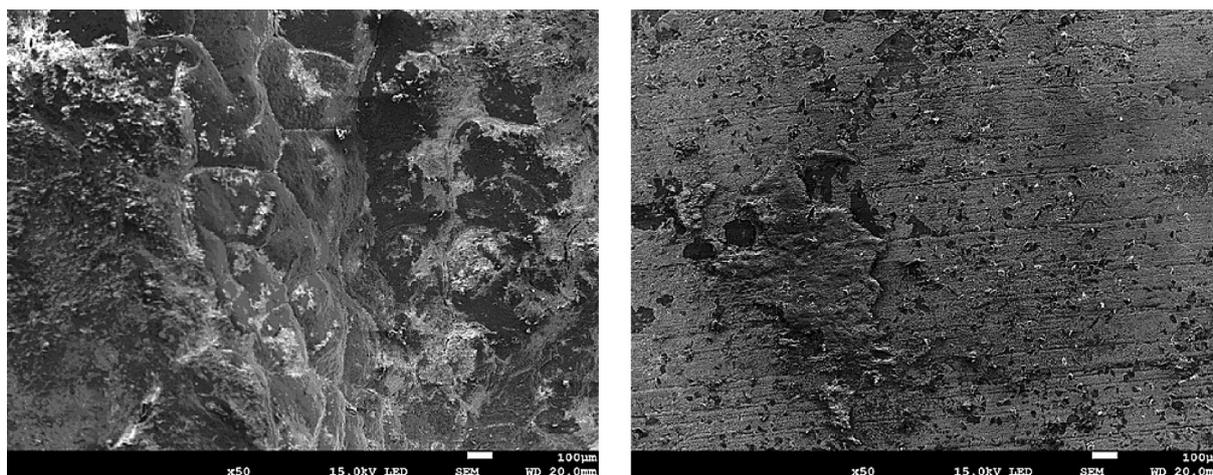
Fig. 4. N valve destroyed during operation – face surface (a), face surface in a different area (b)

condition of the N valve after service. Significant differences of the appearance of the valve face surface were observed. It also indicates different properties of the material in different area of the face which is not acceptable.

Observed destruction of the face can be caused by various factors. It may be the result of incorrect selection of padding materials, improper parameters of the padding process, but also mechanical causes of damage, i.e. overloading or improper valve grinding should be taken into account. In this work only chemical composition of the clad and changes in mikrostrusture were analyzed.

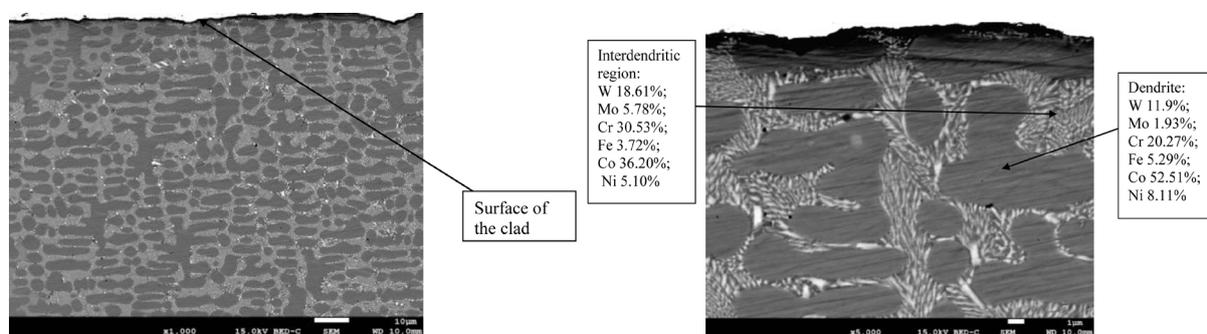
Fig. 5. N valve destroyed during operation – microstructure on the cross-section, close to the face surface; it is visible dendritic structure characteristic for free solidification of melted metal during surfacing (a); microstructure on the cross-section, near the top surface; EDS results for dendritic and interdendritic region (point analysis) (b)

The valve was cut into samples, included and a specimen prepared, which was observed on a scanning electron microscope (SEM). On Figure 5 is presented mikrostruktue of destroyed valve N. Mikrostruktue is typical for cladding

technology [3, 4, 10, 26]; visible dendritic structure (dark) and interdendritic regions (light under low magnification). Dendritic region are a solution of alloying additives in cobalt, mainly nickel, iron, chromium, tungsten and molybdenum. The interdendritic region consist of mixture of carbides end eutectics (Fig. 5a). During previous tests of welds made of the same powder as designated L12, occurrence was found was found by XRD analysis presence of carbides were identified as mainly $M_{12}C$ (Co_6W_6C), M_7C_3 and $M_{23}C_6$ ($Cr_{23}C_6$). EDS analysis shows a significant presence of tungsten, chromium and molybdenum

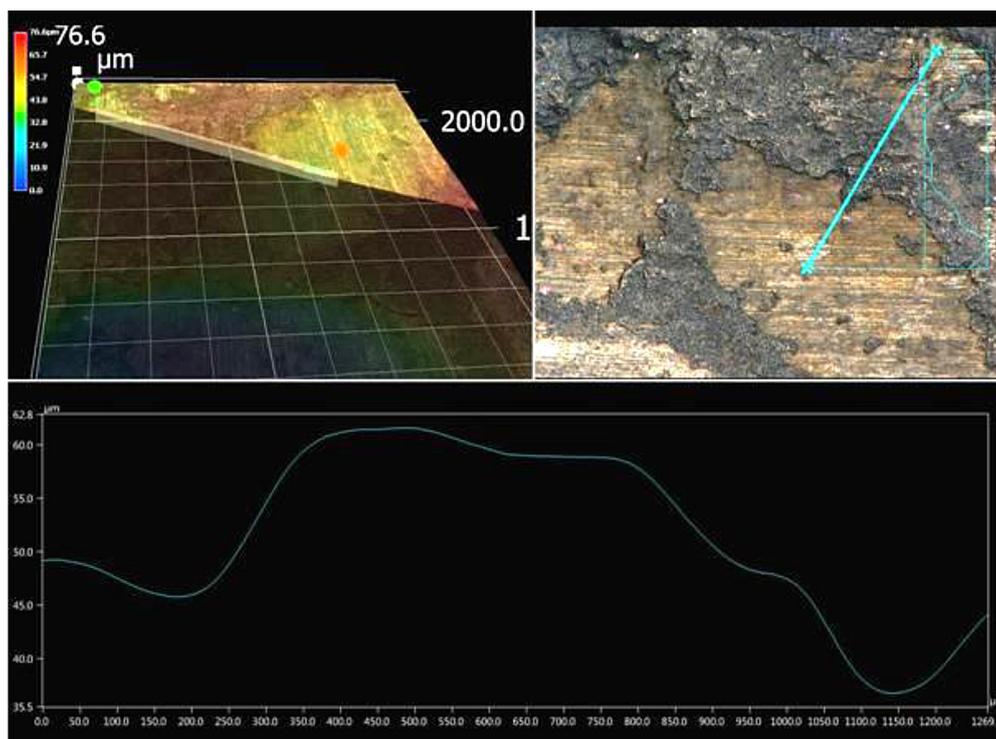
Fig. 6. Surface profile of L12 valve face after operation –visible regions of existing scale. Analyse made by laser profiler KEYENCE

surface of the outlet valve face has been slightly degraded. Keyence equipment was used for surface analysis. This equipment is a microscope coupled with a profilograph and allows measure the surface profile of targets in X and Z directions. The height, width or gap on a surface profile can be measured. Observation of the face surface showed the presence of crumbling scale and areas of the exposed metal surface. In

Figure 6 a multilayer scale with a tendency to crack and delaminate is visible. However, the largest layer thickness did not exceed 60 μm. SEM analysis of the valve face marked L12 showed the slight plastic deformation of the surface was observed, which can be interpreted as the effects of plastic deformation during work, this is illustrated in Figure 7.

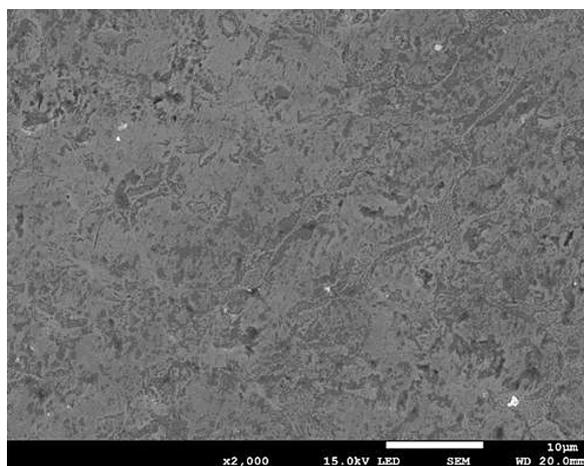
Fig. 7. L12 valve face after operation – plastic deformation

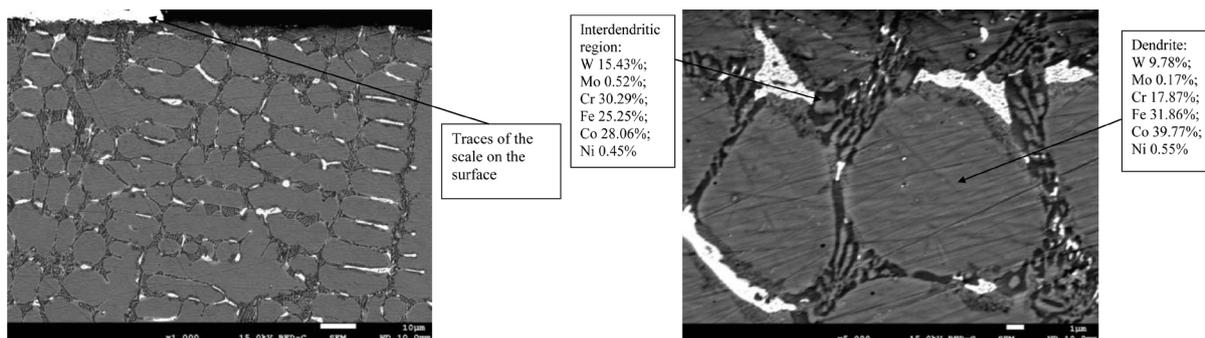
SEM observation of the cladding layer cross-section does not show any significant changes in relation to the typical microstructure of the clad layer. However, the presence of the scale on the face surface indicates changes in chemical composition resulting from diffusion processes. The EDS analysis results for the padding area just below the scale was as follows: Si-2.49%; Cr-23.12%; Fe-31.83%; Co-35.30%; Ni-0.60%; W-5.79%; Mo-0.86%. It may cause changes in material hardness because the scale is mainly composed of chromium oxide, which has protective properties. This is also the reason for using alloys with such high chromium content. Chromium is mainly contained in carbide secretions and they are also the main source of diffusion to the surface. Degradation of carbides decreases the hardness of the material [10, 24, 25].

Fig. 8. (a) L12 after operation - microstructure on the cross-section, near the top surface. No visible changes in dendritic microstructure under the scale (b) L12 after operation - microstructure on the cross-section, near the top surface. EDS results for dendritic and interdendritic region (point analysis)

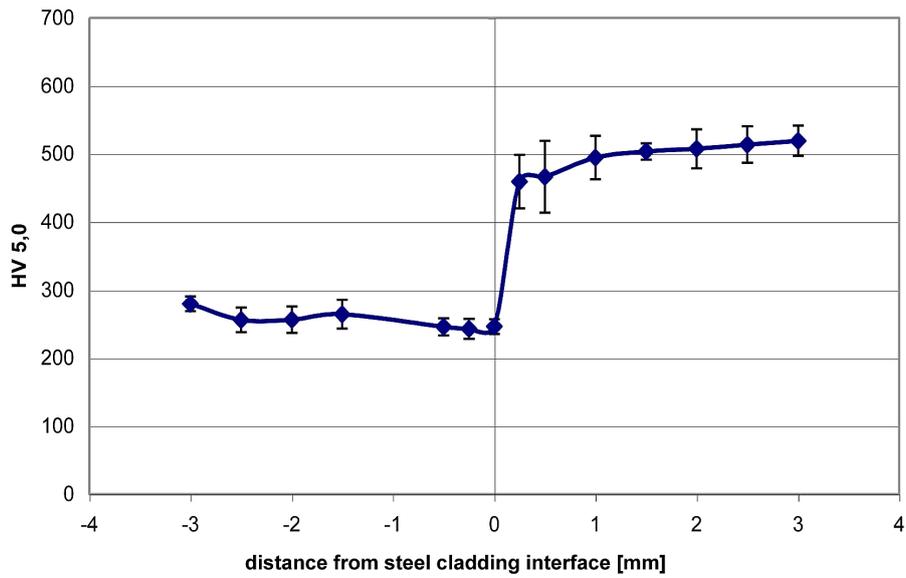
Fig. 10. Statistical analysis of the hardness measurements for the L12 valve after 3000 hours of operation

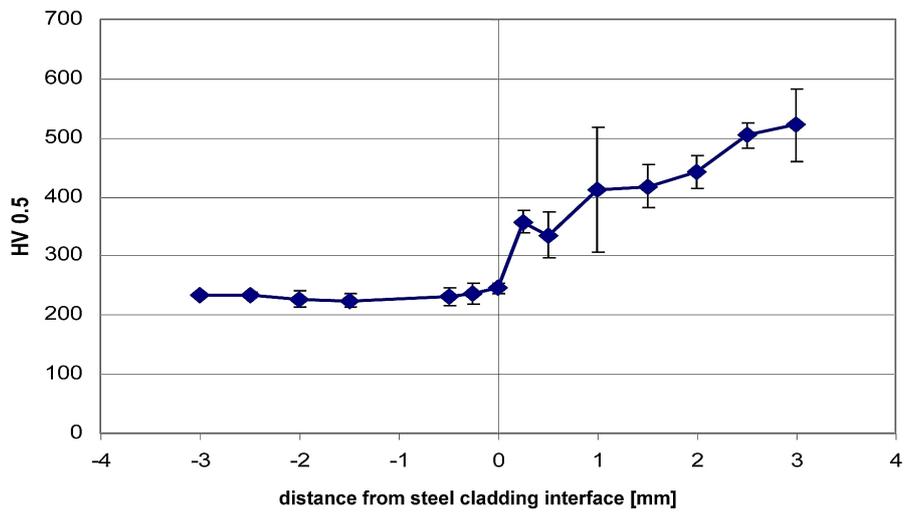
Fig. 11. Statistical analysis of the hardness measurements for N valve after 2000 hours of operation

found in the range 480 to 581 HV5.0 at distance 3mm from the steel-clad interface (close to clad top surface) – similar to L12, but in the deep of the clad hardness decreases up to 195-447 HV5.0. In means large changes in hardness on the cross-section. In both cases no significant decrease in hardness was observed close to the top surface, which indicates that despite the formation of the oxide layer, no degradation of the material will occur.

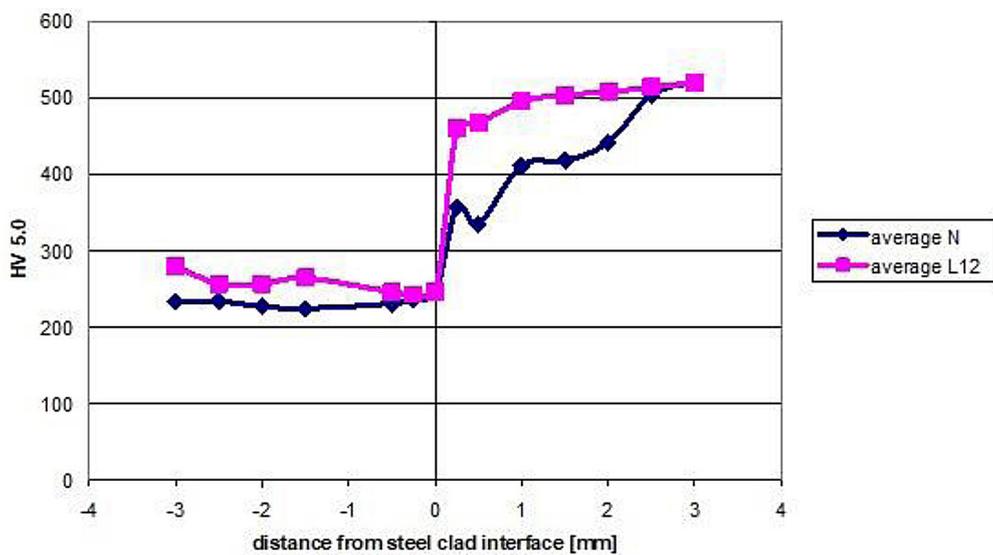
Fig. 12. Comparison of average values of hardness of the N and L12 faces claddings
