# Thermal failure of a second rotor stage in heavy duty gas turbine

Daniel Sławiński<sup>(1)</sup>, Paweł Ziółkowski<sup>(2)</sup>, Janusz Badur<sup>(1)</sup>

<sup>(1)</sup> Institute of Fluid-Flow Machinery, Polish Academy of Sciences, Fiszerza 14, 80-231, Gdańsk, Poland

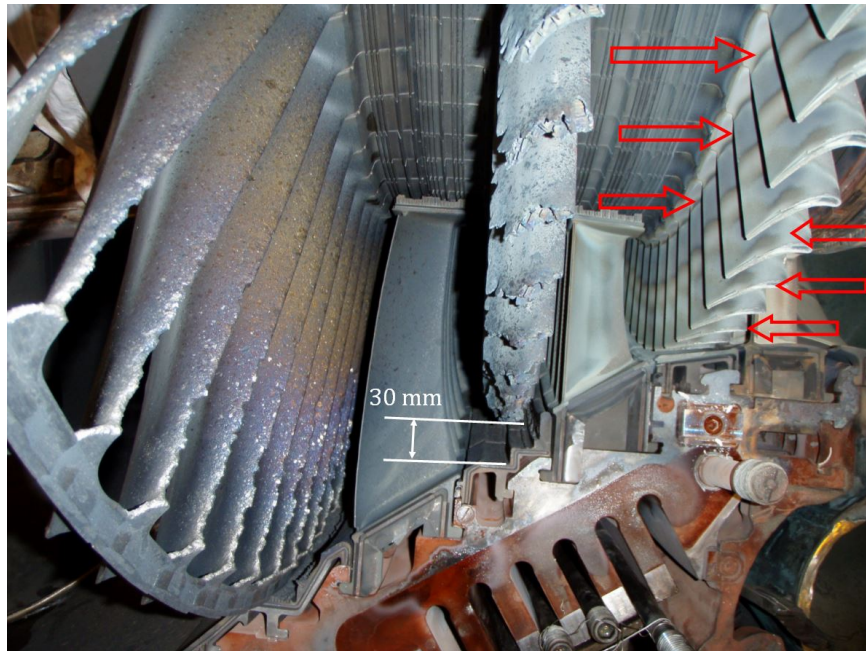
37 The gas turbine blade was broken in the upper part of the blade, near the bandage. The even  
38 melting of all blades of the rotor stage and the jagged nature of the damage proves that we  
39 are dealing with failure resulting from the presence of a large heat source. This source was,

1 most likely, (Fig. 1) the friction of the rotating blade bandages against the seals separating the  
2 body case. The specific stepped shape of this seal, which has no equivalent in subject  
3 literature, is also not without significance here.

4  
5 Figure 1 View of the 2nd stage following the failure with a characteristic even melting  
6 of the upper parts of the blades.

7 The melting occurred evenly, stopping at a distance of 30 mm from the internal walls of the  
8 body case. An additional argument in favour of thermal damage to the blades are tarnish  
9 indicated by arrows, clearly visible on the first stage of the turbine. These stains are the result  
10 of high temperatures, and their formation is primary in its nature, resulting from too high a  
11 temperature of the flowing exhaust gas. In an interview with the power plant operator, we  
12 determined that the failure was preceded by a change in the fuel supplied to the turbine.

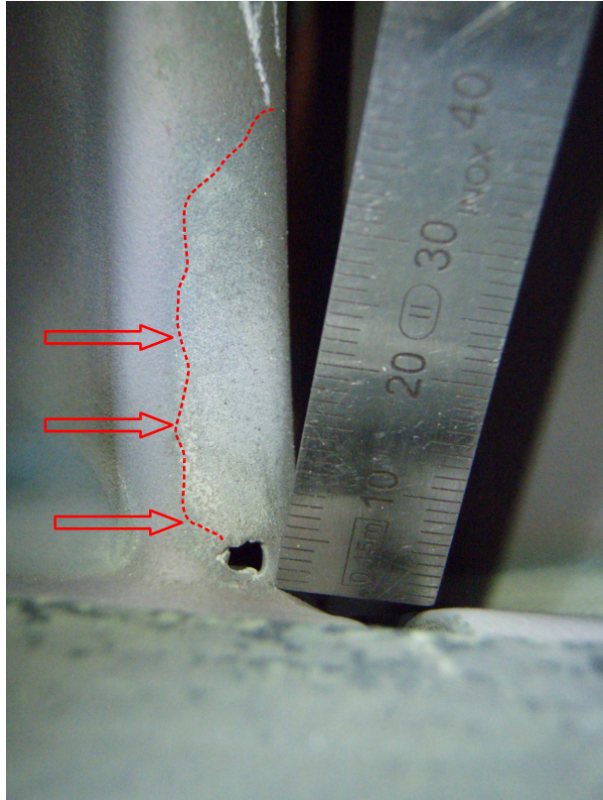
1  
2 Figure 2 Damage to the blade profile at the base and characteristic discoloration  
3 resulting from the effects of high temperature.

4 Another damage of this type observed after a failure was the discoloration located (Fig.2) in  
5 the lower part of the blade in the place of the profile face. This discoloration was discovered  
6 on the blade of the 2nd rotor stage and its dimensions are similar to those found on the 1st  
7 rotor stage, and marked in the previous figure. A small hole with a diameter of 5 mm was  
8 found at the base of the profile. Its creation was probably the result of high temperatures and  
9 mechanical loads.

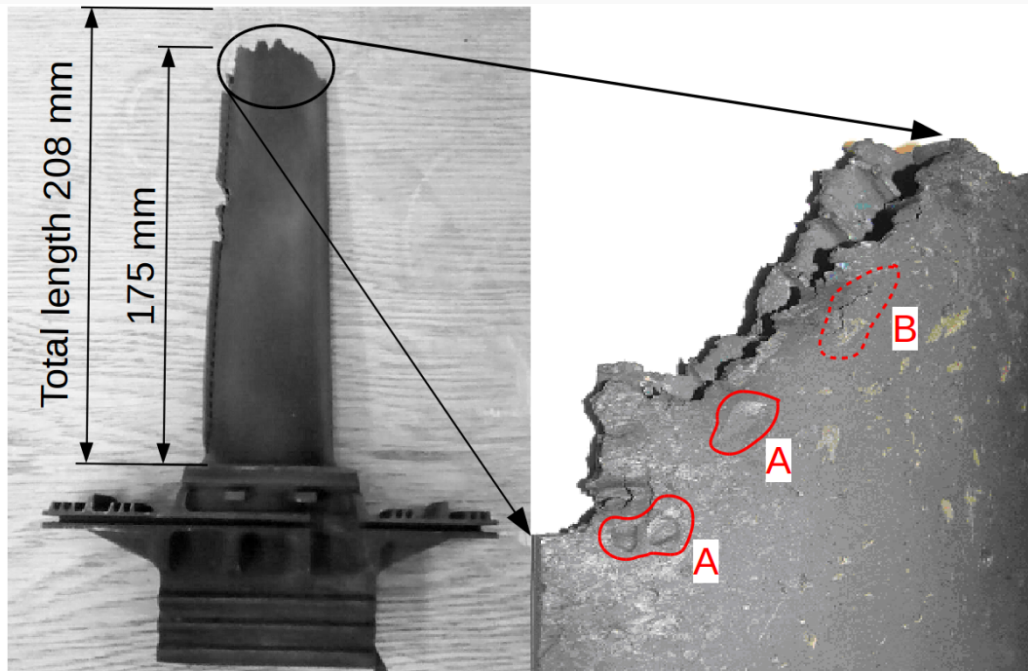
10 This section contains images of the blade after failure captured by scanning microscopy  
11 (SEM). Visual inspection confirmed that during the failure the rotor blades were in good  
12 condition and observations under the microscope ruled out micro-cracks on the blade  
13 surface as well as corrosion or high temperature creep effects (Fig.3). Visible dents or cracks  
14 of the surface layer of the blade are the consequence of failure, and occurred during the said  
15 failure in the result of impact of pieces of hot and detached steel on the remaining blades in  
16 the said stage. They did not have the nature of the primary cause of the failure, but were its  
17 consequence.

1  
2 Figure 3 Macroscopic image of the damaged blade with the following references: A)  
3 dents and surface layer damage, and B) cracks formed during the development of failure.

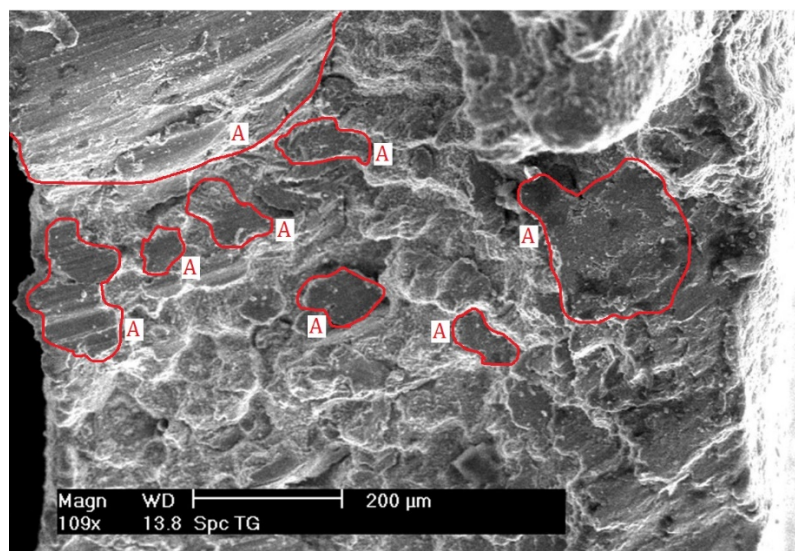
4 Based on the macroscopic image of the damaged location and its image at low magnifications,  
5 it can be assumed that the observed fracture does not belong to the group of trans-crystalline  
6 cleavage. SEM images shown in Fig.4 at the highest magnifications show the occurrence of  
7 facets that link through plastic deformation [25], which allows us to classify the fracture as the  
8 quasi-cleavage type.

9  
10  
11 Figure 4 View of the fracture magnified 109, (A) describes the places of cleavage,  
12 which gives the whole section the character of quasi-cleavage.

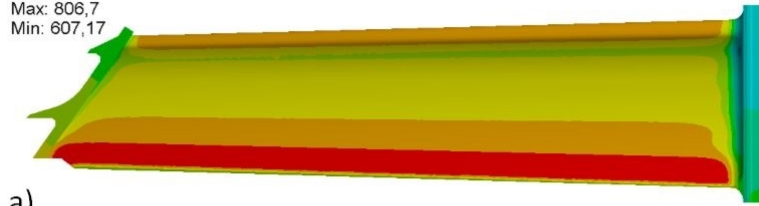
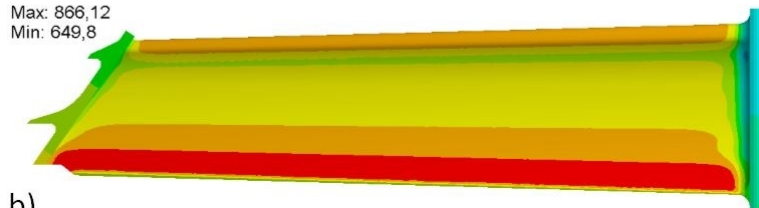
1  
 2 Figure 6 Temperature field, as numerically estimated a) for nominal gas parameters;  
 3 and b) after change.

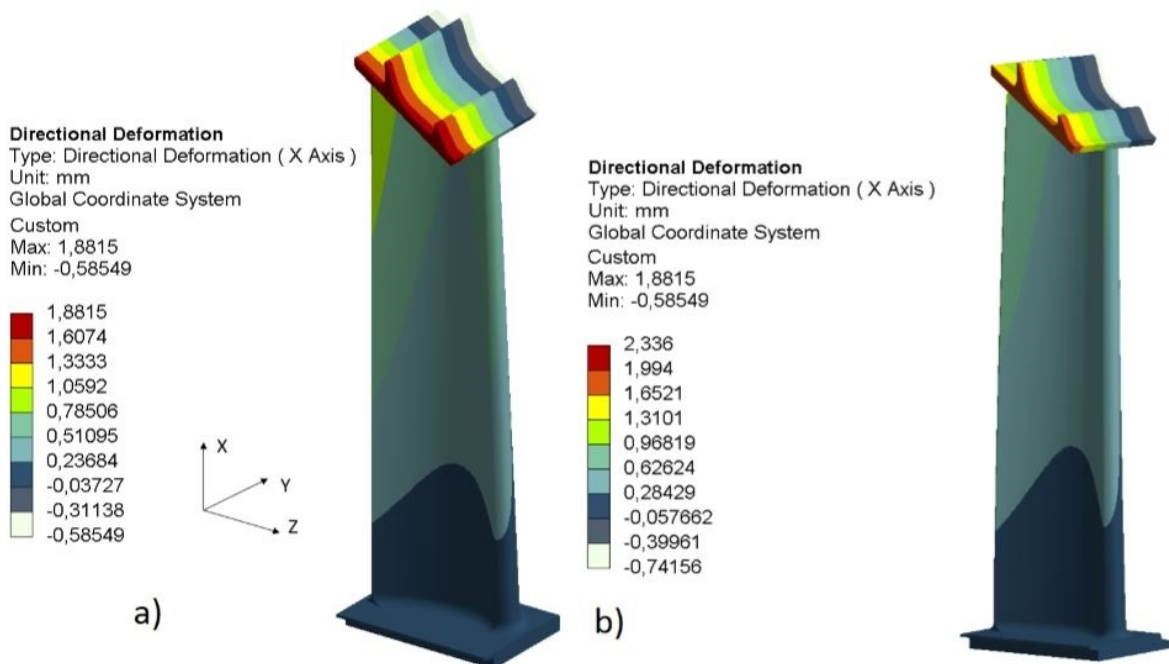
4 Displacement fields for both cases are shown in Fig.7. Not only did the displacement values  
 5 change, but also their area, which resulted in a change in the blade deflection mode. The  
 6 value of the maximum radial displacement when using the replacement fuel increased from  
 7 1.14 to 2.13 mm. The resulting displacement field generated stresses inside the blade  
 8 material.

1 Figure 7 Blades displacement in radial direction for a) nominal gas parameters; and b)  
 2 after change of fuel.

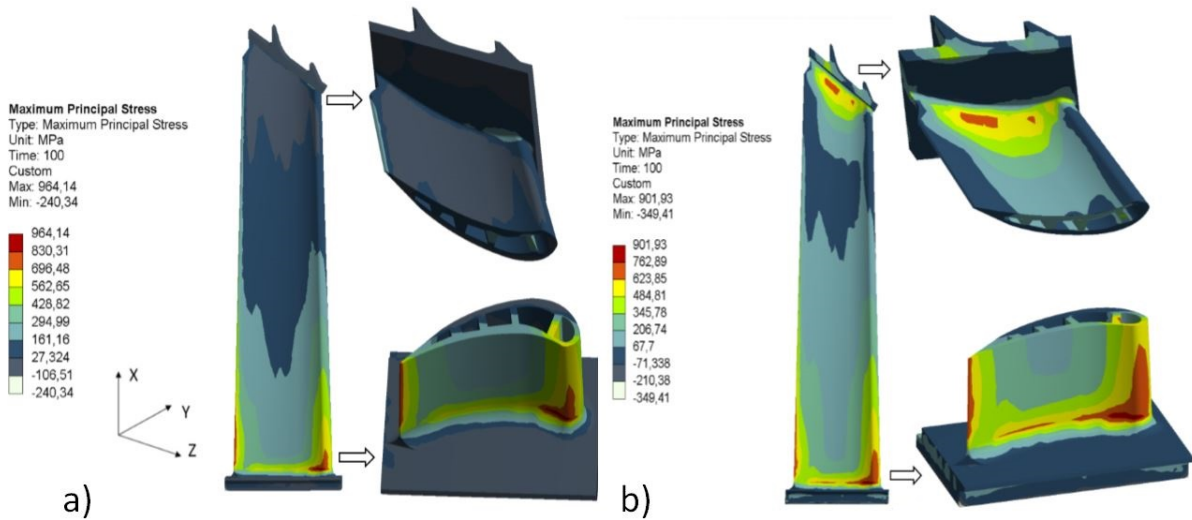
7  
 8 Figure 8 Main stress field read in radial direction for a) nominal gas; and b)  
 9 after fuel change.

10 The maximum principal stresses were read during nominal operation and after the fuel  
 11 change. For the nominal case (Fig.8.a) maximum stress is concentrated around the base of the  
 12 blade, which is consistent with the theory of design turbine blades. In the event of a fuel  
 13 change we observed areas of stress concentration in the area of the base and bandage.  
 14 Stresses reach up to 126 MPa, and in the place of the greatest strain at the base, they increase  
 15 to 395 MPa.

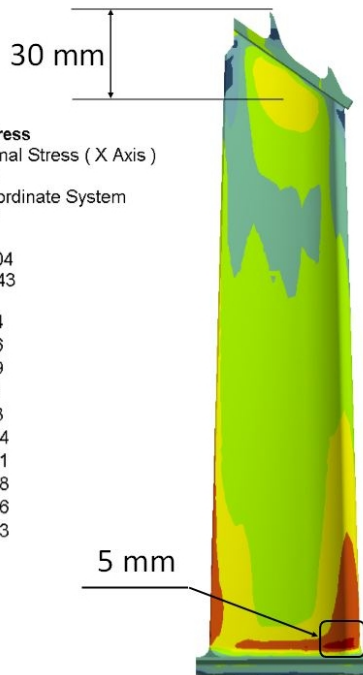
Figure 9 Normal stress field read in radial direction for a) nominal gas; and b) after fuel change.

For more details, the differences in stress values are shown in Fig. 9. The contours of maximum stress are located around the base of the profile, focusing on the front part and on the trailing edge. In the bandage area, stress of 116 MPa was read. In the event of change of fuel, these stresses increased their value to some 450 MPa. Another observation is the small stress concentration area near the profile face at its base. After changing the fuel, the value of stresses read there increased from 480 to 840 MPa. Such high stresses did not exceed a circle with a diameter of 5 mm. The distance between the centre of the stress field around the bandage and the top of the highest seal was 30 mm. This value is identical to that measured during the visual inspection of the failure and previously marked in Fig.1. Also the field of stress concentration at the base of the turbine blade in area coincides with the hole shown in Fig.2.

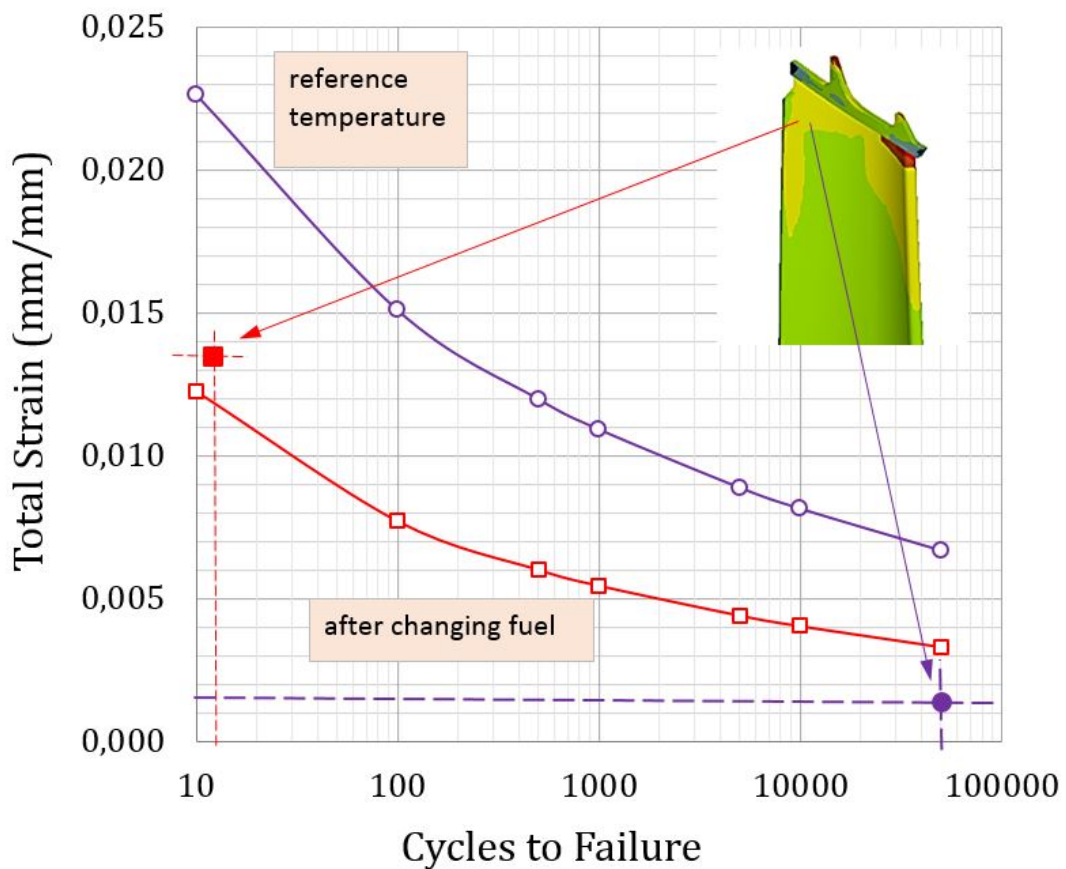
As the first method we applied the Manon's criteria. The results of these calculations are presented in Fig. 10. The presented values were read from the most strenuous area located at the bandage.

1 Two curves were drafted, presenting the relationship of the amount of deformation to the  
 2 number of cycles required to destroy the material. The first (upper) curve presents the  
 3 relationships for the nominal operating conditions of the stage powered by reference fuel.  
 4 The calculated point is located at the bottom of the graph, indicating some 50 000 cycles to  
 5 failure. This value is close to the design value, which for heavy duty stages equals 100 000  
 6 cycles. The magnitude of deformations also falls below the critical line.  
 7 After changing the fuel and increasing the stage temperature, the read size of deformations  
 8 increases drastically, adopting the location of the critical curve drafted for the changed fuel.  
 9 Now the number of cycles to failure reads about 20.

Fig. 10 Estimated number of cycles to failure by using Manson's criteria

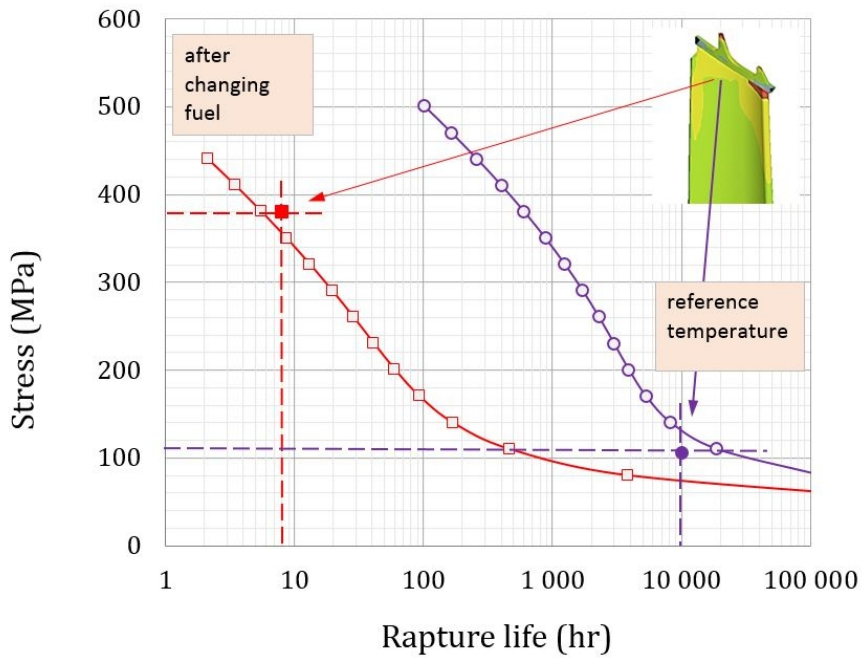
10 A similar relationship was observed when plotting the relation of service life to the magnitude  
 11 of stress generated in the blade. The results are presented in Fig.11. Stresses generated in the  
 12 blade during nominal operation are below the critical line indicating an estimated service life  
 13 of approximately 10 000 hr. The resulting value is also acceptable in terms of design criteria.  
 14 After changing the fuel, the increasing stress caused the crossing of critical line, thus  
 15 determining the value of service life at just 10 hr. This change in available service life is drastic  
 16 and should not be left unnoticed.

Fig. 11 Estimated time to failure using the first technique of data description.

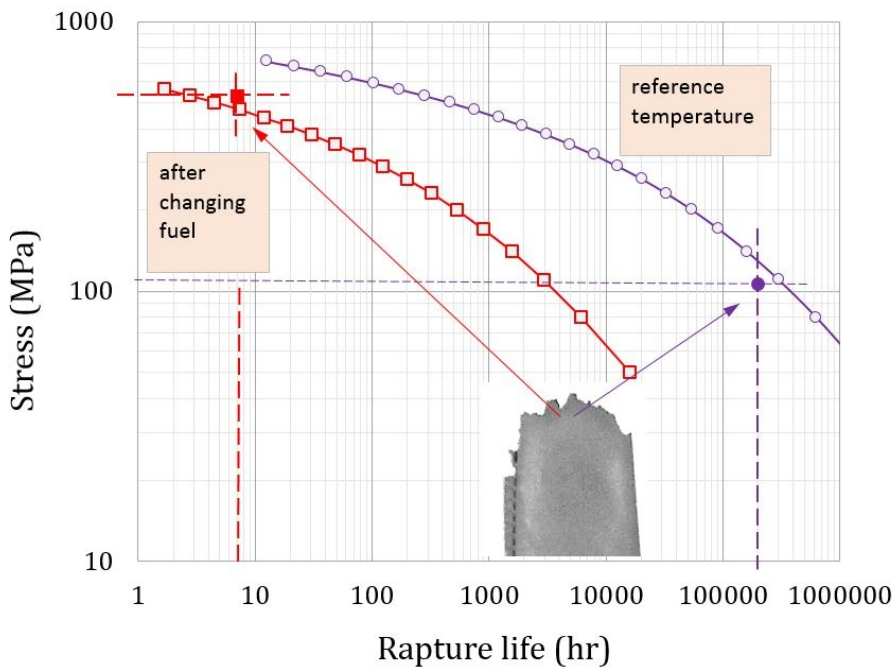
Fig. 12 Estimated time to failure using the second technique of data description.

The results presented in Fig. 12, confirm the existing rule. Stresses read in the blade material in the FEM analysis indicated the possibility of seamless blade operation of up to 200 000 hr. Changing the fuel, and thus the working conditions of the stage and stress of materials reduced the permissible operating time to 8 hr. These results are consistent with previous observations.
