# Typology, current state and non-destructive testing of timber roof trusses of historic churches in the West Vistula Delta, Poland

## Abstract

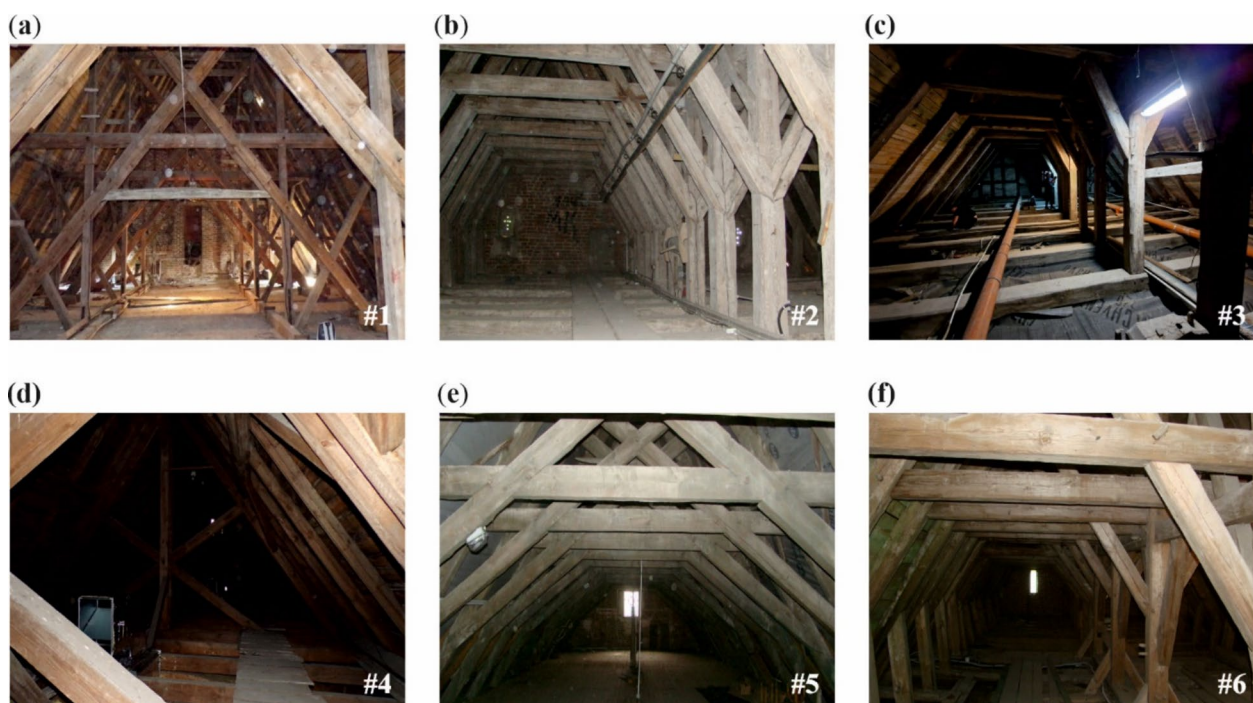
The analysis shows that the most common type of roof truss in the historic churches located in Żuławy is the king post truss (Figs. 4, 5b, c, f). In church #5 (Fig. 5e) there is a collar beam truss with struts, in church #4

(Fig. 5d) there is a scissor truss. In the church #1 (Fig. 5a) there is an attic truss shaped similar to that of the previous structure, that one from before the war damage.

**Fig. 5** Roof trusses in: **a** Miłobądz (#1), **b** Pruszcz Gdański I (#2), **c** Kieźmark (#3), **d** Pruszcz Gdański II (#4), **e** Koźliny (#5), **f** Trutnowy (#6)

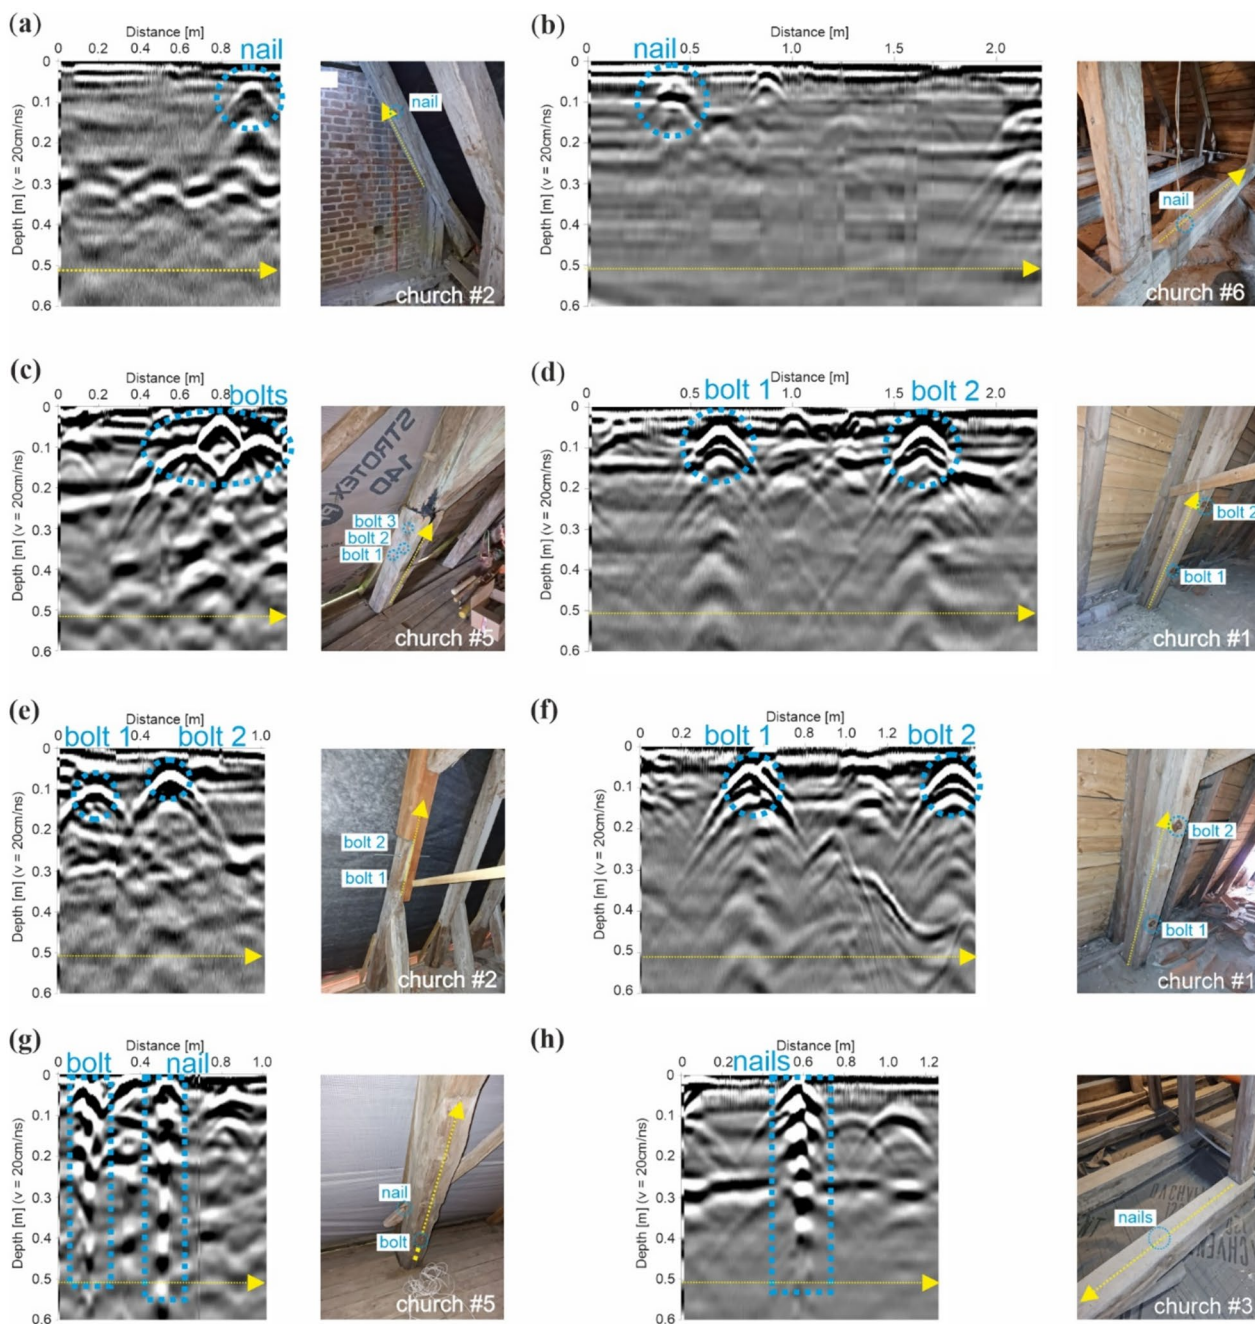
In the case of screws and nails, where the main axis is perpendicular to the direction of GPR movement, their location is marked on the B-scan in the form of several hyperbolas located one above the other (Fig. 8g, h). GPR

**Fig. 8** GPR radagrams locating bolts and nails in timber beams a plane parallel (a–f) and perpendicular (g, h) to the moving GPR antenna

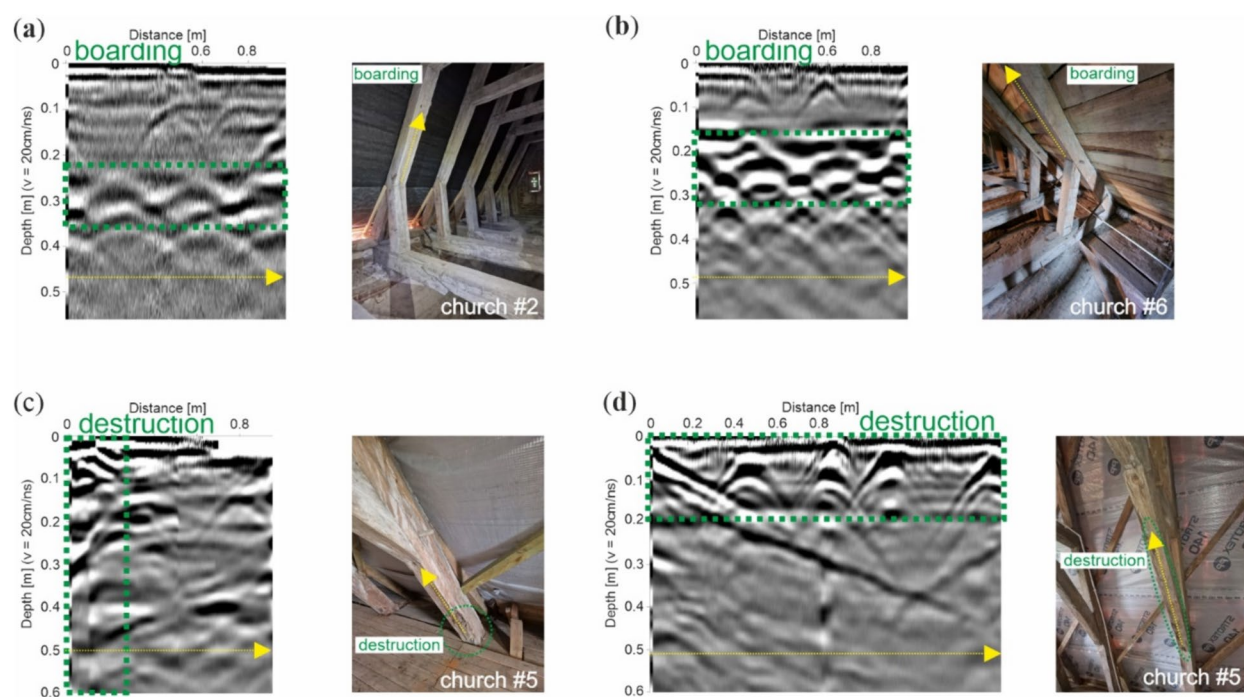
The reflections from the boarding are also characteristic and they form a sequence of evenly spaced hyperbolas on the radargrams, indicating the locations of board joints (Fig. 10a, b). Damage to timber elements causes disturbances in GPR radargrams. Figure 10c shows a local failure on the lower part of the beam. The beam shown in Fig. 10d is completely and shallowly damaged, causing numerous reflections. Figure 11 shows beams from three different girders from the churches in Trutnowy, Pruszcz Gdański I, Kiezmark, and Koźliny, respectively which show varying degrees of destruction. The scans prepared for undamaged beams can be considered as reference. The reflections from the bottom of these beams are visible here, which allows the thickness of the element to be assessed. The scans prepared for the damaged beams indicate a significant disturbance in the propagation of electromagnetic waves. This demonstrates high sensitivity of the GPR method to any defect in a timber element. The reference scan is not always feasible, but it makes the interpretation of the results much easier.

**Fig. 10** GPR radagrams locating the boarding of the roof truss and decay of timber beams: **a**) Pruszcz Gdański I (#2); **b**) Trutnowy (#6); **c**) and **d**) Koźliny (#5)

- Damage and air voids in the timber beams affected the path of electromagnetic waves in the wood, causing severe distortions.
- Comparing the results for several beams made of the same material, being the same age, shape, dimensions and location allowed for a more accurate analysis of the technical condition of the tested beams. With the undamaged reference element, it was possible to

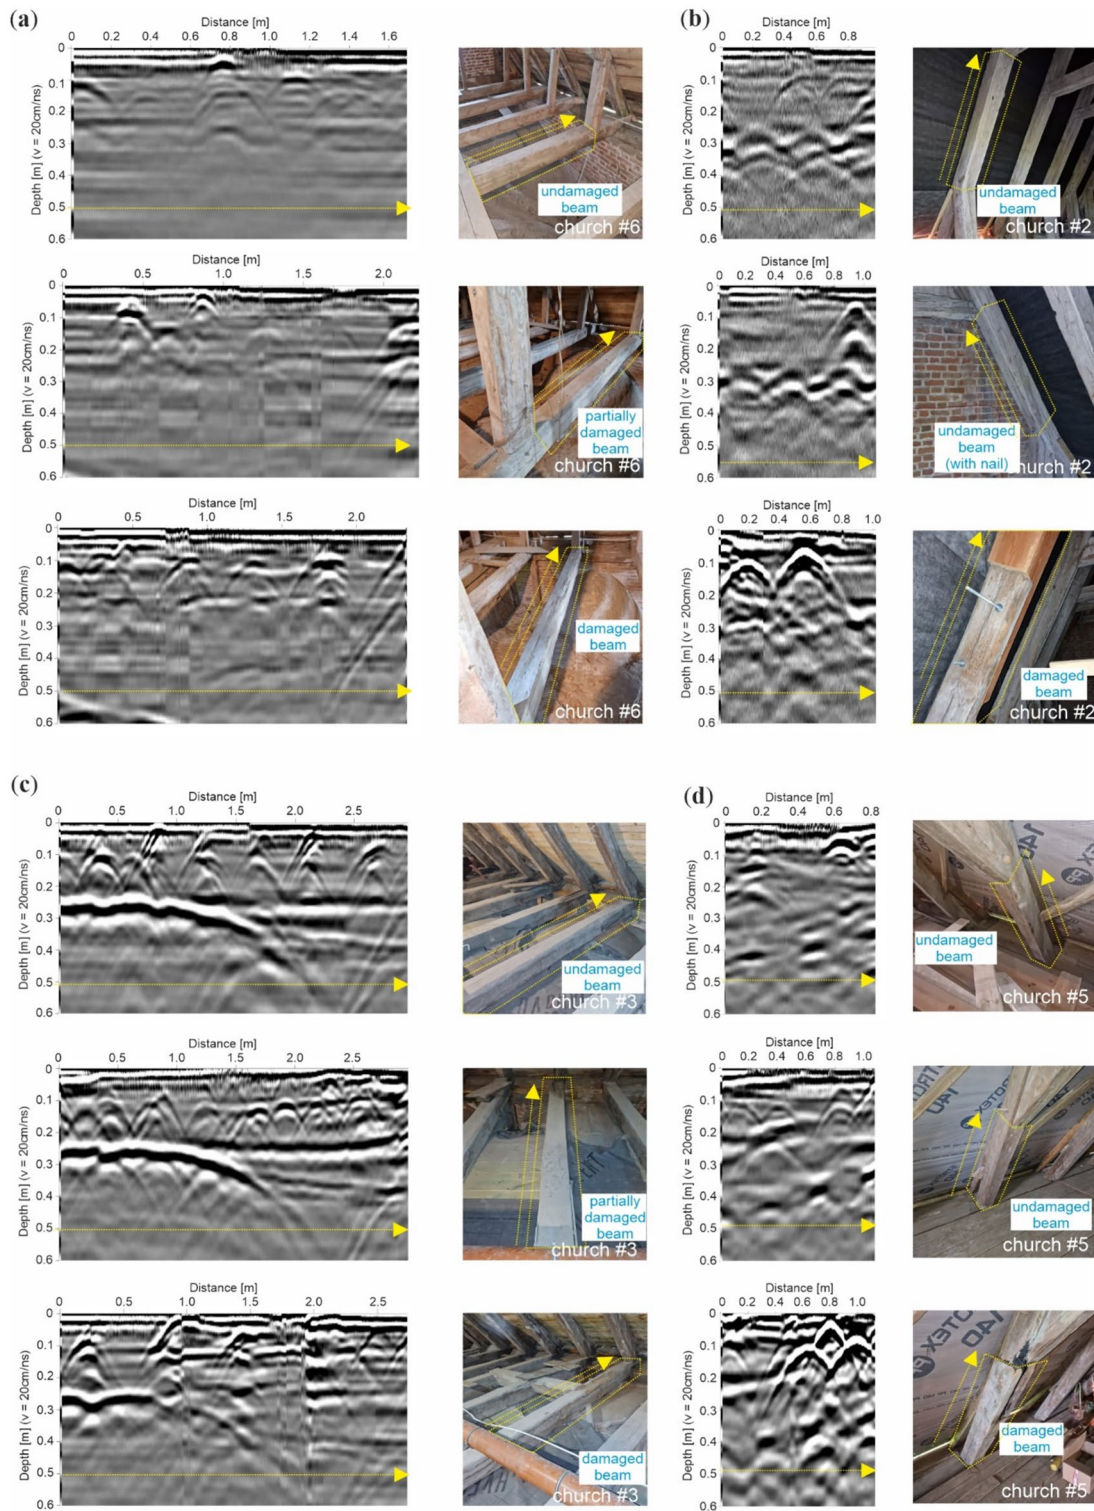
**Fig. 11** Comparison of GPR radargrams of beams from three different trusses from churches in **a)** Trutnowy, **b)** Pruszcz Gdański I, **c)** Kiezmark and **d)** Koźliny

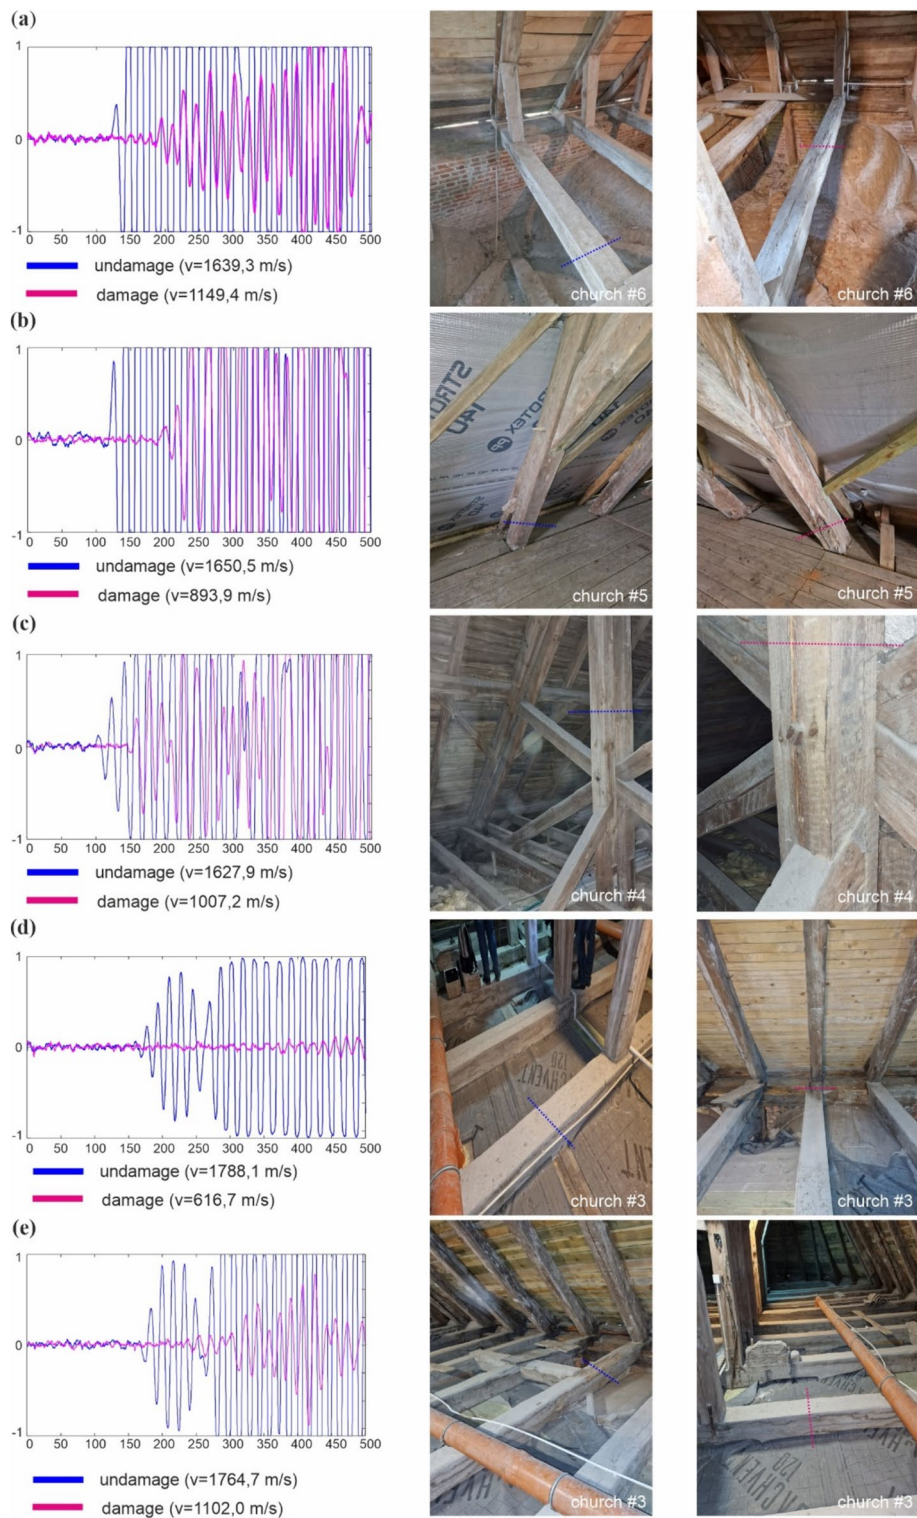
tested, the density of the material and the type of wood, the minimum velocity is 893.9 m/s, while the maximum is 2777.8 m/s. The fact that the tests were carried out on three similar roof beams in each church made it possible to compare the signals for the beams of the same type, geometry and significance. Figure 12 a–e show graphs of the signals from measurements performed on two beams. Photographs of both beams are shown alongside the diagram. One of the beams is undamaged, while the other one shows varying degrees of damage in the form of voids (Fig. 12a–c), cracks (Fig. 12d) and moisture (Fig. 12e). The location of the measurement is marked in the photographs with blue and pink lines, for the undamaged and damaged beams, respectively. The TOF (time of flight) of the damaged elements is longer than that of the reference elements. The undamaged elements have similar velocities, ranging from 1627.9 (Fig. 12d) to 1788.1 m/s (Fig. 12e). The velocities in the damaged elements decrease significantly and reach the values of only 616.7 m/s (Fig. 12e) to 1149.4 m/s (Fig. 12a). It is worth noting that the amplitude of the signal also decreases for the damaged elements.

- The reference element (an undamaged beam) helped to determine the degree of failure of an element of the same geometry and importance degree.
- Damage in the form of voids, cracks and moisture significantly reduced the velocity of the ultrasonic wave.
- The diagnostic indicator based on ultrasonic wave velocity was sensitive in locating joints between elements with air voids. In the case of adhesive joints, the wave propagation velocity did not change significantly.

**Fig. 12** Ultrasonic wave signals in undamaged and damaged elements with photos of the tested beams: **a)** Trutnowy (#6); **b)** Koźliny (#5); **c)** Pruszcz Gdański II (#4); **d)** and **e)** Kiezmark (#3)

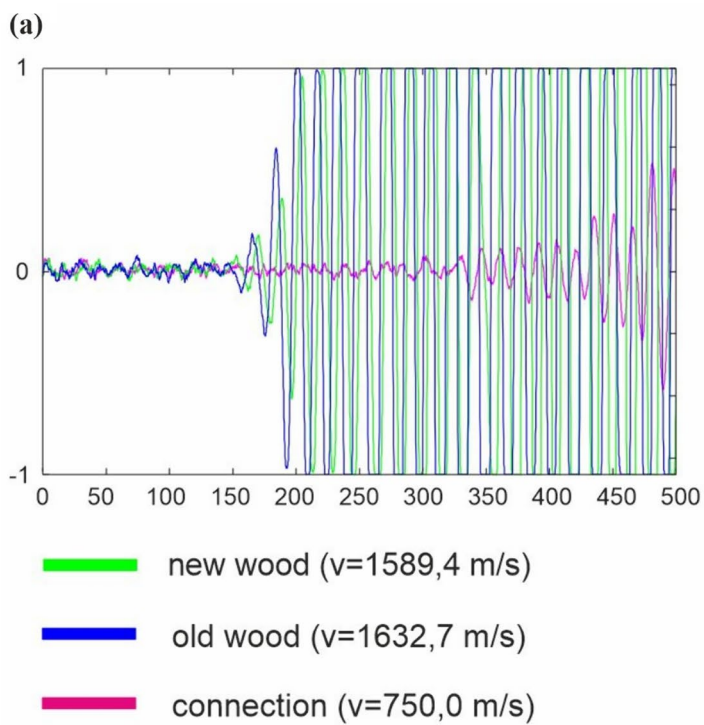
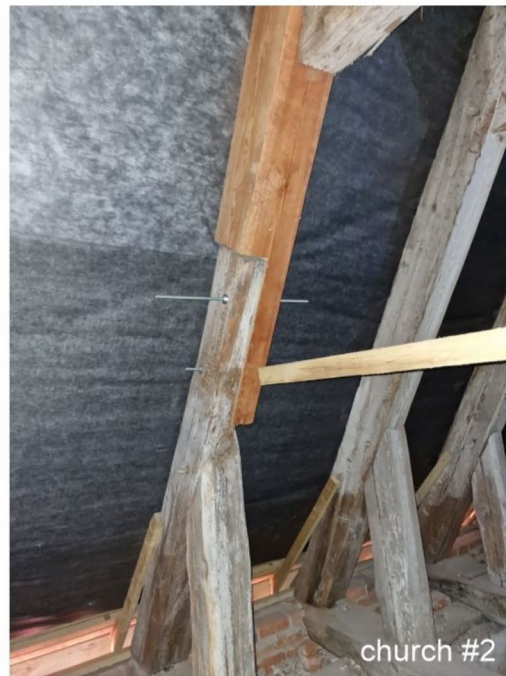
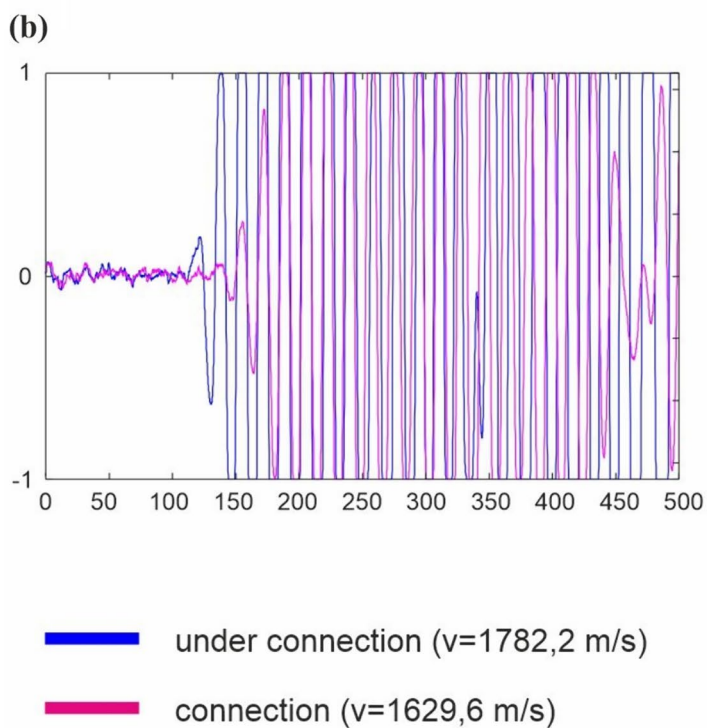
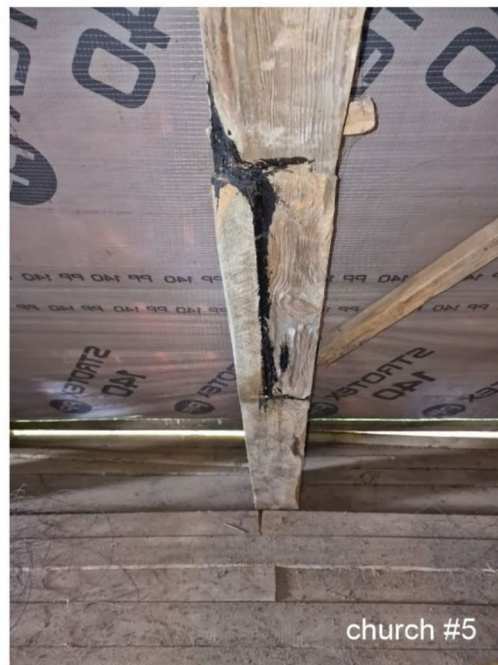
The ultrasonic wave signals propagating through the connections of the elements were analyzed. The measurements were made for straight overlap joints (Fig. 13). The first joint analyzed was in the church #2 and the second in the church #5. Both connections were bolted, and the second was additionally sealed with some adhesive. For the first analyzed joint, the measurements were taken at three levels: above the joint of the new beam, below the joint of the old beam, and at the level of the joint. The propagation velocities were 1589.4 m/s, 1632.7 m/s and 750 m/s, respectively. The signals obtained for the new

and old beams were similar. At the level of the connection, the signal weakened significantly and the propagation velocity decreased more than twofold. In the case of the second joint, where a sealing adhesive was used, the velocity of wave propagation decreased slightly from 1782.2 m/s for a full beam to 1629.6 m/s at the level of the connection. The results obtained prove high sensitivity of the ultrasonic method in the case of joints with air

**Fig. 13** Ultrasonic wave signals in wooden beam connections: **a)** Pruszcz Gdański I (#2); **b)** Koźliny (#5)
