# Causes of damage and methods of repairing floor made on polystyrene concrete

**Abstract.** The paper describes damages, tests and repair of the floor made on existing ceiling and expanded polystyrene concrete underlay. The floor was built on a reinforced concrete ceiling with an area of about 1050 m<sup>2</sup>. Significant damage in the form of cracks, detachments and unevenness was found in the floor. In order to determine the causes of damage, in situ tests and laboratory tests were carried out. It was found that the damage was caused by numerous performance errors. A test repair of the damage (4.7x6.0 m) was carried out, and then the repair method was applied on the entire floor surface.

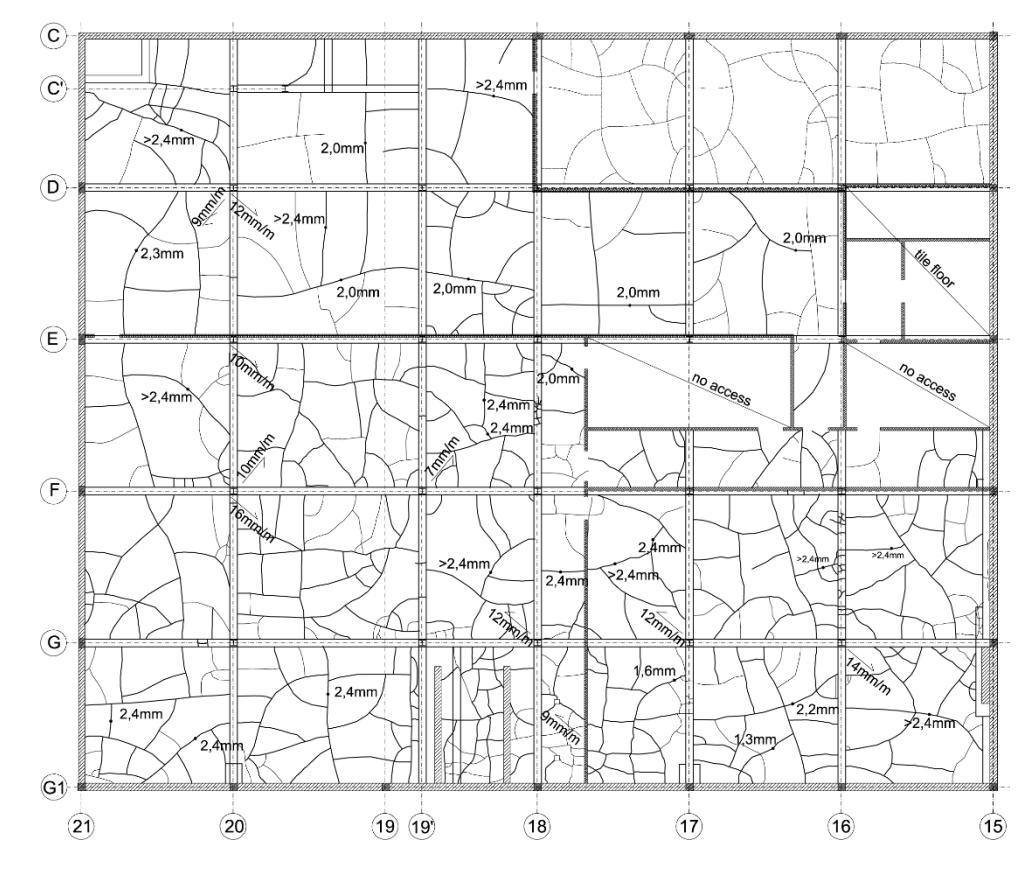
Already a few hours after the screed was made, numerous cracks have appeared on the surface. Additionally, top layer detachment as well as lack of homogeneity were observed. The crack width often exceeded 3 mm. The cracks occurred both on surfaces of self-levelling screed over the EPS concrete layer and concrete poured over reinforced joists. Near the joists the cracks propagated down to the layer of the EPS concrete.

Visual inspection determined several performance errors, including uneven thickness of screed and EPSC, lack of precision in the execution of expansion joints and stratification of the concrete (up to three layers). The floor was clearly uneven - the slope of several slabs reached up to 16 mm/m, while spacing under two-metre-level and floor was up to 7 mm. It was observed that floor cracks protruded beyond expansion joints, which proves that the cuts were made too late.

Attempts to repair the damages by injection were made, however, the holes were drilled vertically at a distance from the cracks, not as supposed through the cracks at a certain angle. The map of cracks, their width as well as floor slope are presented in Fig. 3. Chosen damages to the floor were shown in Fig. 4 and Fig. 5.

Fig. 3. Floor damage. The values of slopes and crack width are given.

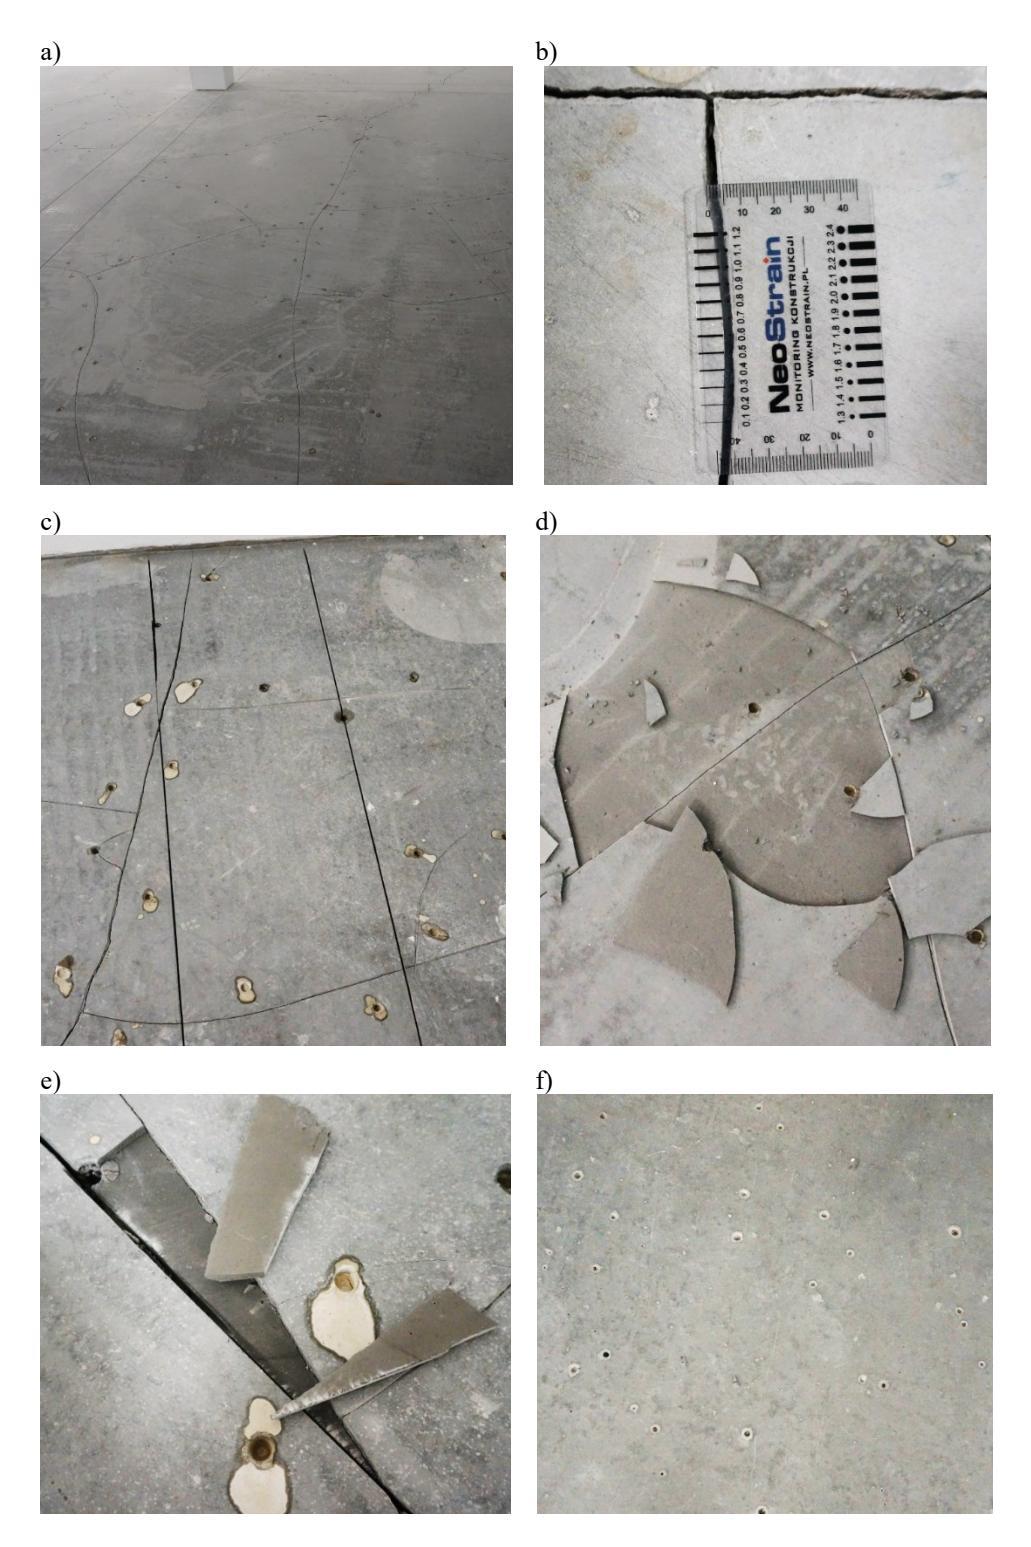
**Fig. 4.** Damage type: a) cracking, b) crack width measurement, c) cracks protruding through expansion joint, d) e) self-leveling layer detachment, f) pores caused by improper mixing.

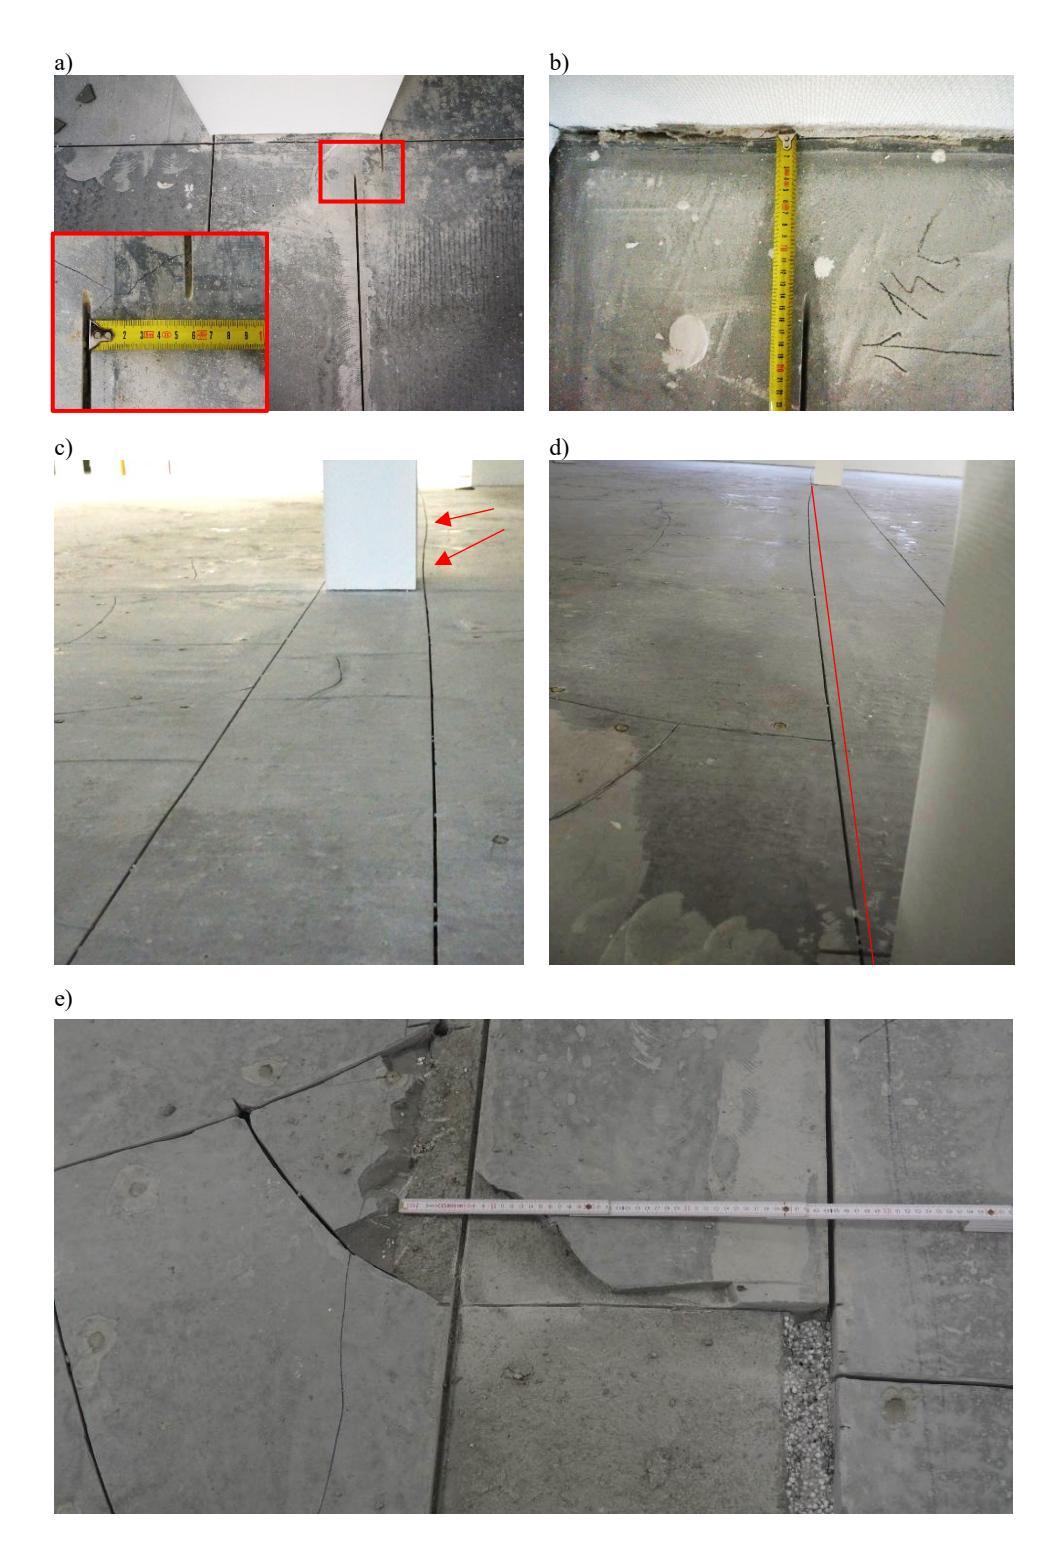
**Fig. 5.** Imprecise expansion joints: a) lack of continuity, b) improper cut near the wall, c), d) uneven cuts e) inverted beam exposure. Expansion joints are at the distance of 7 cm.

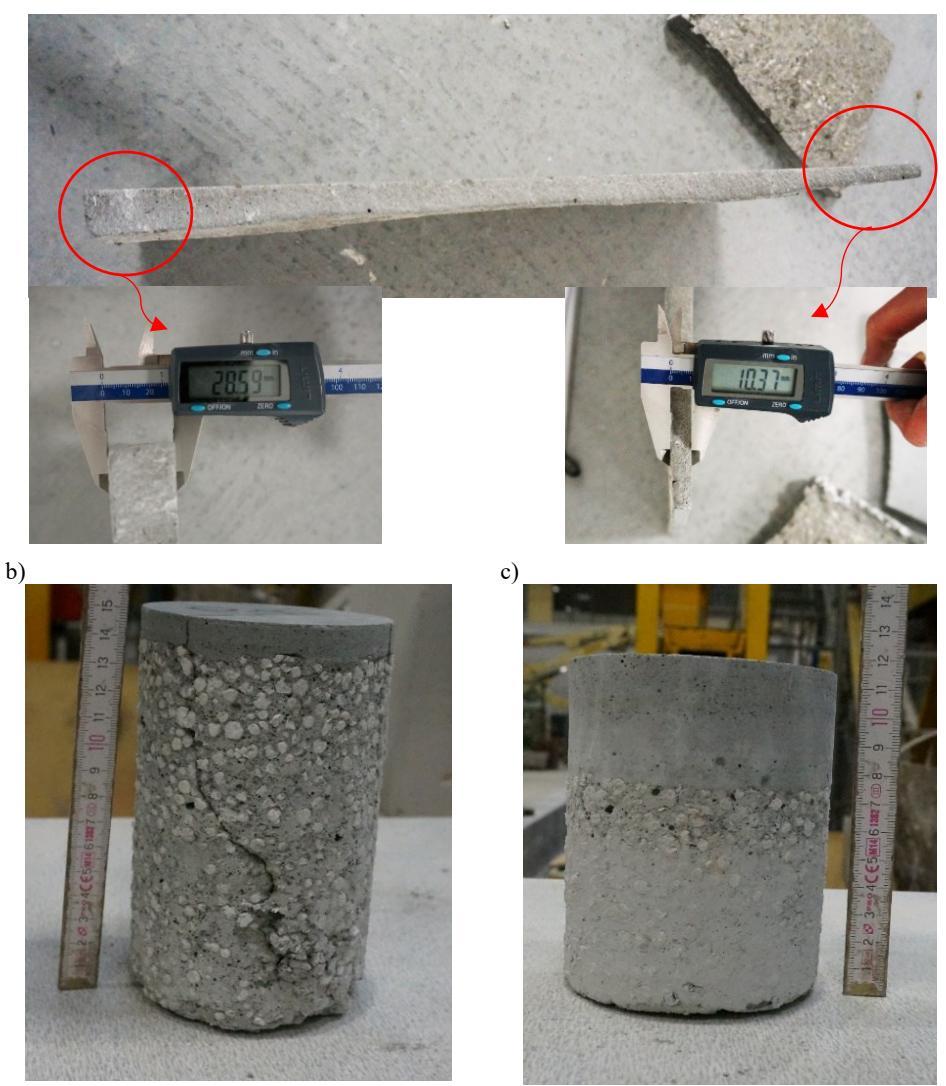
**Fig. 6.** Changes in thickness of self-leveling screed and EPSC layer: a) measurement of detached screed layer 10.37÷28.59 mm, b) EPS concrete layer (140 mm) in a core sample, 10 mm of screed, c), EPS concrete layer (75 mm) in a core sample, 42 mm of screed.

The pull-off tests conducted on the damaged floor resulted in the stress at break between  $0.12 \div 0.34$  N/mm<sup>2</sup>. The test concurred previous observation of uneven thickness of the floor screed. The thickness of the screed was between 12 and 40 mm, only in P1 measurement point obtaining desired value. The samples before and after the pull-off test are shown in Fig. 11.

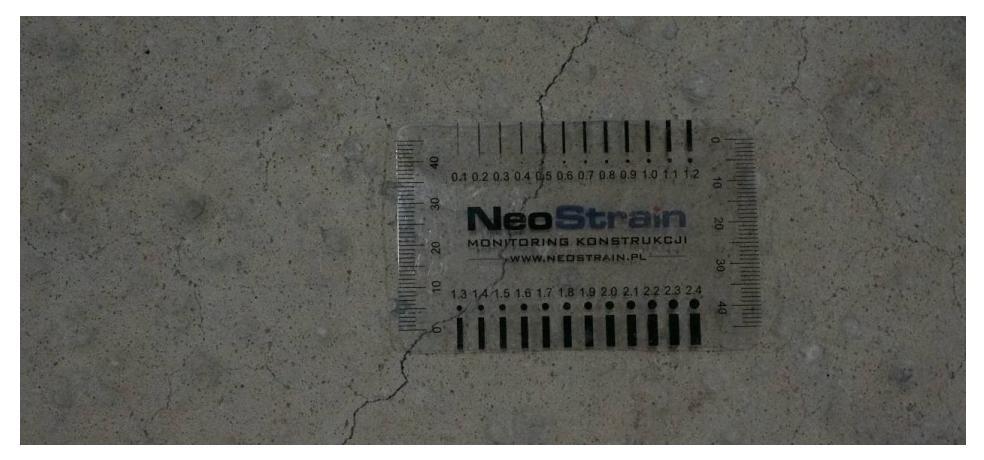
The visual evaluation of the samples was being conducted for over 2 months. The observations lasted over 2,5 times longer than the time in which the cracks occurred in analyzed floor. After 49 days first three samples did not exhibit any signs of cracking. The last sample exhibited small shrinkage cracks. Local width of the crack reached between  $0.1\div0.5$  mm. The cracks on the surface of the EPSC occurred after two weeks due to lack of curing. The cracks are shown in Fig. 10.

Fig. 10. Measurement of the cracks in sample no. 4.

Comparative tests have shown that it is possible to make a self-levelling screed for the designed floor. Lack of curing resulted in the occurrence of cracks in the EPS concrete.

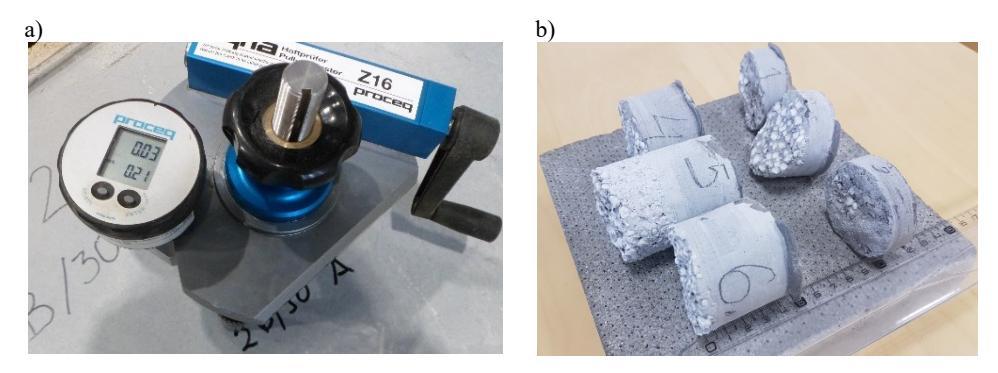
In the performance declaration, the manufacturer declares layer-to-layer adhesion of at least  $0.2 \text{ N/mm}^2$ . As seen from the results, the local adhesion did not meet the requirements.

Fig. 11. Sample (no. 2) during the test and afterwards (samples from the damaged floor).

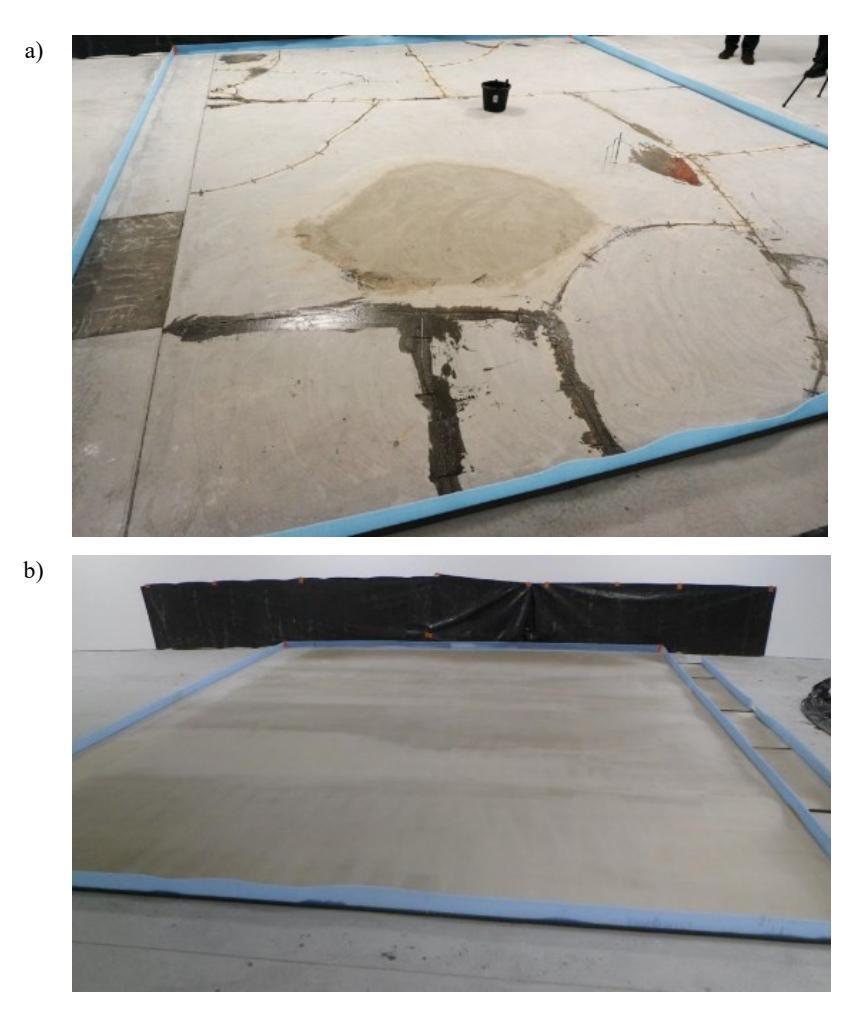
Fig. 13. Repair method: a) view after stitching and injection of the cracks, b) finished top layer.

An attempt was made to repair damaged floor in a selected field of  $4.7 \times 6.0$  m. It was decided to perform repair by stitching cracks with a thin copper stainless steel wire, perpendicular to their course, filling possible empty spaces with cement-based mortar. Stitching reinforcement was placed in incisions every  $20\div25$  cm. The places of stitching and cracks were filled with an injection resin (Fig. 13). This method allowed for a tight connection of floor fragments separated by cracks. It also allowed to obtain a smooth surface under the planned top floor, which was the base for the final finishing of carpet floors. Since the sample repair has proved correct, the whole floor was repaired with this method.
