Journal of Polish CIMAC Gdansk University of Technology The Faculty of Ocean Engineering and Ship Technology

# ENDOSCOPIC IMAGE PROCESSING AND ANALYSIS OF PISTONS' SERVICE FAILURES OF MARINE DIESEL ENGINES

# Zbigniew Korczewski

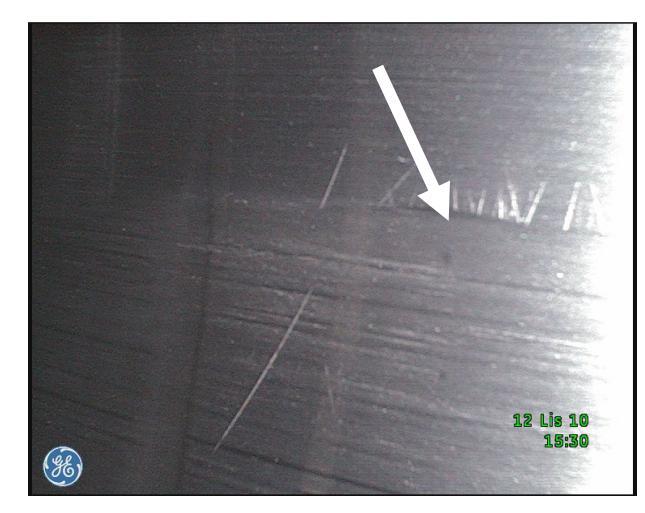
A considerable, local piston head's overheating, up to exceeding a plasticity border of the constructional material, causes its local upset. If a temperature growth of the piston's head is only temporary there could be also affected a temporary wearing down and even seizing the piston's crown in the cylinder bearing surface - Fig. 2a [4].

a) cylinder bearing surface - friction traces originated from the piston leading part

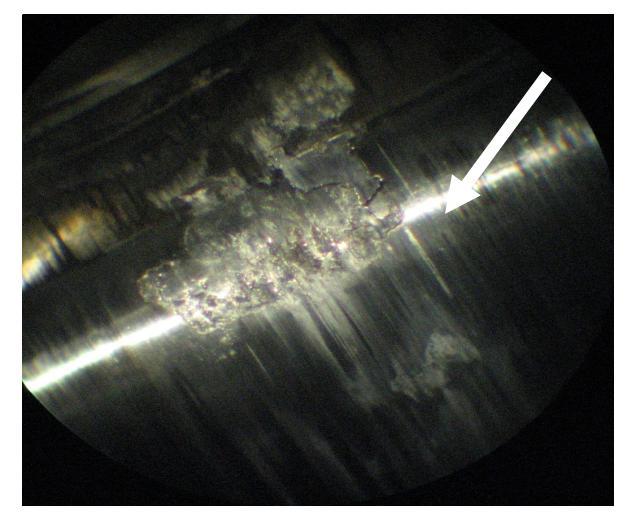
If a temperature growth of the piston's head is so large that the engine's cooling system is not able to take over a warmth stream from the combustion chamber's constructional elements a stable growth of external dimensions of the piston's crown occurs. Consequently, lubricating conditions of the friction pair: piston-cylinder are altered. In such a situation, with regard on "favorable" conditions of appearing the second kind adhesive waste, a decay of the surface layer of the piston's constructional material (made of an aluminum alloy) takes place. Such a phenomenon consists in a local joining the frictional surface's tops of the piston and cylinder liner together as well as a tearing off the aluminum particles and in consequence - their smearing over the cylinder bearing surface - Fig. 2c. Often, a surface of the rolling areas does not encircle the whole circuit of the cylinder liner. It proves, at small rolling thickness, that only a short-lived excess of the flow temperature of the piston's crown happened. The rings, that work properly, take off the piston's material rolled on the cylinder surface after lowering

c) cylinder bearing surface – smearing traces of the piston material's layer (aluminum alloy)

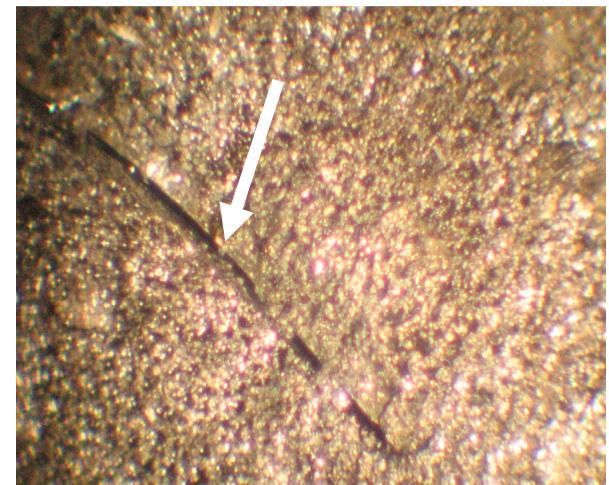
A low-cycle fatigue of the piston's head up to cracks' occurrence, connected with cyclic squeezing and spreading tensions of the constructional material represents a different consequence of this phenomenon - Fig. 2b. They result from cyclic, respectively: the material overheating and widening as well as its cooling down and shrinking, during the engine's work cycle realization.

b) piston head – a crack fatigue

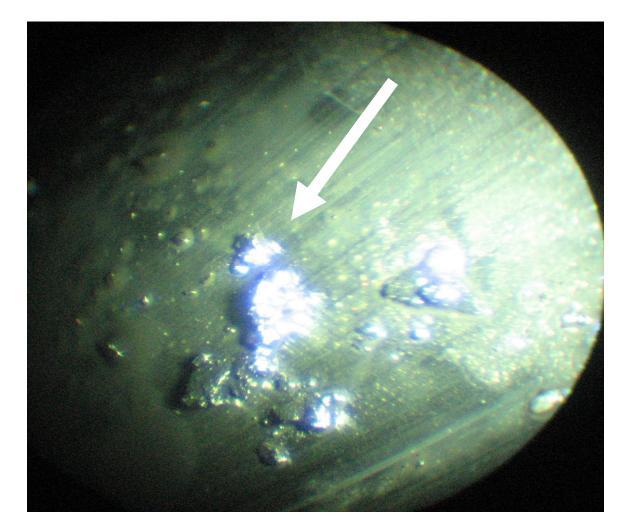
the piston head's temperature when the lubricating conditions get better. Unfortunately, it usually produces undesirable results - an intensive growth of the aluminum particles quantity in the engine's lube oil system - Fig. 2d.

d) cylinder bearing surface – metal fillings (aluminum alloy)

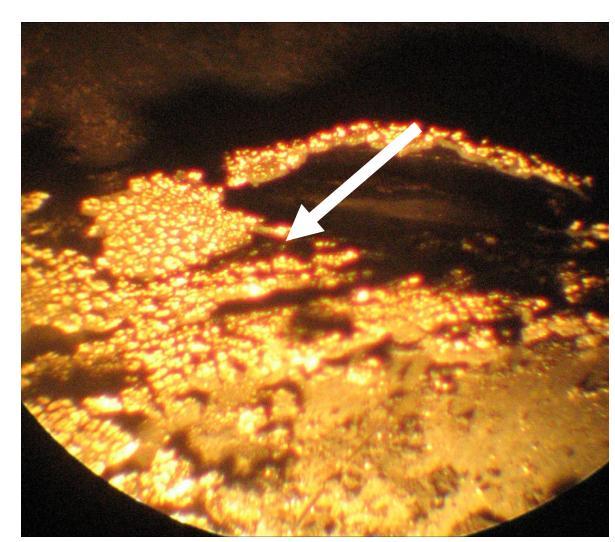
e) piston head – a thick layer of the carbon deposit *Fig. 2. Endoscopic image of marine engine pistons' damages and their consequences*

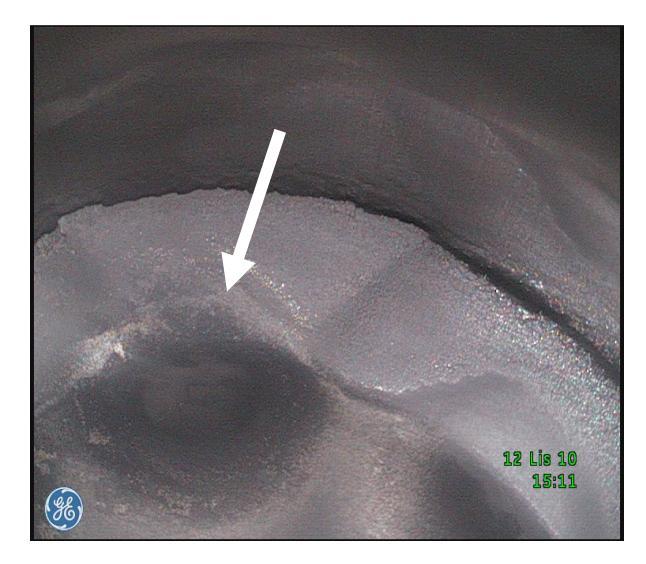
a) piston head - traces of the fuel after-burning

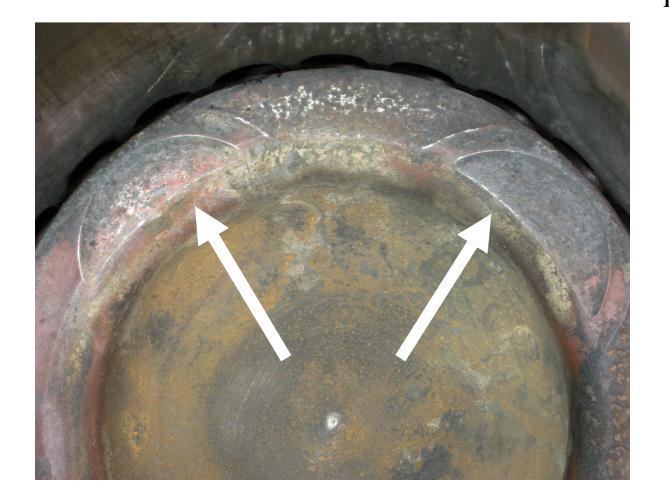
b) cylinder bearing surface - traces of the piston ring's seizing

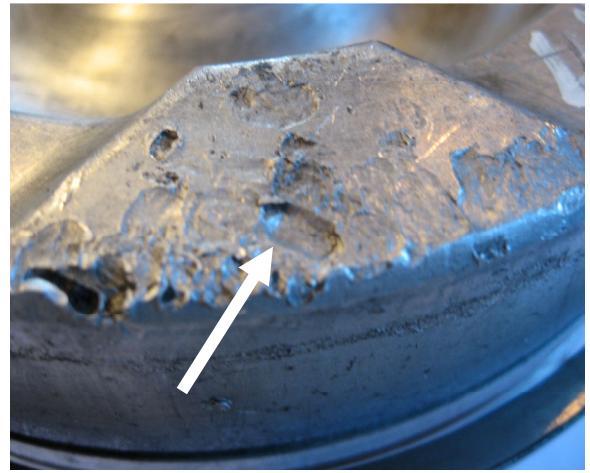
c) piston head – traces of the piston strokes over the valves (a state after the "water hammer")

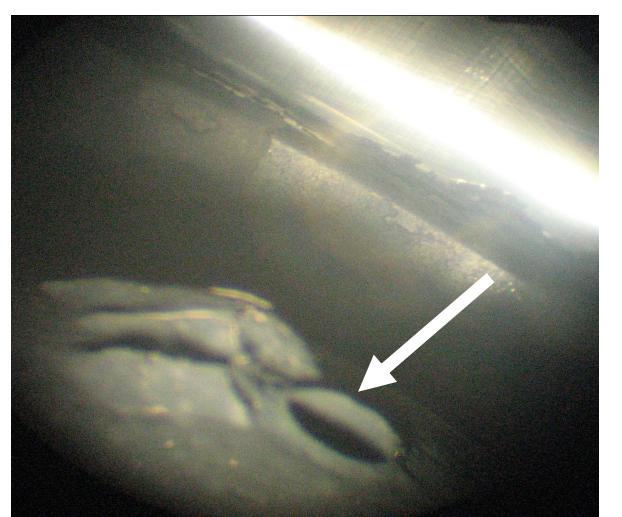
Piston mechanical deformations represent its relatively often occurred damages. They are usually caused by the valve's part (the exhaust valve generally) e.g. a broken off valve's head, which has fallen into the combustion chamber - fig. 3d. During its operation the cylinder valve is forced to move along its spindle in the guide which undergoes irreversible friction wear. The process goes at high temperature of the spindle whose additional task is to absorb heat from the valve head. As a result an excessive increase of radial clearance is produced between the guide and spindle, which, in all the cases, leads to an undesirable skew of the valve especially, that it is loaded with transverse component from the pressure of the timing lever or cam. Consequently, a loss of cylinder tightness (compression pressure drop), gas eruption, returnable flows, lubricant leakage from the spindle – guide precision pair until an

d) piston head's crown - traces of the strokes made by the broken-off part of the valve head

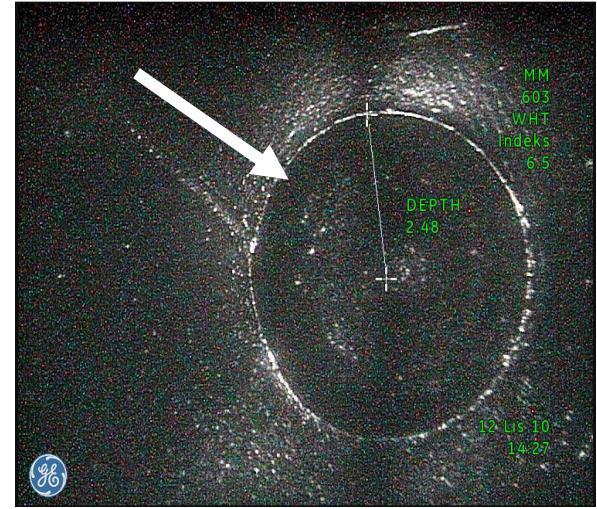
A presence of the punctual dent on the piston head, that is placed in an injector's axis (fig. 3e,f) testifies about the piston's mechanical strokes over the injector resulting from e.g. the elongated piston stroke (for some high- speed engines, a distance between the piston head and injector's ending at TDC is not more than 3-4 mm [11]). Such a situation might represent a consequence of excessive clearances in an assembly of crank-shaft or intensive wear and tear of bearing pans.

An excessive injector's lowering which is mounted in the head stands for different probable reason of this type dents' formation, caused by the inappropriate-chosen washer under the injector. It in such a situation was one should explain the prime causes of the dent's presence, and independently - the injector has to be definitely exchanged. Further operation in such state usually drives to cracks and even breaking-off the injector's ending. Moreover, an intensive fuel leakage to cylindrical spaces and thinning the lubricative oil with fuel might occur until to development of the extensive secondary damages in cylindrical sets, threatening with the engine's breakdown.

e) piston head – a dent after the piston stroke f) piston head – a measurement of the dent's over the injection sprayer

depth by means of the "Shadow" method (2,48 mm)
