Application of materials science in the investigations of power cable damage

The subject of the investigations was the XRUHAKXS-WTC 1x300RMC/95, 76/132 kV cable, which is part of a 110 kV cable line. Damage to the aforementioned cable, located on a pole constituting a transition to the overhead line, caused an earth fault in the process of connecting the

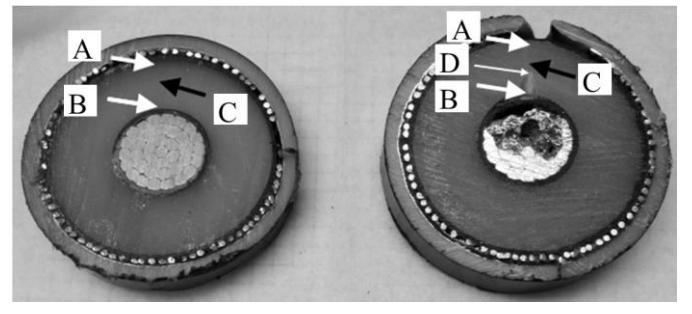
line. In order to determine the cause of the incident, a sample of the damaged cable was submitted for testing. A Zeiss LSM710 laser scanning confocal microscope (LSM) in the material (reflected light) and photoluminescence modes was used for characterization of the cable cross section. The laser beam of 633 and 458 nm wavelength was used. Photoluminescence (PL) spectra were collected using LSM system conjugated with Stellarnet Inc. Black-Comet CXR-SR-50 grating spectrometer in wavelength range 220-1100 nm. Laser beams with wavelengths of 458, 488, 543 and 633 nm were used to record photoluminescence spectra. Raman spectra were measured with a Labram HR 800 spectrometer (Horiba Jobin Yvon), using a He-Ne laser (λ = 632.8 nm) and a liquid-nitrogen cooled CCD detector; the Si line (520.7 cm⁻¹) was used for calibration. The beam was focused on the sample using a x20 objective, and the beam power on the sample was about 1 mW to avoid overheating. A typical exposition time for a single spectrum accumulation was about 30 s and the spectrum was determined after averaging 10 accumulations. Exposure time in some spectra has been reduced to 20 or 10 seconds due to the intense signal and related detector limitations. Figure 1 shows the approximate locations of the spots on the reference and the sample from which the spectra were collected.

Fig. 1. Investigated sample (right side) with the reference sample (left side). Indications: arrows indicate spots A-D.

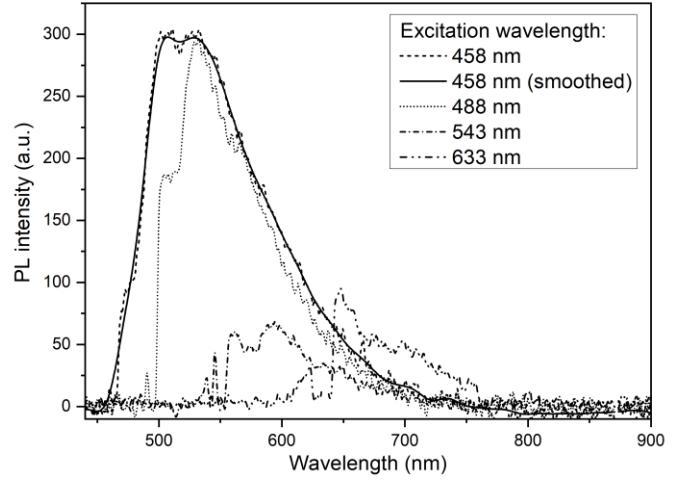
In order to exclude a manufacturing defect of the mentioned cable, the material investigations were conducted. The LSM images of the sample near the damaged area were obtained in reflected light and photoluminescence modes. The clear and intense photoluminescence is visible in the damaged region appearing as a half ellipse shape in the middle from the top of images. For comparison, similar images were collected for a reference sample in which photoluminescence was only observed at an excitation wavelength of 488 nm. Furthermore, in the reference sample, photoluminescence was only observed near the center of the wire, which contains an additional isolating layer. Figure 3 presents the PL spectra collected in the damaged area under irradiation with a laser beam of different wavelength. In the analysis of PL spectra, the 458 nm excited spectrum is most accurate due to the presence of color filters and dichroic mirrors in the light path, which distort the shape of the spectrum at longer excitation wavelengths. The photoluminescence is characterized by wide band with two separated maxima around 505 and 530 nm. In contrast, freshly synthesized polyethylene shows PL spectra of maximum near 425 nm under 375 nm excitation wavelength. However, for the thermally aged polyethylene a strong bathochromic shift of PL spectrum is observed [15]. Therefore, most probably the PL observed in the sample comes from thermally damaged polyethylene.

Fig. 2. The photoluminescence spectra of sample damaged area excited with light beam of varied wavelength.

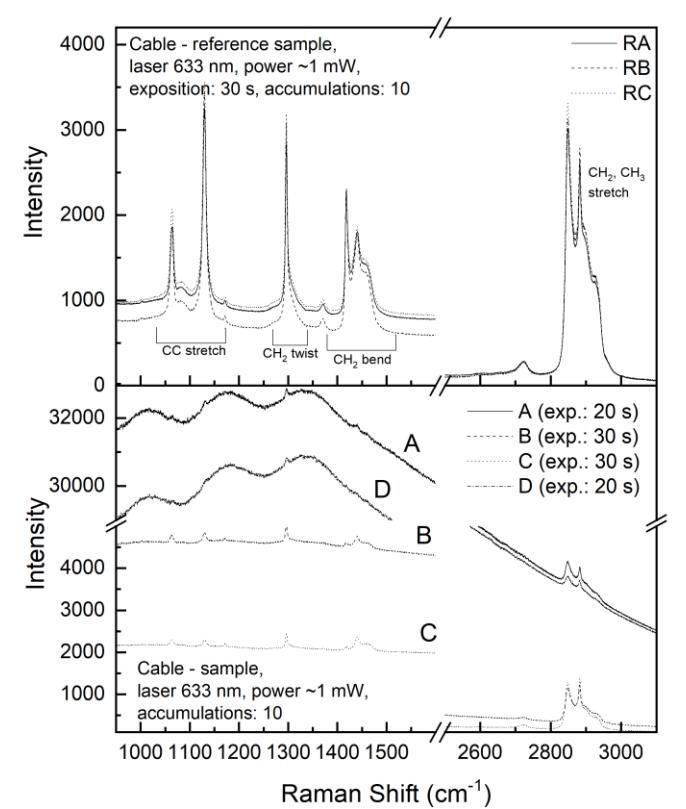
In the Fig. 3A the Raman spectra of reference sample at 3 spots (RA, RB and RC) are presented. The spectra are typical for polyethylene with characteristic bands at about 1063 cm⁻¹, 1130 cm⁻¹, 1296 cm⁻¹, 1418 cm⁻¹, 1441 cm⁻¹, 2849 cm⁻¹, 2882 cm⁻¹ [16], [17], and shows that investigated material is rather homogenous without significant differences between the spots.

Fig. 3. The Raman spectra of the reference sample (A) and sample from the damaged part of the investigated cable (B)

Figure 3B shows the spectra recorded from the sample of the damaged cable at indicated points. It is easy to notice, that spectra at the spots A and D are completely different from the reference data. Moreover, a strong background is observed for these spots, which arises from the fluorescence of the sample. However, there is still visible some reminiscence of the polyethylene bands. The spectra at spots B and C are not affected as much as at spot A and D but the differences are still distinct. The obtained results indicate that polyethylene in the sample was decomposed severely at spots A and D. Furthermore, the investigated sample loss some of its crystallinity at spots B and C. The above-mentioned premises shows that the material changes in the damaged area are a consequence of thermal phenomena most probably related to the impact of an electric arc. The spectra measured at points A and D resemble the spectra obtained for polyethylene exposed to temperatures above 150 °C [18]. The changes observed at points B and C also indicate the melting process in the tested sample. Measurements of the reference sample taken far from the damaged location ruled out the occurrence of material defects in the investigated HV cable.
