Assessment of Wooden Beams from Historical Buildings Using Ultrasonic Transmission Tomography

Monika Zielińska D^a and Magdalena Rucka

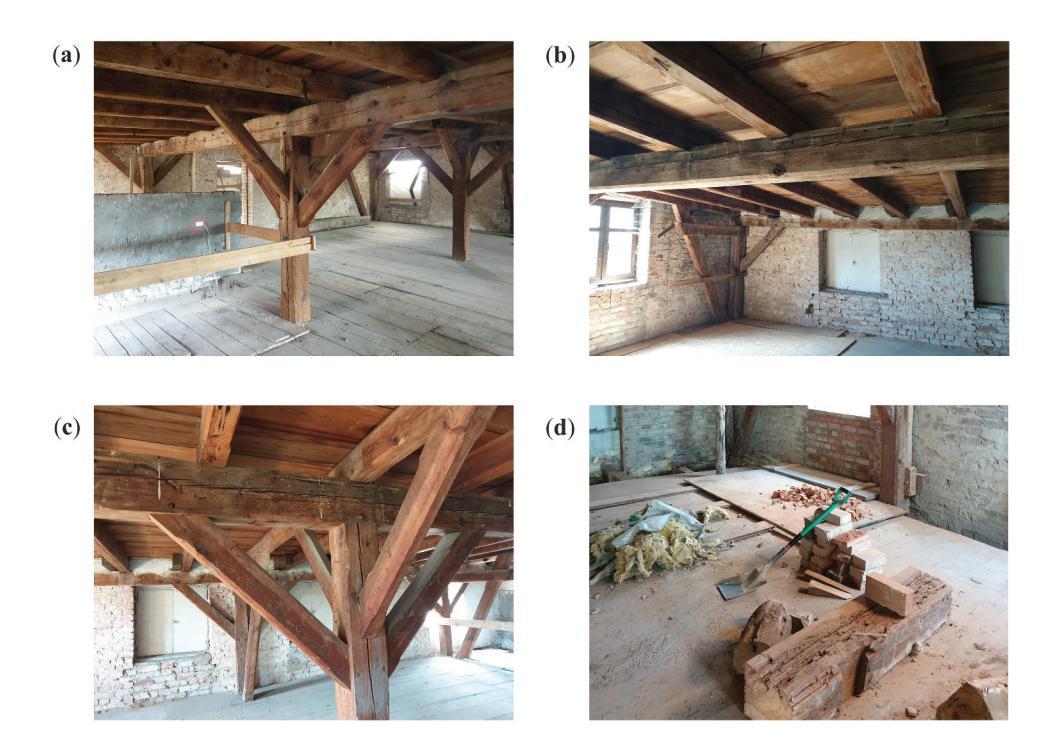
Figure 4. Photographs of the roof framework from the monastery of congregation of the sisters of St. Catherine in Orneta (Poland) before starting construction work (a-c) and when the works are carried out (d).

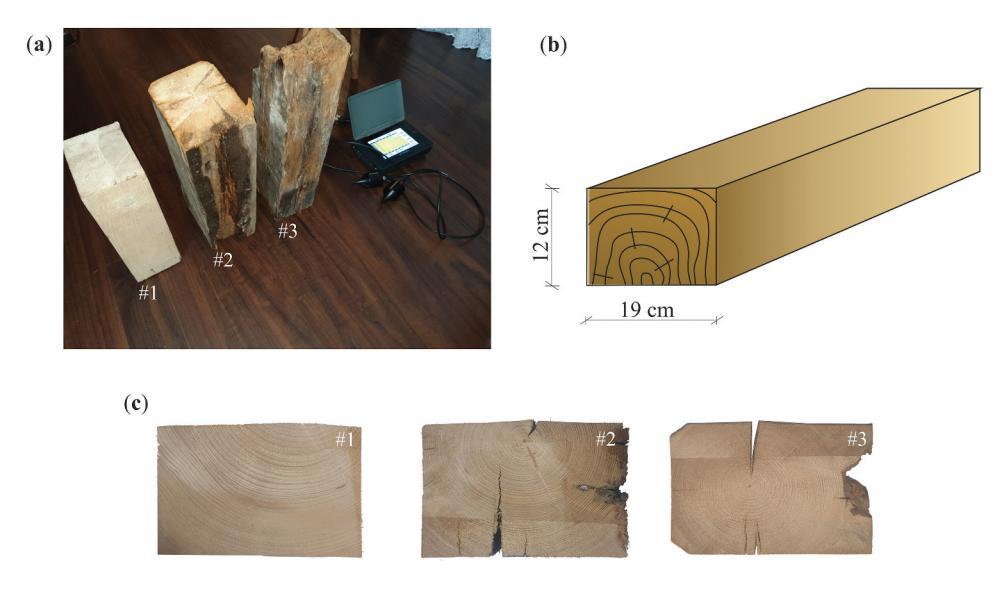
beams were significantly damaged. There were defects in the material on one edge. In addition, cracks run along the wood fibres. They were replaced due to their bad technical condition by new wooden beams. After the tests, all tested samples #1-#3 were cut at the height of the reconstruction image. As a result, it was possible to identify the course of the fibres and the damage exactly at the plane of measurement (Figure 5c).

Figure 5. Laboratory models of wooden beams: (a) view of the beams, (b) dimensions of the beam, (c) cross-section of the tested beams #1-#3.

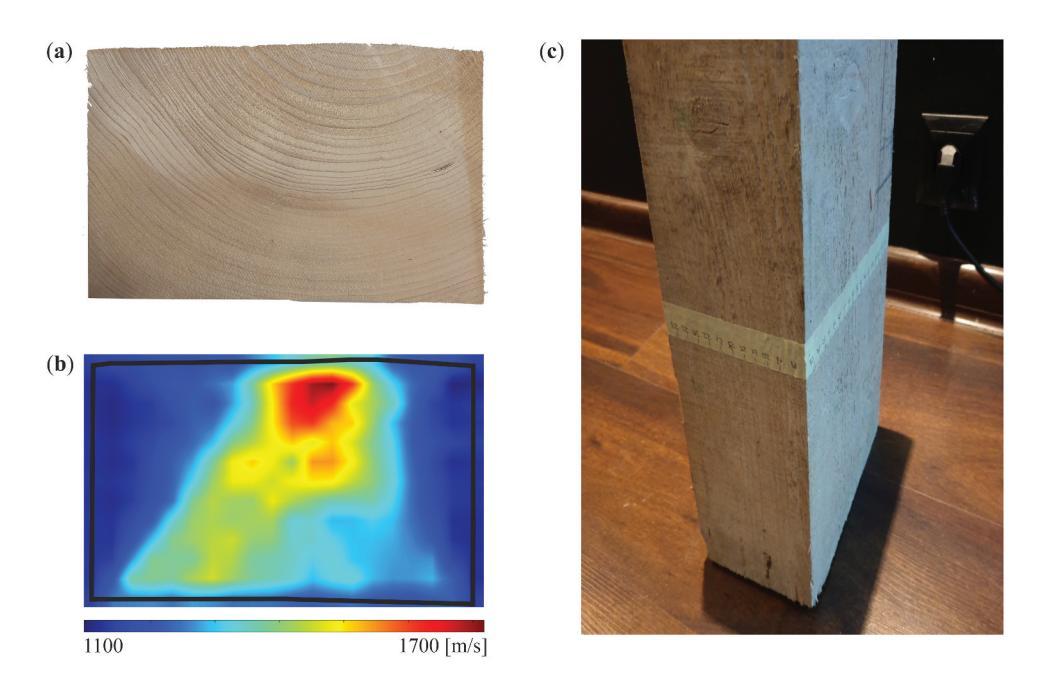
The first laboratory model (#1) was a new pine beam. The edges of this beam were straight and the beam did not have any significant damages or cracks. Figure 8 shows the resulting tomography velocity map for beam #1 together with the photograph of its cross-section. Significantly higher values of wave velocity were observed in the upper part of the image. This area indicates that the pith can be located near the upper edge of the cross-section or even outside of it. The measured values of the wave velocity for beam # 1 ranged from 929.7 m/s to 1637.0 m/s, thus the difference between the lowest and the highest velocity was 707.3 m/s. The average value of the velocity for this beam was 1231.5 m/s. The variability of measurements along different paths was determined were: SD equal to 154.2 m/s and CV equal to 12.5%.

Figure 8. Results obtained for beam #1: (a) top view of the beam, (a) ultrasonic tomography image, (c) side view of the beam.

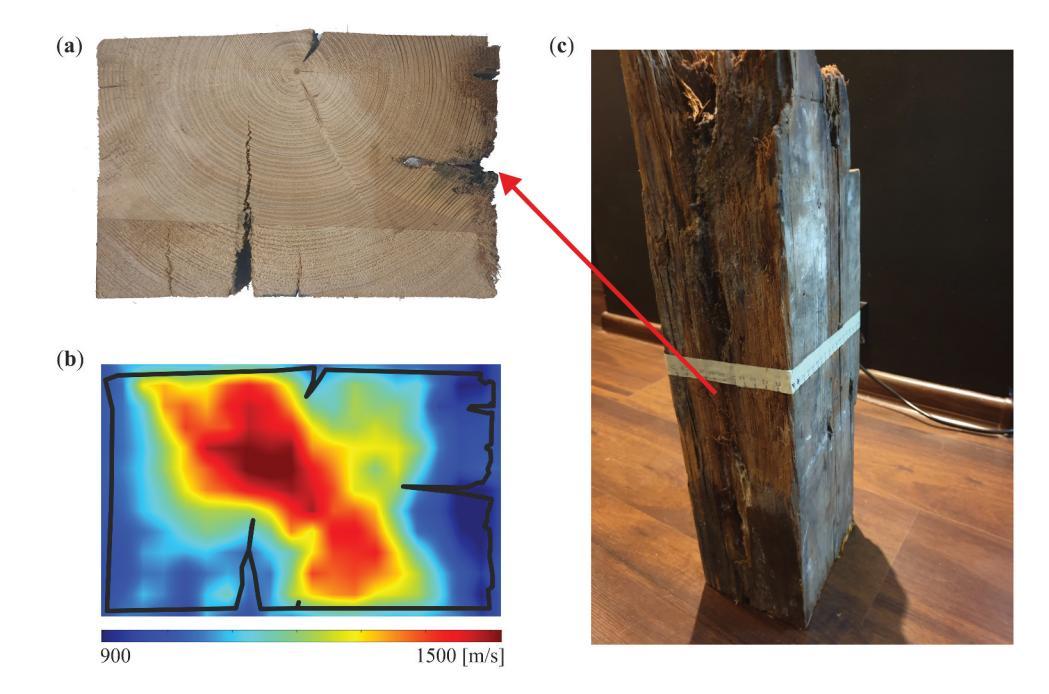
Beam #2 was taken from the historical roof framework. One of its sides included major wood fibrosis (see Figure 9a). The remaining three contained cracks. The ultrasonic tomography image clearly indicates the places where the beam is damaged (Figure 9b). The edge with the wood fibrosis showed the reduced wave transfer velocity. A similar effect was observed in the places where the cracks were located. Furthermore, an increased velocity may be spotted at the location of the pith, similar to the reference beam (#1). The wave propagation velocity varied between 632.7 m/s and 1442.3 m/s. The difference between the minimum and maximum velocity was, therefore, greater than in the reference beam (#1) and equal to 809.6 m/s. The average velocity of wave propagation was 1093.3 m/s, the standard deviation was 137 m/s. Both of these values are smaller than in the undamaged beam. The coefficient of variation was equal to 12.5% and it was at the same value as for reference beam #1. However, it should be noted that the pith of the undamaged beam is outside the cross-section, while in beam #2, the pith is within the tested cross-section.

Figure 9. Results obtained for beam #2: (a) top view of the beam, (a) ultrasonic tomography image, (c) side view of the beam.

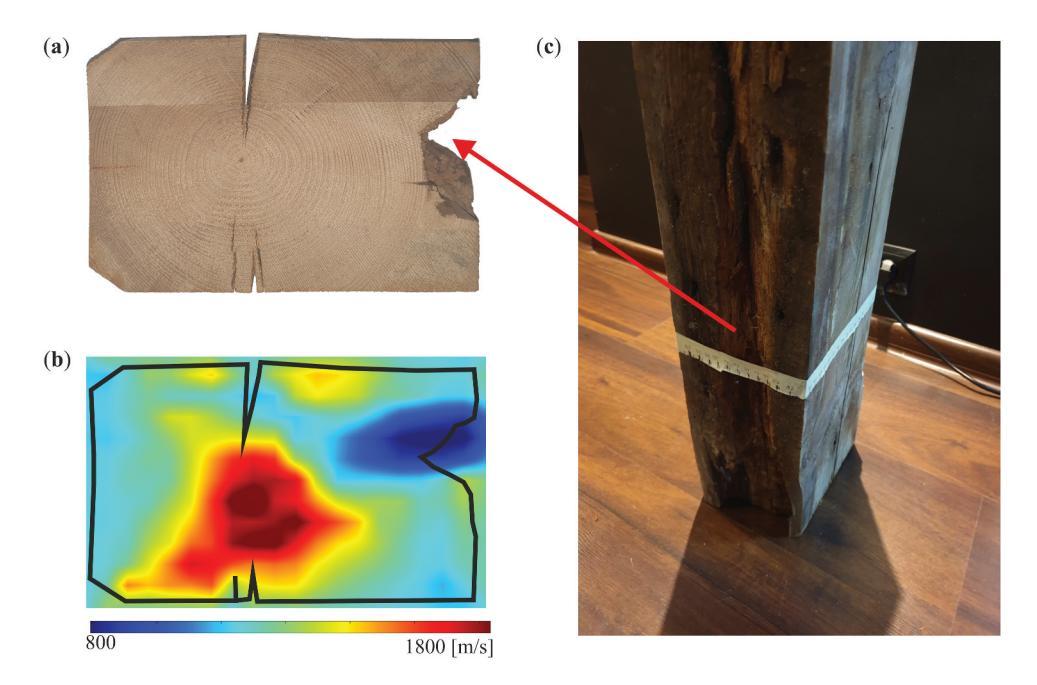
Beam #3 had the highest level of degradation. One of the sides included a significant cavity caused by insects (Figure 10a). This place is marked in blue on the ultrasonic tomography map (Figure 10b). The remaining sides included cracks. The biggest crack is marked on the tomographic image. Similarly to beams #1 and #2 the greatest concentration of the wave propagation velocity determined the location of the pith. The

propagation velocity of ultrasonic waves was between 478.6 m/s and 2262.3 m/s. The difference between the minimum and maximum velocity was the largest compared to the other two beams. It was twice as high as in the reference beam. The average velocity was 1462.3 m/s. The standard deviation (SD) was 293.4 m/s, while the coefficient of variation (CV) is 20.1%. Such a high value indicates significant damage to the beam.

Figure 10. Results obtained for beam #3: (a) top view of the beam, (a) ultrasonic tomography image, (c) side view of the beam.

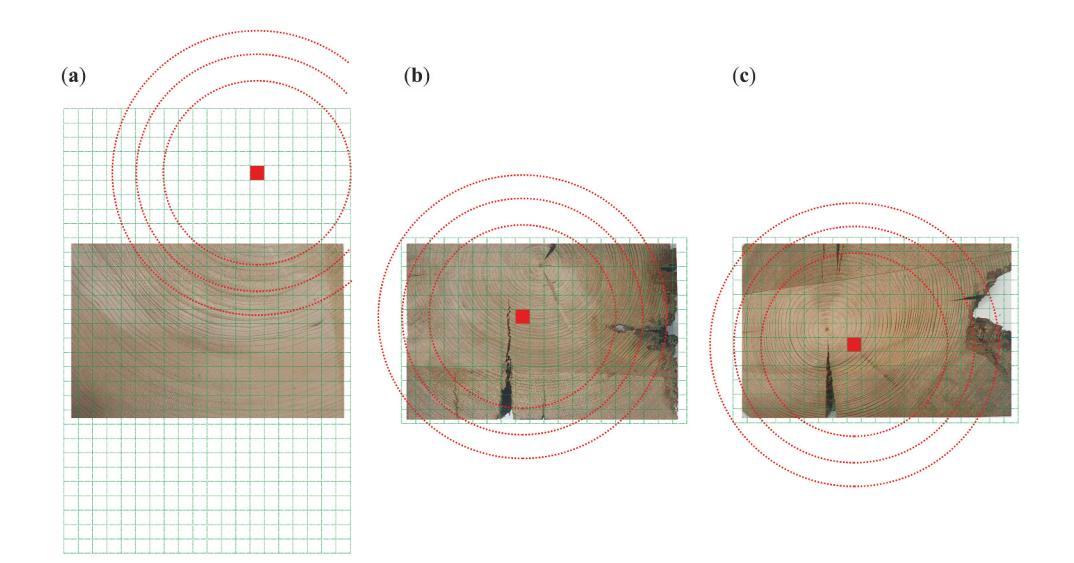
This can be seen in the case of beam #1. For the remaining beams (#2–#3), the fastest rays occurred between two pairs of opposite edges. This indicates the location of the pith inside the tested cross-section. Moreover, the average velocities of waves propagating from two perpendicular walls were compared (Table 2). The first edge took into account the measurements made between the transmitters t_1 – t_{18} and the receivers r_1 – r_{18} , while the second edge included the measurements made between the transmitters t_1 9- t_{29} and the receivers r_1 9- r_{29} . In the case of the pith located outside the cross-section, this difference will be much greater. This is because waves propagating perpendicular to the fibres have a much slower velocity than waves propagating along the fibres. It is assumed that a value greater than 1.15

indicates the possibility of the wood pith occurring outside the tested cross-section. This coefficient appears only in beam # 1.

Figure 12. Determining the location of the pith form beams #1-#3.

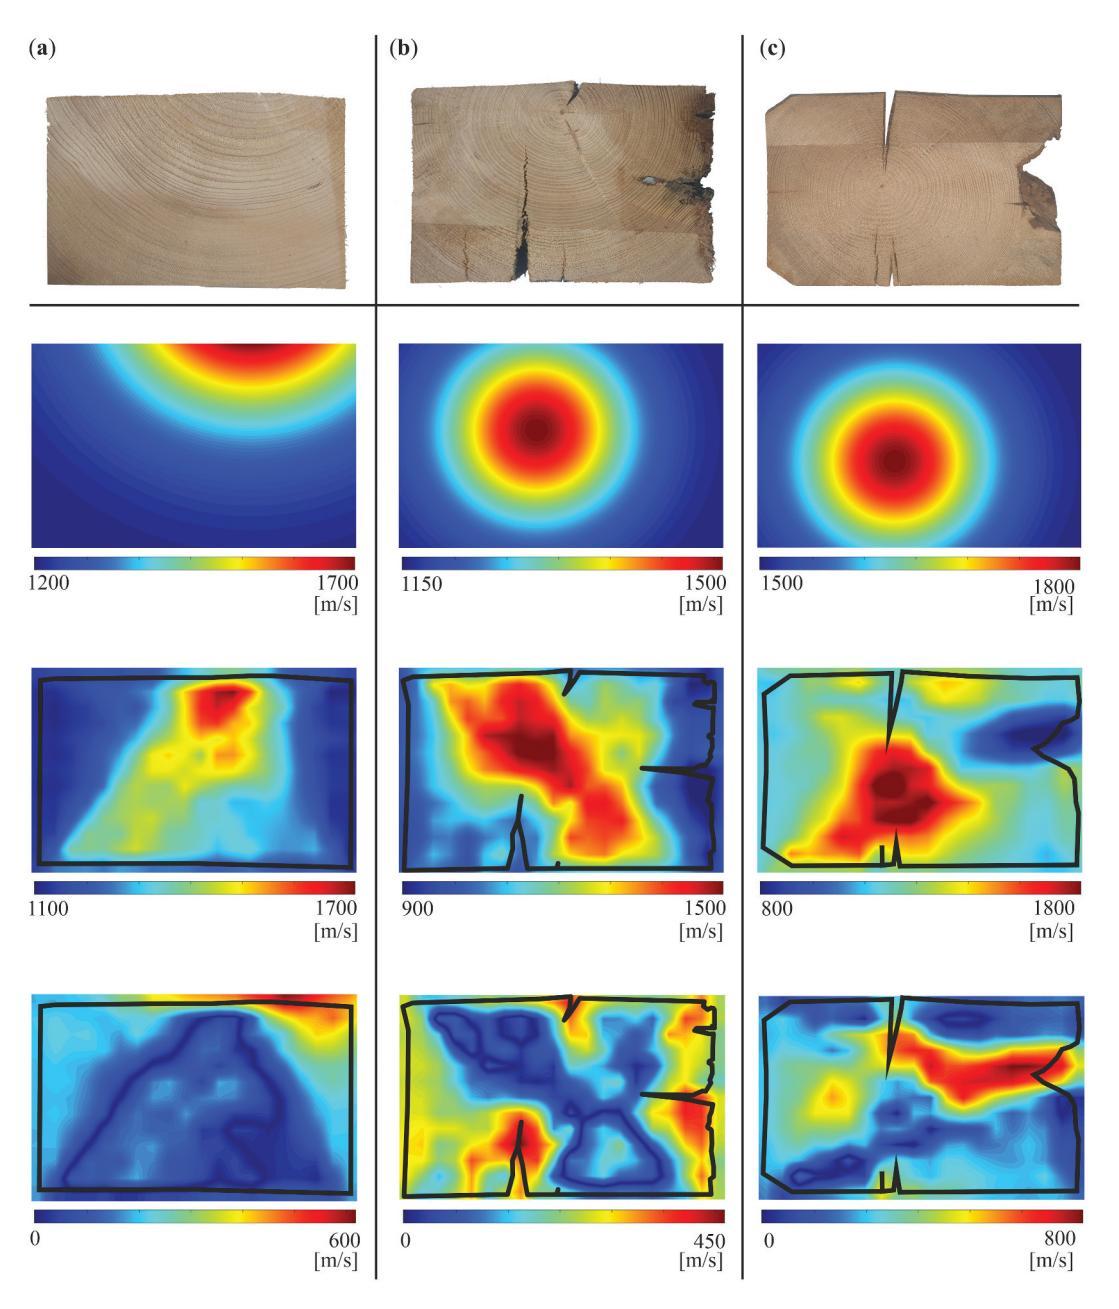
Idealized maps of wave propagation velocity in the wooden element were created after determining the pith location (Figure 13, second row). The highest speed was identified at the designated pith and was equal to the maximum value in the preliminary topographic map (Figures 8–10). It was different for

Figure 13. Ultrasound tomography maps: cross-sections (first row), idealized models, taking into account the location of the pith (second row), initial tomographic maps from Figures 8–10 (third row), the difference between the idealized maps and the initial maps (fourth row).

each of the three samples and was 1637 m/s, 1442.3 and 1842.5 m/s respectively for samples # 1- # 3. The velocity decreased circularly and uniformly for each direction of the outer edges of the beams. The third row in Figure 13 summarizes the initial tomographic maps. The final result is the maps shown in the fourth row. They are the difference between idealized and initial maps. Due to the subtraction of the idealized model indicating the location of the pith, only places showing a decrease in wave propagation velocity due to discontinuities, voids, scratches or fibrosis are visible on these maps. The final ultrasound tomography maps with a visible beam cross-section are shown in Figure 14.

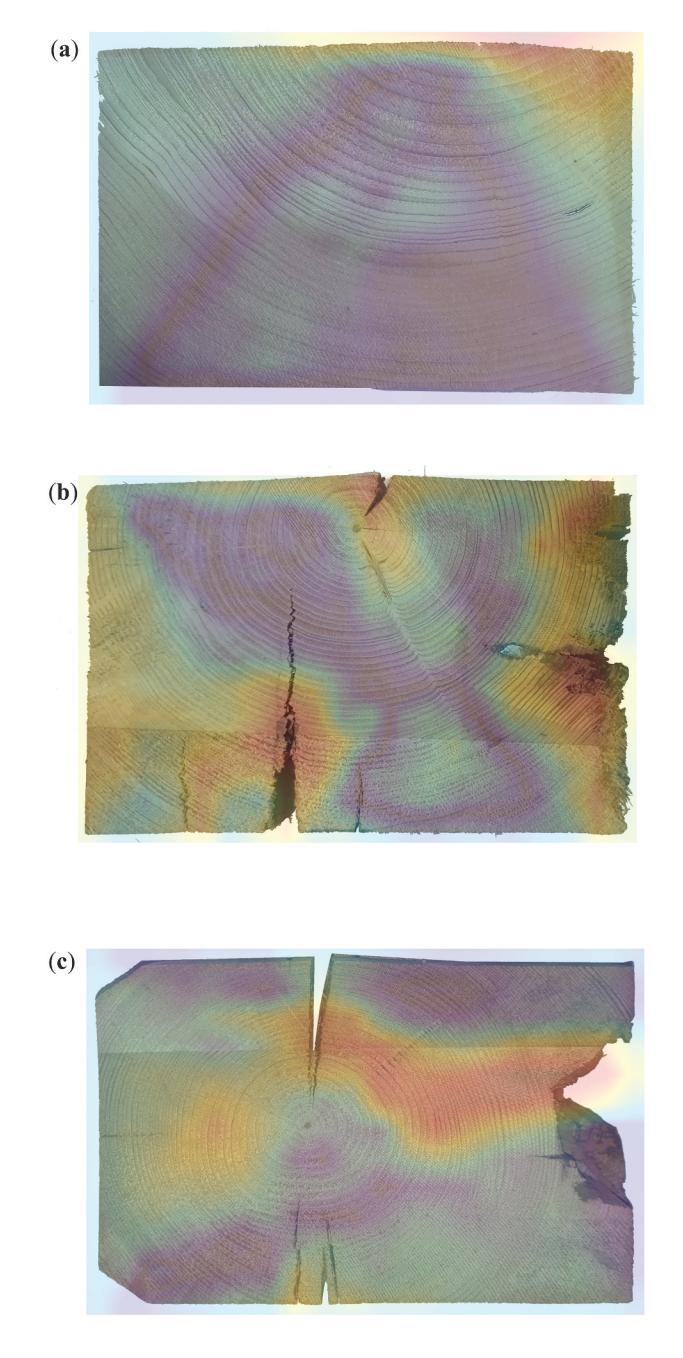
Figure 14. Final ultrasonic tomography maps imposed on crosssections of tested beams.
