Case study of masts damage of the sail training vessel POGORIA.

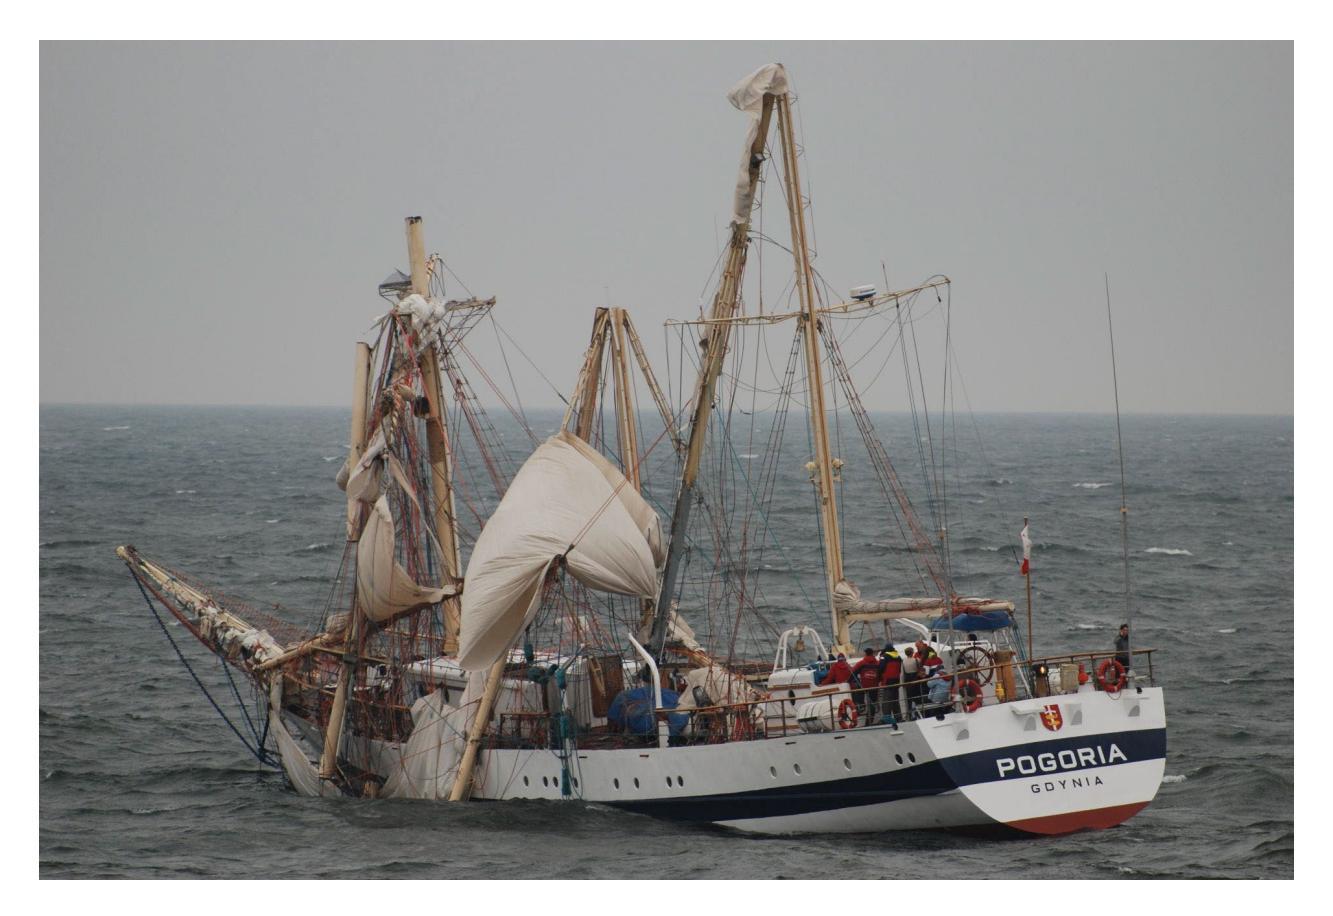
At the entrance to the Gulf of Finland (Baltic Sea), Polish barquentine Pogoria with 50 crewmembers onboard had an accident during Tall Ships Race in the first half of July 2009. All three masts were broken and destroyed both the running and standing riggings (fig. 1). Any significant consequences for the crewmembers did not come into existence.

Fig. 1. The snapshot of Pogoria made just after accident

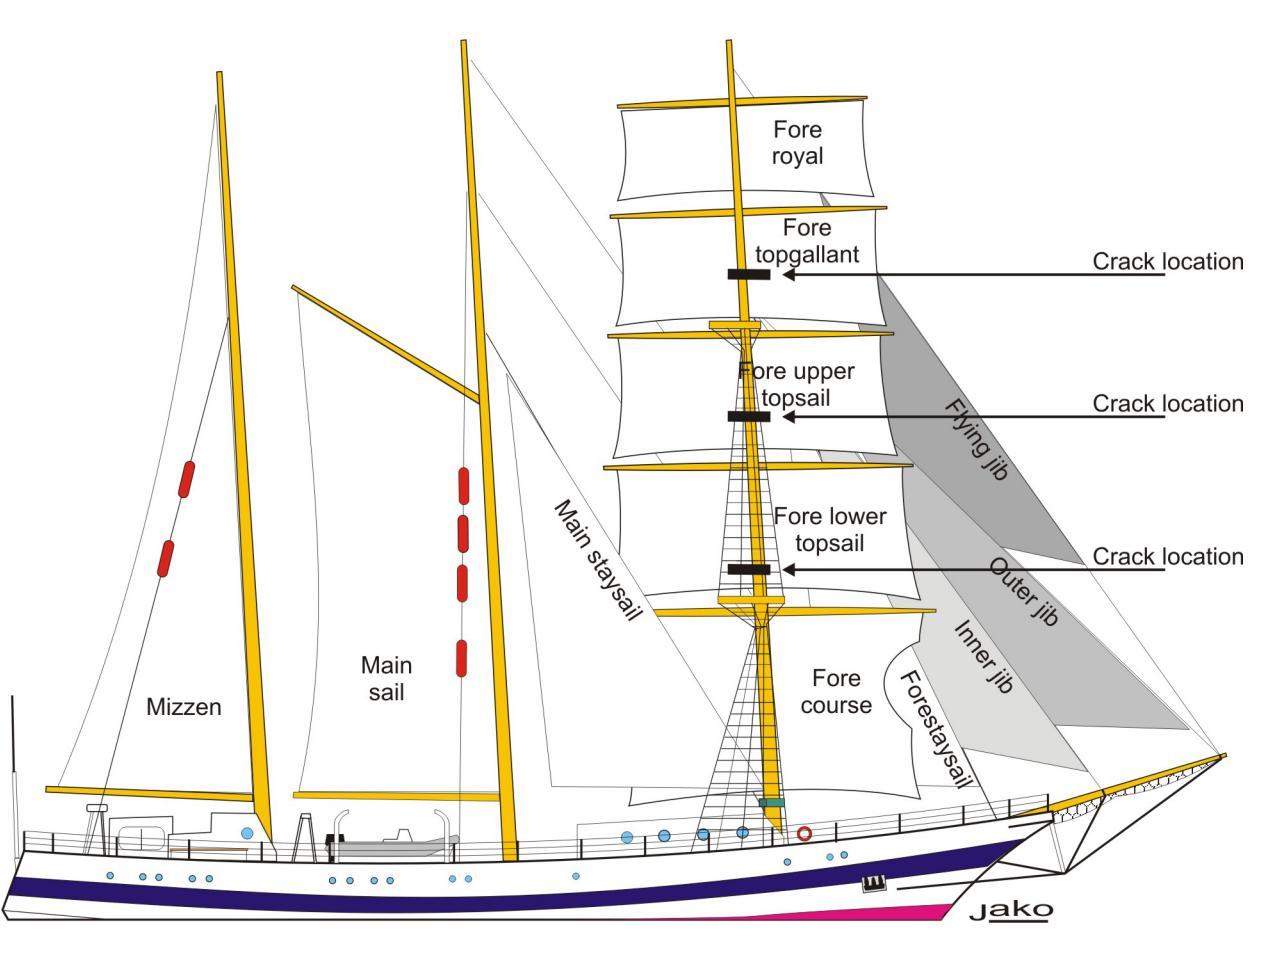
Fig.2. Pogoria sails set and foremast crack location in the moment of the accident

In our opinion, cooperation of two main factors was the direct cause of the fracture of foremast in its upper part:

- substantial weakness of the mast skin material in the determined cross-section,
- periodical action of dynamic strength triggered off by upper foremast sails called flying and outer jibs respectively.

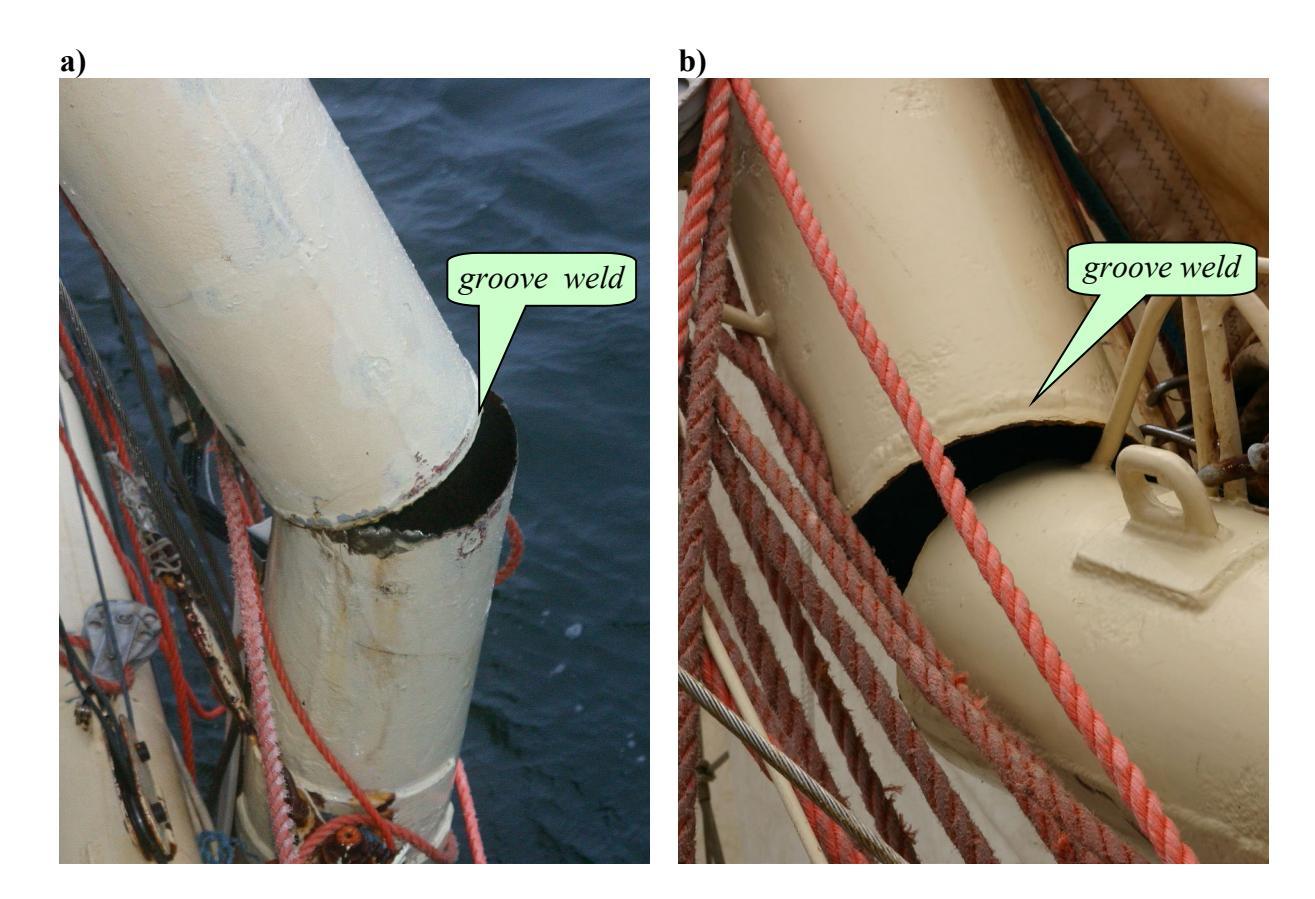
Fig. 3. Fracture examples of with marked butt welds: a) the foremast; b) mainmast.

- the material coherence of standing and running rigging was not violated, excepting a crack of the mounting eye welded to the top mizzenmast which kept the right after-back-stay,
- all weakening places were situated beneath the fusion welds connecting the individual parts of the foremast and mainmast (fig. 3a,b),
- fractures had the clear wedge sharpness at bottom parts of the broken tubes (fig. 4),
- fractures show signs of the characteristic stratification at upper parts of the broken tubes (fig. 5).

As it was already mentioned, all weakening places were situated beneath the welded connections joining the separated parts of the foremast and mainmast (fig.3). In our opinion, the accelerated corrosion of the skin material in heat-affected zones of weld joints was the main cause of the foremast and mainmast destruction. This kind of corrosion resulted from the synergic co-operation of two factors which had both the design and the technological nature.

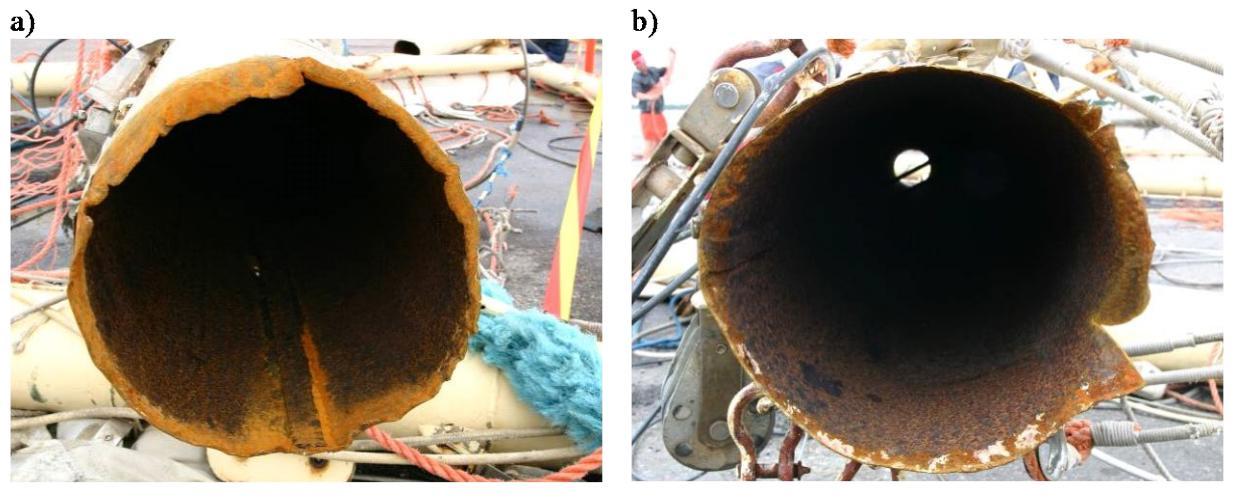
Fig. 4. Examples of the clear sharpness at the bottom parts of the broken tubes: a) foremast; b) mainmast.

Undoubtedly, the synergic cooperation both **the design and technological factors** caused to acceleration of the skin material corrosion of Pogoria masts (Fig. 6b). Such phenomenon has been proved by analysis carried out directly after the accident. It allowed us to unambiguously affirm that all mast fractures had the clear wedge sharpness at their bottom parts (Fig. 4) and the characteristic stratification at their upper parts (Fig. 5).

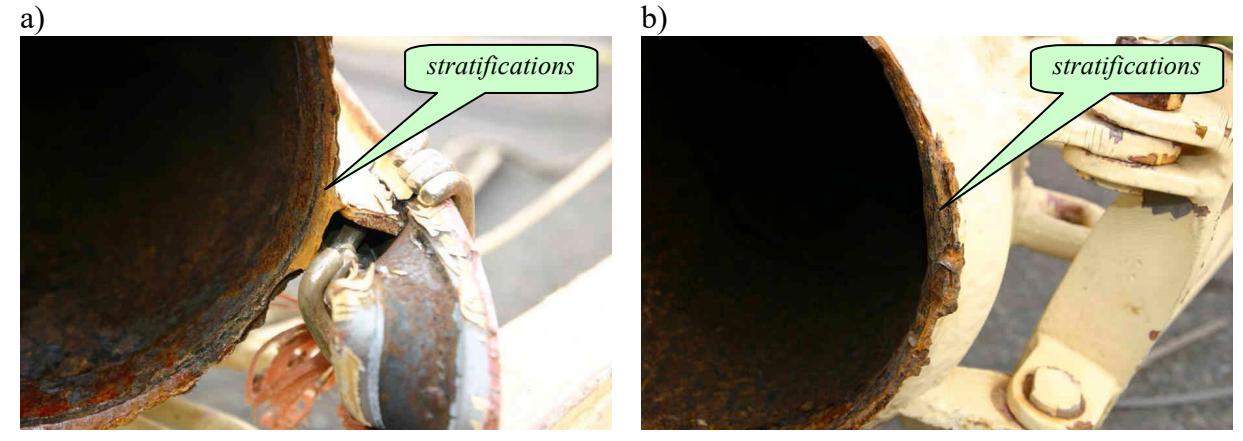
Fig. 5. Examples of the characteristic stratifications at the upper parts of the broken tubes: a) foremast; b) mainmast.

In our opinion, due to both the high transverse strain and the mast skin poor ductility in the through-thickness direction such situations occurred in welded joints of Pogoria masts because the surface of the fracture was fibrous and 'woody' with long parallel sections (Fig. 5). The orientation of the tears in butt welds of Pogoria masts are presented in Figure 6a.

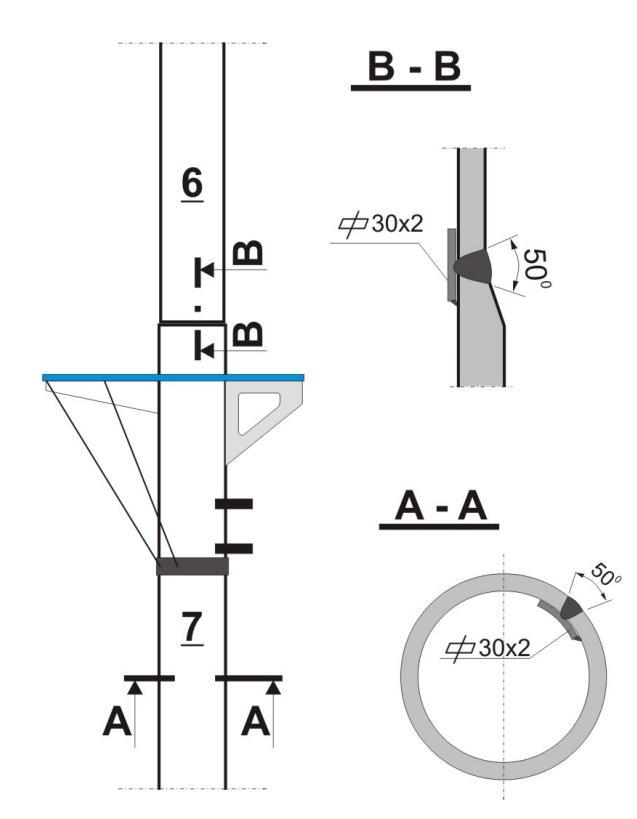
Fig.6. Mast structure and details of the joints

Individual segments of mast tubes were connected together by the butt joints with the groove weld (Fig. 6). In order to prevent various discontinuities in fusion welds (for example incomplete or lack penetrations), inside all of tubes connections were applied the special welding pads fixed by the fillet weld (Fig. 6).

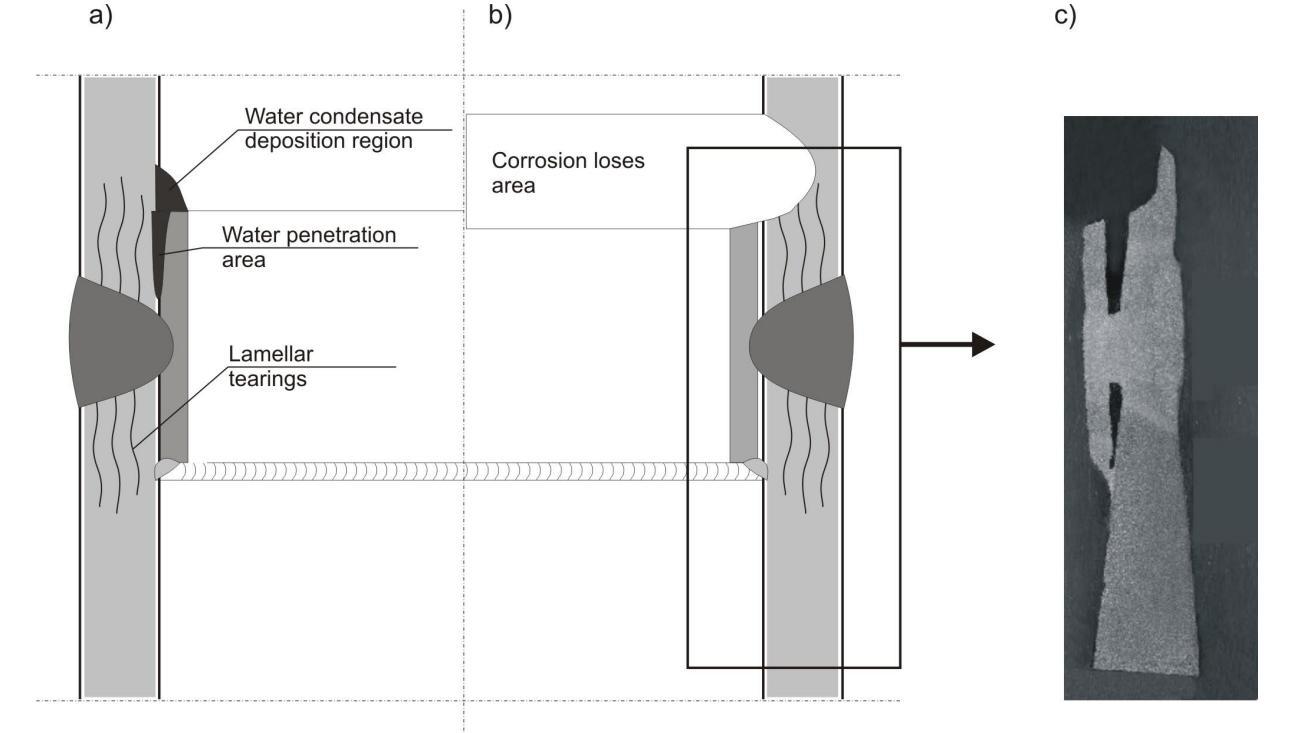
The design factor is just related with a use of the mentioned sleeves. Such a joint design caused to accumulate of water at the upper part of sleeves (fig. 7a). It appeared as the result of water steam condensation due to air temperature decreasing especially at nights. Such a phenomenon have been observed and confirmed by Pogoria crew. Designers of masts also knew about such a phenomenon because they foresaw the special ventilating openings in the upper parts of masts. Nevertheless, the accumulated water penetrated places between tubes and sleeves what contributed to accelerate corrosion of the mast skin material. (fig. 7b). Picture of phractography of cross section of failure part of mast is presented in Fig.7c.

Fig. 7. Way of destruction of the segment connection of mast tubes: a) the places of water penetration and lamellar tearing; b) places of mast skin weakening; c) fractography of corroded joint region

Analysis of the fractography of corroded region (Fig.7c) reveals, that local depth of corrosion centers is relatively high. Such type of corrosion can be described as deep local pitt corrosion. Moreover – the same picture evidences that corrosion processes developed only internally and not penetrated through whole thickness of tube wall.

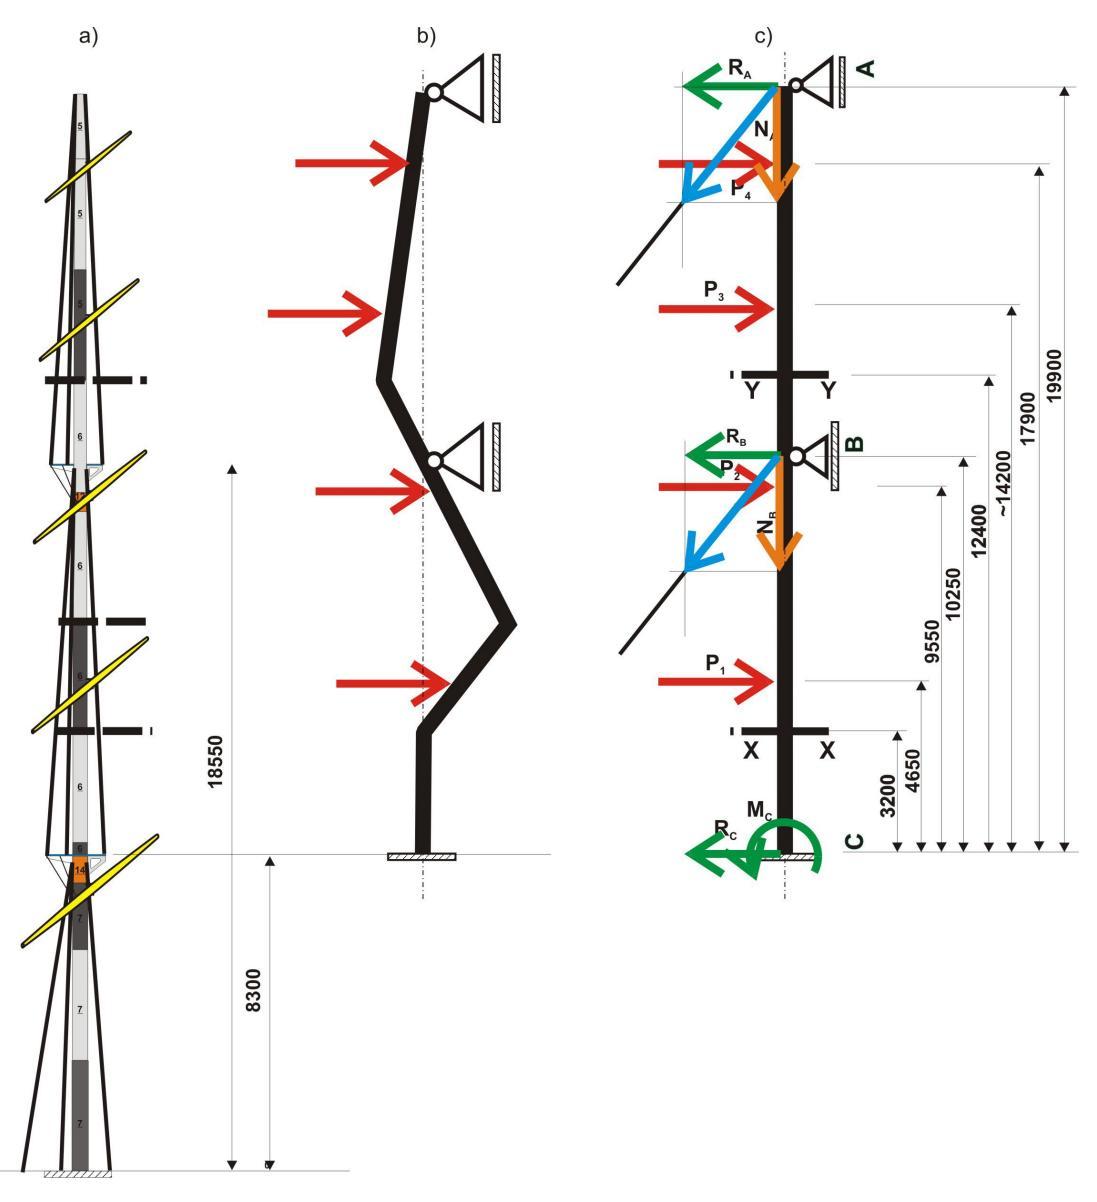
During of analyze of the pictures made just after damage (Fig.1) one can found, that beside of remained on the deck part of the foremast, rest was broken into three parts – as it marked in Fig.2 and Fig.8.b. It was certified, that during the accident, all ropes and hooks worked properly. Taking above mentioned into account, one can assumed expected model of the foremast damage – as it is presented in Fig.8.b. For the calculation, cantilever beam model semi-supported in places of platforms was applied – presented in Fig.8.c.

Fig. 8: Failure of the foremast: a) location of failures, b) model of damage, c) substitute model for calculation.

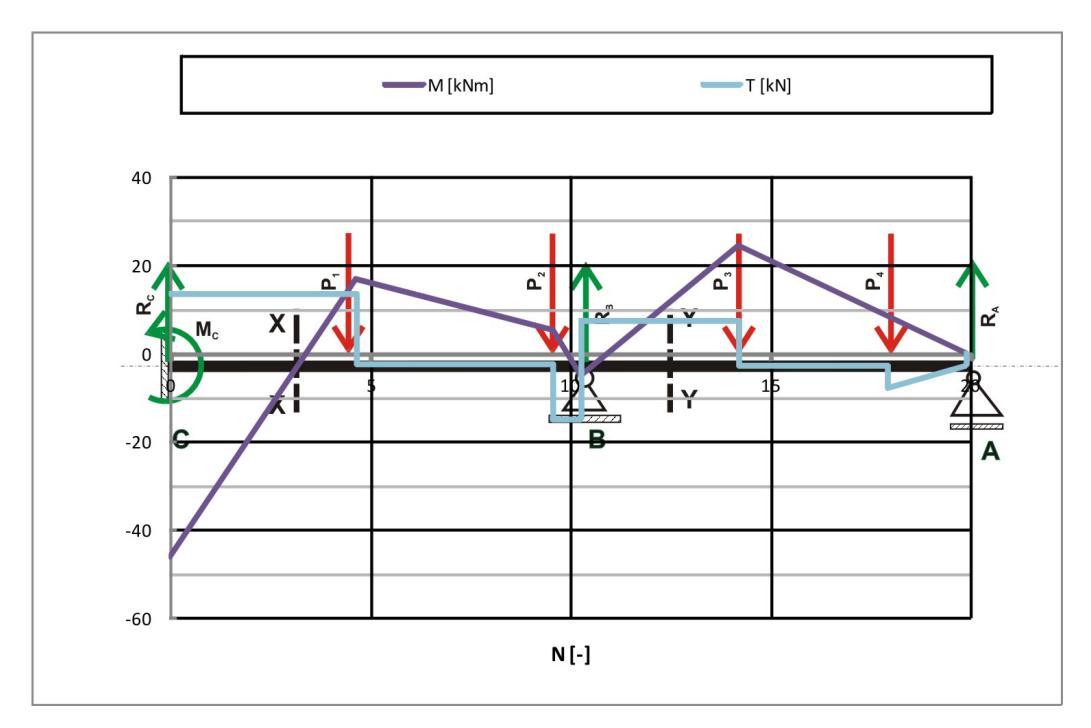
Fig. 9. Calculated distribution of the bending moment (M) and shear force (T)

For nominal design cross section parameters: section X-X: 23 [MPa], section Y-Y 32 [MPa].

For real shell thickness measured for section X-X equal 0,5 [mm]: section X-X 268 [MPa] and 308 [MPa] for section Y-Y. One can see that safety margin for non-corroded structure was about 8. Analysis of calculations shows that such corrosion like presented reduced safety margin to zero.

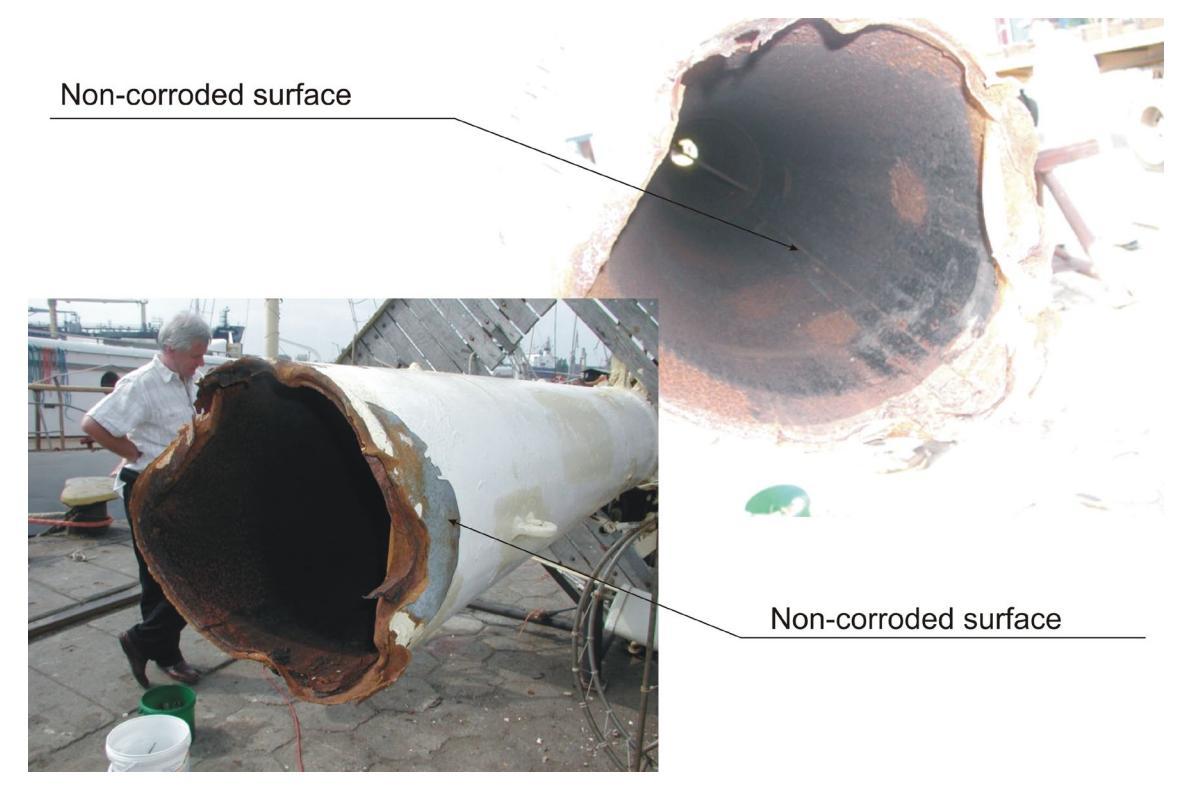
Analysis of pictures of parts of destroyed masts reveals (Fig. 10) that corroded area cover limited part of mast volume – region close adjacent to circumferential welds. Rest of the surface is steel covered – from inside by original protected coating, - from outside – by zinc layer – Fig. 10.

Fig.10. Location of the corroded area in the foremasts segments

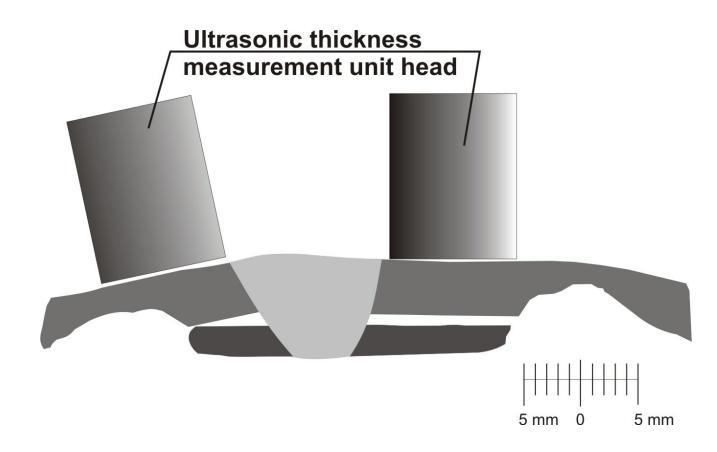
This fact means, that even after total removing of external paintings by sand blasting, it was not possible to find out of the existence of such deep corrosion loses area. From the other side application of the most common steel thickness method – ultrasonic measurement – also can bring not quite clear data due to specific of the internal joint geometry. As one can see in Fig. 11 location of the corroded regions is strictly connected with position of the welding pad in relation to but weld centre: for one case this is region located closely to the weld fusion area, for other case – in the some distance of it. If one compare size of the typical measurement unit of ultrasonic thickness meter with size of corrosion losses, one can see that for some cases typical measurement process conducted closely to the root of the weld will not detect of the such type of corrosion loses.

Fig.11. Size of the typical ultrasonic thickness meter measurement unit on the background of contour of corrosion losses.

So during standard periodic surveying procedures, probability of detecting of such type of corrosion effects is relatively low. The last conclusion presents risk factor for such type of structure – only very careful systematic thickness measurement procedure with internal thickness profile analysis can indicate potential loosing of the safety margin.

- the possibility to predict of results of all adopted design solutions not always exists, especially with reference to a prototype unit like Pogoria,
- such a kind of event will occur in not long time maybe as a result of gravity loading,
- it is necessary to check the technical conditions on board of all sailing vessels with similar design of masts,
- it should be developed new technologies providing the high quality of welded joints in such types connections of individual segments of sailing vessel masts.
- it should be introduced new surveying standards related to the steel welded sailing vessel masts.
