Monitoring of a historic sacral building on an example Basilica St. Nicholas in Gdańsk

Tomasz MAJEWSKI^{*1}, Maciej NIEDOSTATKIEWICZ²

Abstract

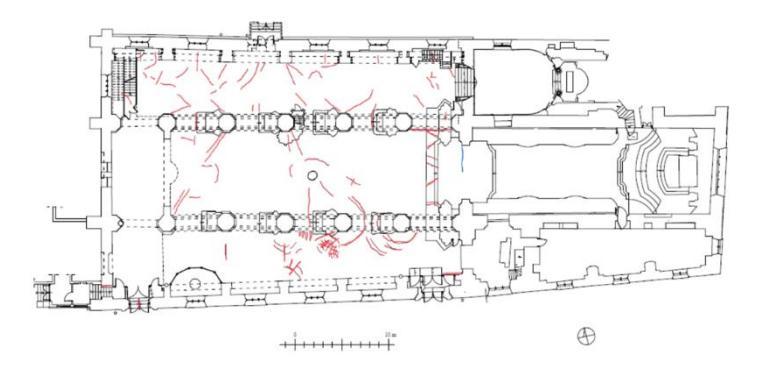
Fig. 1. Basilica of St. St. Mikołaja in Gdańsk: morphology of the features - as of January 19, 2019. [24]

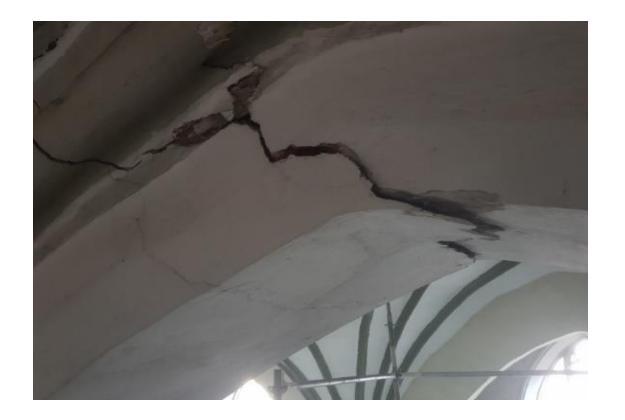
In the initial stage of the recognition, a visual inspection of the condition of the Basilica's structural elements was made (Photo 1 and Fig. 1), photographic and drawing documentation of the faults and damages was prepared [24]. Photo 2 and Photo 3 show the photos of the cracked arch between the pillars of the southern aisle and representative damage to the vault rib for the southern aisle. Based on the information collected, it was decided to immediately temporarily support the damaged vaults of the south aisle with temporary supporting scaffolding. The scaffolding was to be placed on the historic floor of the church, which was deformed and locally collapsed. For this reason, local covers were made to check the condition of the subfloor under the floor, in which voids and cavities were found. Preliminary tests of the entire floor in the Basilica were carried out using the GPR ground-penetrating radar [25]. Based on the results obtained, a decision was made to temporarily dismantle the floor within the southern aisle for the duration of the scaffolding operation. Before dismantling the floor, a detailed conservation inventory was made. After dismantling the floor, scaffolding was erected to protect the vaults of the southern aisle (Photo 4).

Photo 2. Damage to the arch between pillars 2 and 3 of the southern aisle of the Basilica of St. St. Nicholas in Gdańsk (*photo by T. Majewski*)

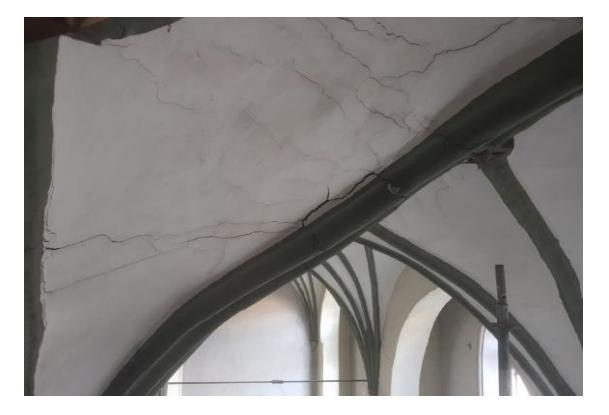
Photo 3. Damage to the diagonal ribs (deformations, scratches and cracks) of the southern aisle of the Basilica of St. St. Nicholas in Gdańsk (*photo by T. Majewski*)

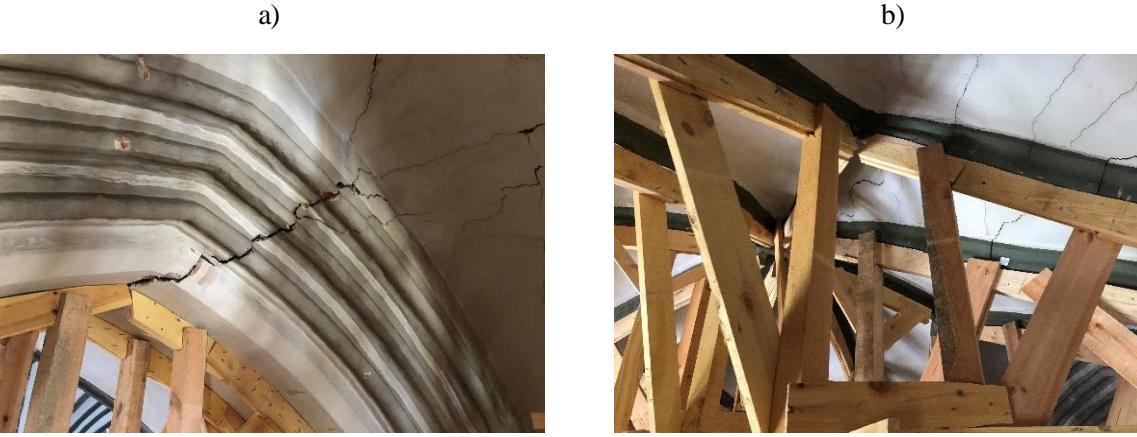
Photo 4. Scaffolding stabilizing the vaults of the southern aisle of the Basilica of St. St. Mikołaja in Gdańsk: a) an arch between pillars no. 2 and no. 3, b) supported ribs of the vaults (photo by T. Majewski)

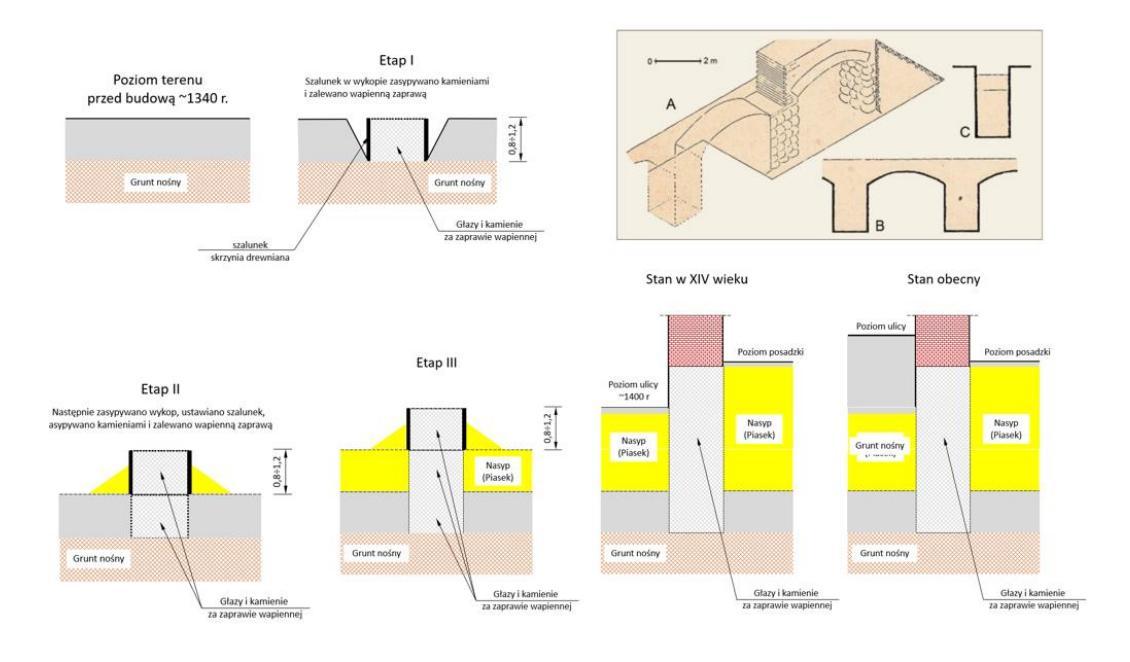
In order to recognize the type and condition of the foundations of the Basilica, classic narrow-spatial excavations were made. The excavations revealed that the foundations of the building were made in the form of stone pillars, on which brick arches are based, above which ceramic walls and pillars of the building were built [31]÷[32]. The condition of the foundations of the building was different in individual excavations. Based on the inspection, it was found that the stone foundations were placed directly on the layers of load-bearing soils (sands and gravels), under which no wooden piles and fascines were found. The layered structure of the pillars at their height was determined. The foundations were made in three stages, approximately 1.0 m high for each layer of stones (Fig. 3). Boulders and stones are laid on lime mortar, and the external surfaces are clad with clay.

Fig. 3. Foundations of the building of the Basilica of St. St. Nicholas in Gdańsk Basilica [31]÷[32]

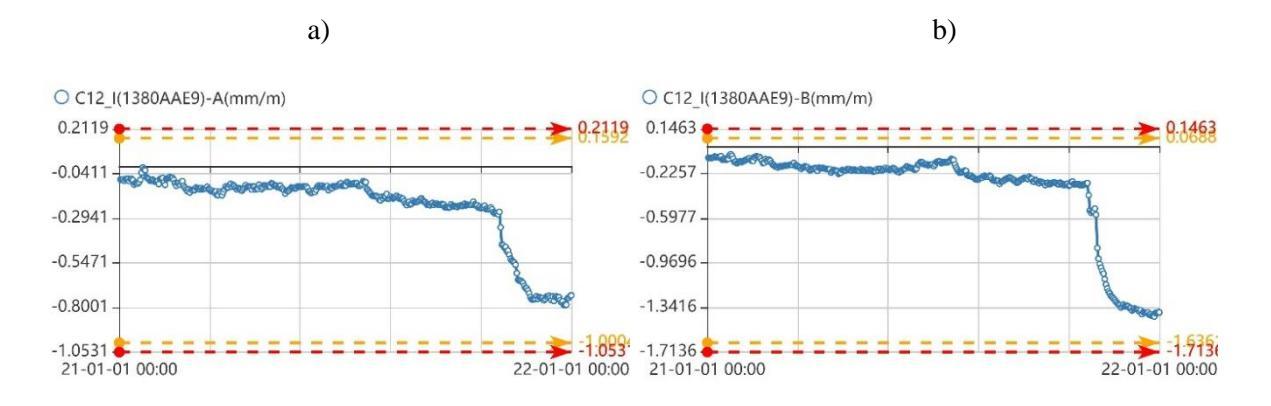
A cracked inter-column arch is based on the F2 and F3 pillars, Fig. 9, Fig. 10 and Fig. 11 show the results of inclination measurements of three selected pillars, F1, F2 and F3, respectively. Fig. 12 shows changes in vertical displacements (settlements) of piers F1 (a) and F2 (b) recorded in 2021. by distance sensors D17_I and D18_I. The charts show changes in the trend of recorded values caused by an increase in the load from the weight of the concrete ribs and the shell reinforcing the arches.

Fig. 9. Inclination of the pillar F1 of the southern aisle in the direction of axis A (a) and axis B (b): readings of the C12_I sensor in the period 01.01÷31.12.2021

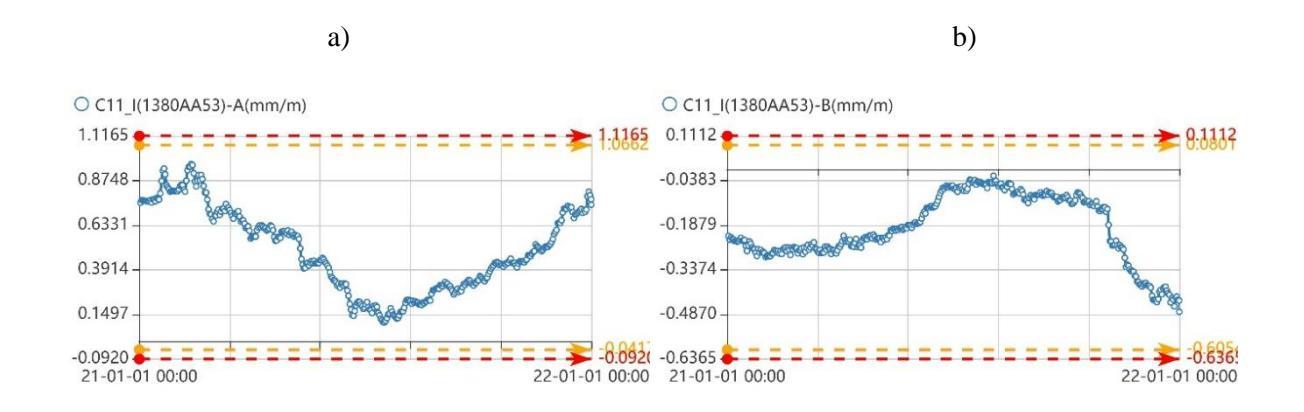
Fig. 10. Inclination of the pillar F2 of the southern aisle in the direction of axis A (a) and axis B (b): readings of the C11_I sensor in the period 01.01÷31.12.2021

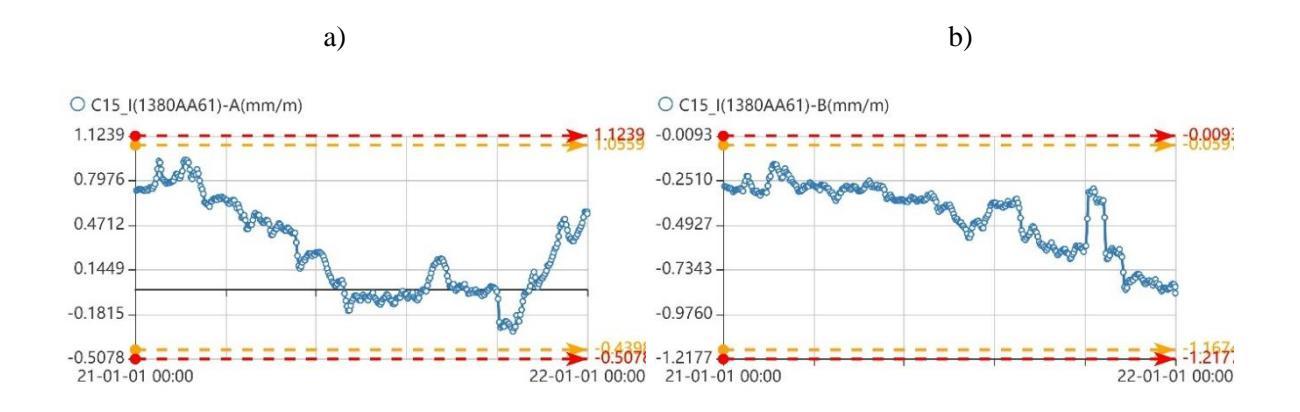
Fig. 11. Inclination of the pillar F3 of the southern aisle in the direction of axis A (a) and axis B (b): readings of the C15_I sensor in the period 01.01÷31.12.2021

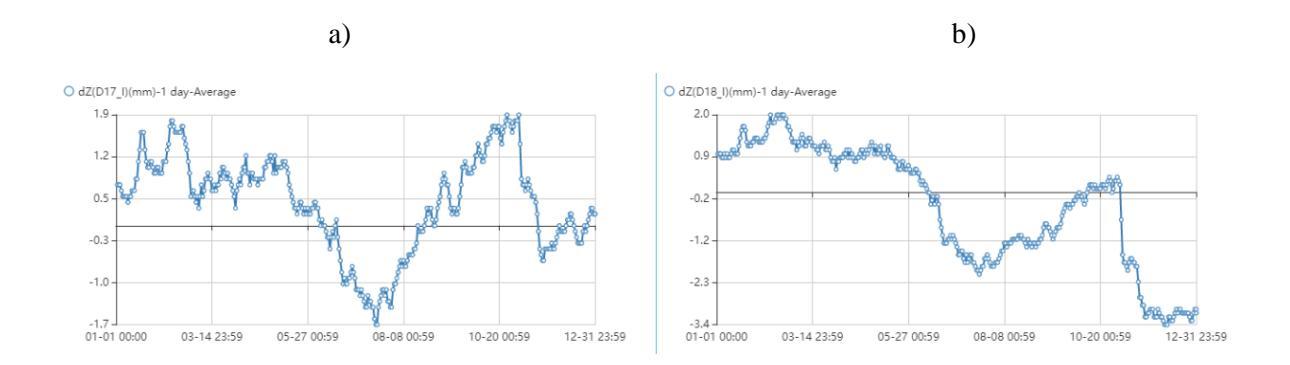
Fig. 12. Vertical displacement of the pillars of the southern aisle based on readings from distance sensors: a) C17_I (F1) and b) C18_I (F2) in the period 01.01÷31.12.2021
