# B. Trybuś<sup>1</sup>, J. M. Olive<sup>2</sup>, N. Lenoir<sup>3</sup>, A. Zieliński<sup>1</sup>\*

# X-RAY COMPUTER TOMOGRAPHY STUDY OF DEGRADATION OF THE ZIRCALOY-2 TUBES OXIDIZED AT HIGH TEMPERATURES

Keywords: zirconium, oxide layers, high temperature, X-ray tomography, cracking, nodular corrosion

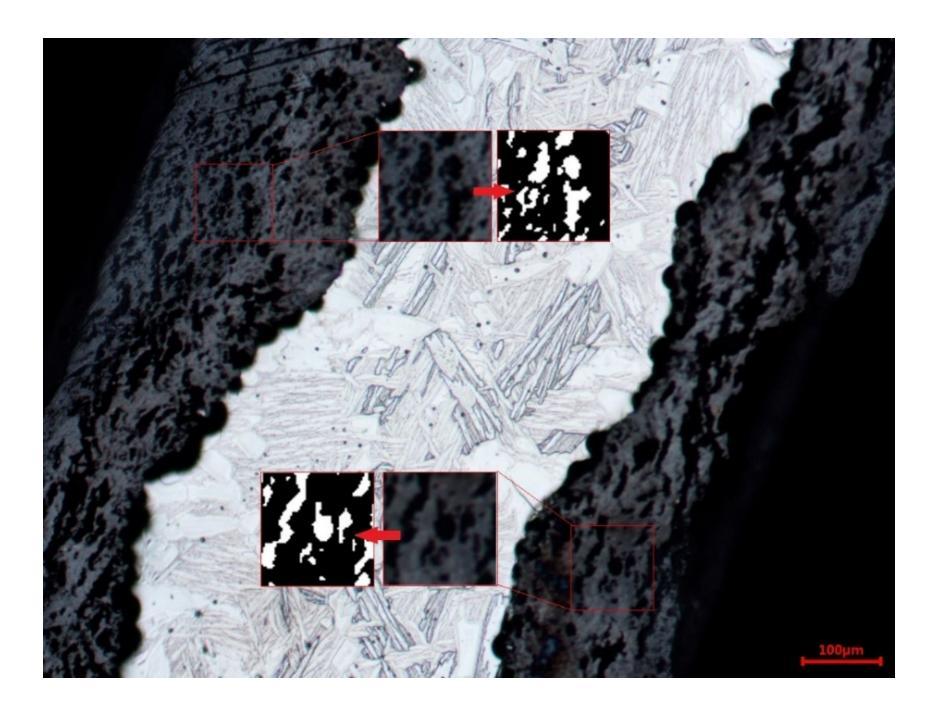
Specimens oxidized at 1273 K revealed multiple cracks in the oxide layers. The image analysis of micrographs shown in Fig. 3 discloses that the cracks occupy about 20% of oxide volume. From each image, two fragments, 0.01 mm<sup>2</sup> each, were taken and converted into binary images for calculation of the number of voxels and volume of cracks. Most cracks were not big enough to be directly visible on the X-ray tomography scans.

Fig. 3. Microscope images of a cross-section of Zircaloy-2 alloy oxidized at 1273 K in air and cooled in oil; the areas used for an assessment of cracks` number (small images, on the left) and their binary images (small images, on the right) and calculation of voxels` number are demonstrated

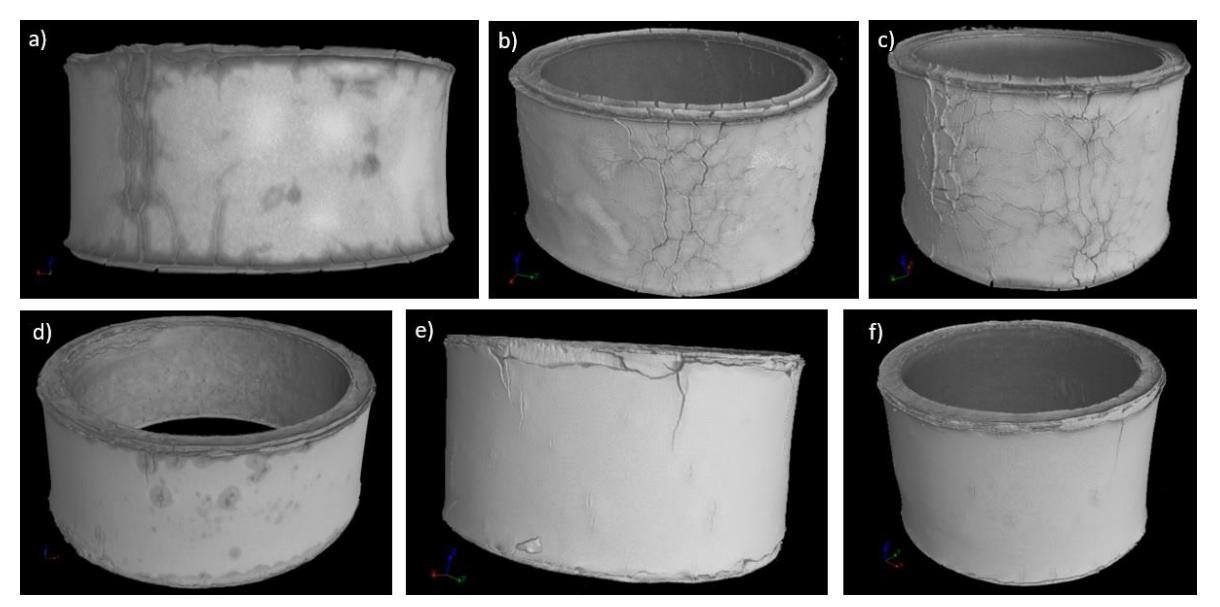
Fig. 5. Scans of the whole zirconium claddings after oxidation at 1273 K (top) and 1373 K (bottom) cooled in air (b, f), water (c, d) and oil (a, e)

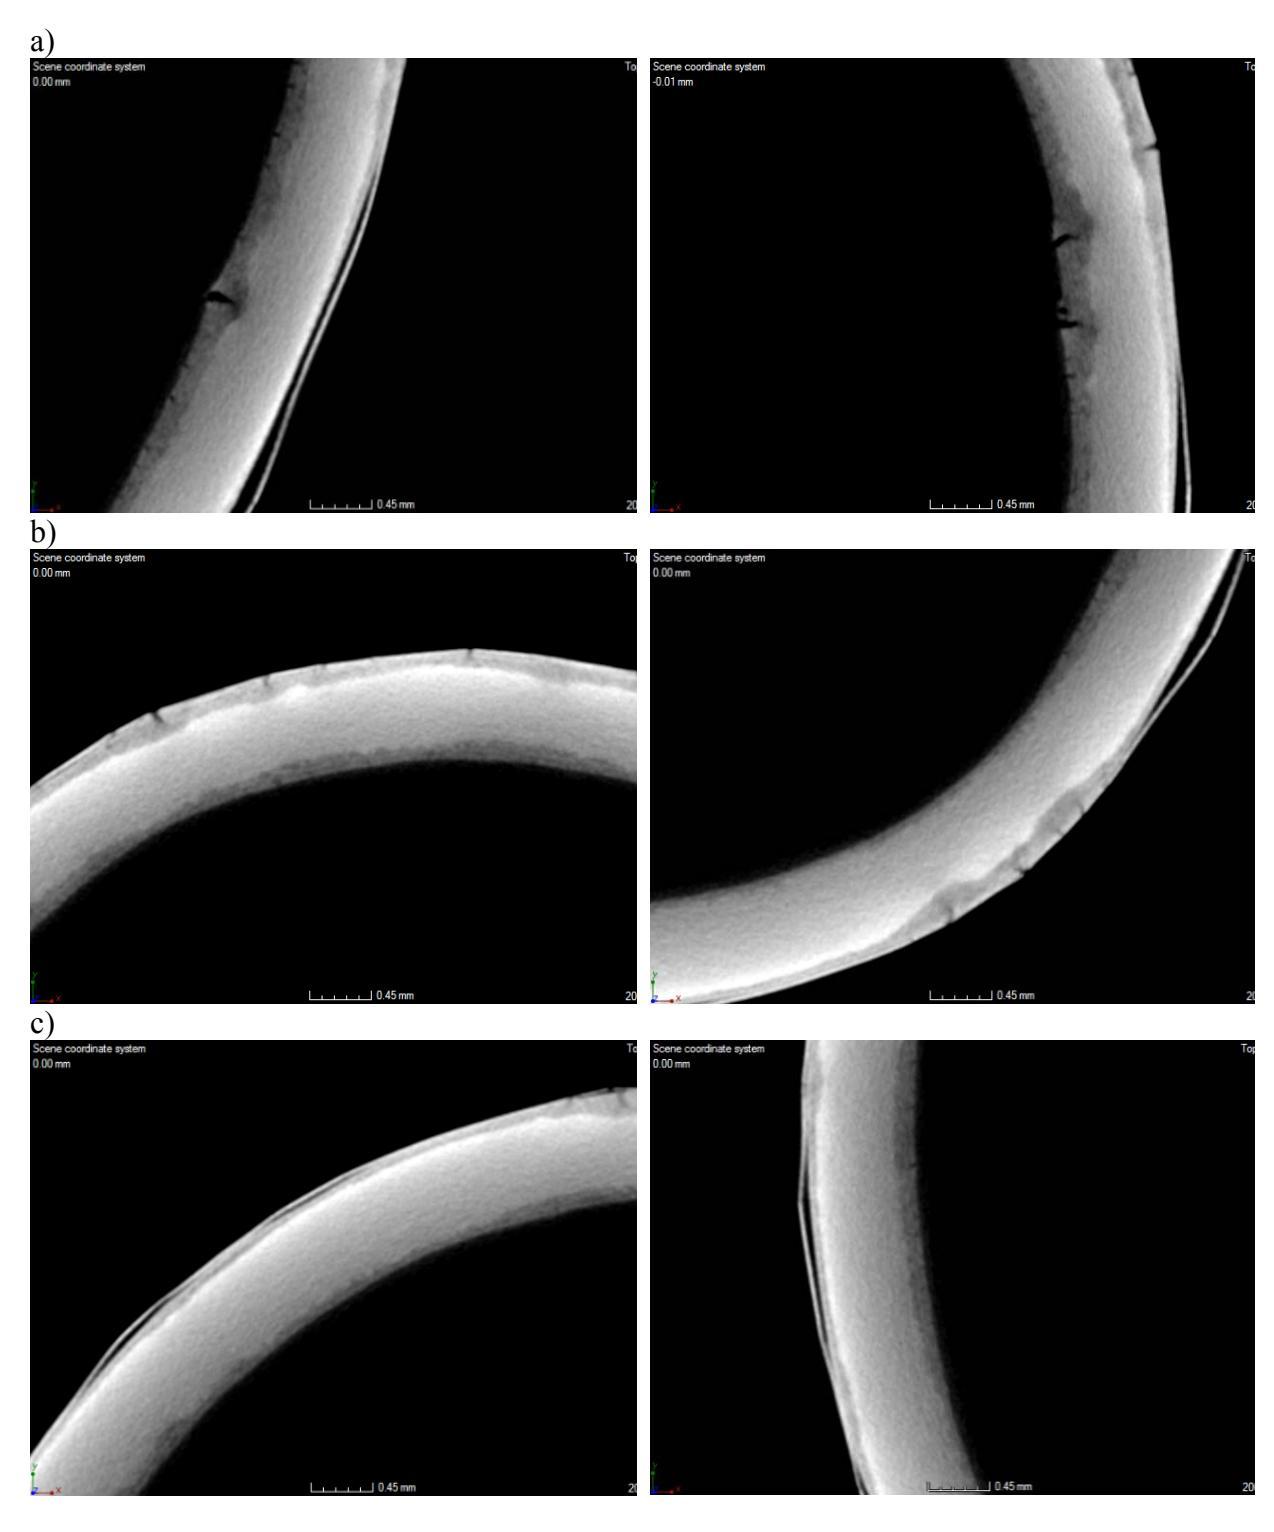
**Fig. 6.** Cross-sections of walls of tubes oxidized at 1273 K and cooled in air (left) or in water (right), different forms of degradation: a) vertical cracks in the inner oxide, b) vertical cracks in the outer oxide, c) detachment of the outer oxide (1273 K in air). Light microscope.

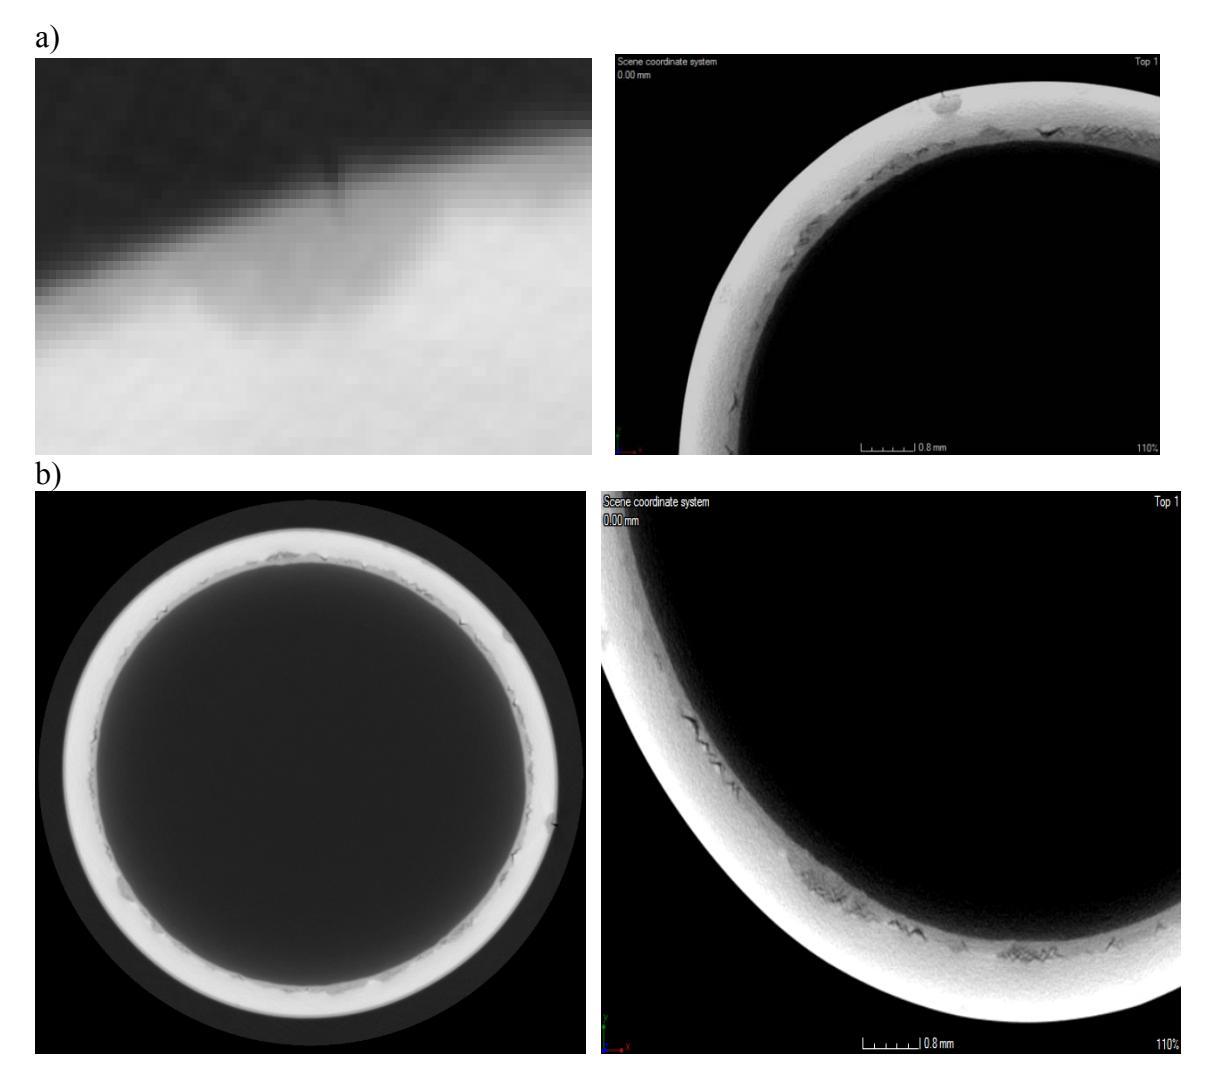
Fig. 7. Cross-sections of walls of tubes oxidized at 1373 K and cooled in air (left) or in water (right), different forms of degradation: a) vertical cracks in the oxide external layer, b) voids in the substrate. Light microscope

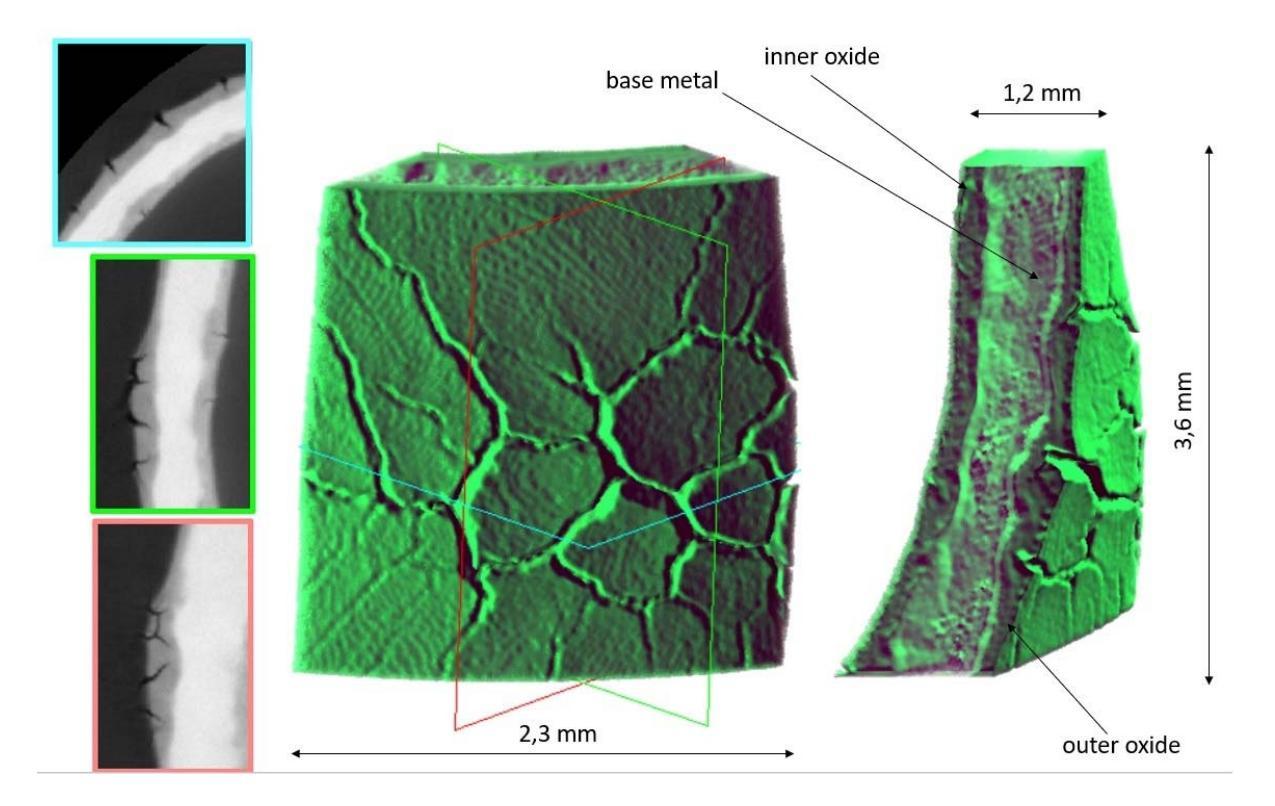
Degradation on external surface of the oxidized tubes appeared as long, spreading out and deep cracks or local, lens-like shaped small cracks. Figure 8 illustrates the long cracks observed on the alloy oxidized at 1273 K and cooled in water. The 3D views show that cracks join together and create island-like areas of size ranged from 400  $\mu$ m to 1000  $\mu$ m. The images on the left represent the cross-sections made along color lines marked in the middle image. The images on the right highlight the extensive oxide growth around cracks. Such behavior might be attributed to thermal stresses, but cooling medium did not affect the cracking

intensity. The oxide near the vertical crack was locally very thick due to the direct exposure of inner oxide to the surrounding gases as already observed [3].

Fig. 8. 3D view of cracks spotted on outer oxide of Zircaloy-2 cladding oxidized at 1273 K for 30 min in air, cooled in water. On the left, grayscale images illustrate cross-sections made along color lines marked in the middle picture. The right image shows 3D view across the wall thickness which presents an increase in oxide thickness around cracks in comparison to an area without cracks

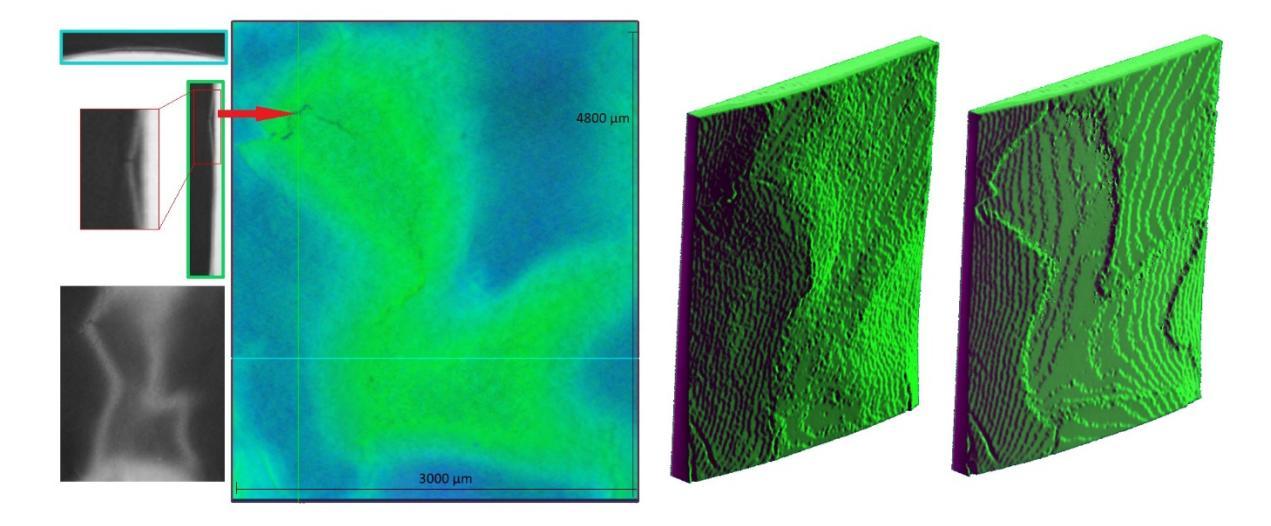
Figure 9 presents an exemplary case of oxide detachment oxide observed for specimen oxidized at 1273 K and cooled in water. The spalled part of the layer was around 60 µm thick, and the oxide layer thickness ranged between 30 and 50 µm. The detached zone extended over an almost full area of the oxidized specimen. The green image in the middle illustrates an overall view of the oxide detachment. It visualizes bulge with a crack on the top. The image on the right shows the oxide under the detached layer. The image on the left presents orthogonal views of the area of interest. This form of detachment occurs in all the specimens oxidized at 1273 K. In all cases, the damage is sizable and exceeds 3 mm parallel to the tube and 2 mm perpendicular to the tube radius. Every specimen in this study possessed the crack or multiple cracks on the top of a bulge. The descaling, again much more intensive on the outer surface, is an obvious consequence of developing cracking as already observed [29].

**Fig. 9.** Detachment of the outer oxide layer on specimen oxidized at 1273 K in air for 30 min and cooled in water. On the left: views of the scanned tube, blue and green lines on the bigger picture correspond to grayscale projections and show the area in which cross-sections were taken. On the right: two green images present 3D views of the detached oxide layer; the left of both shows the outer layer, the right of both illustrates the oxide layer under the detached part

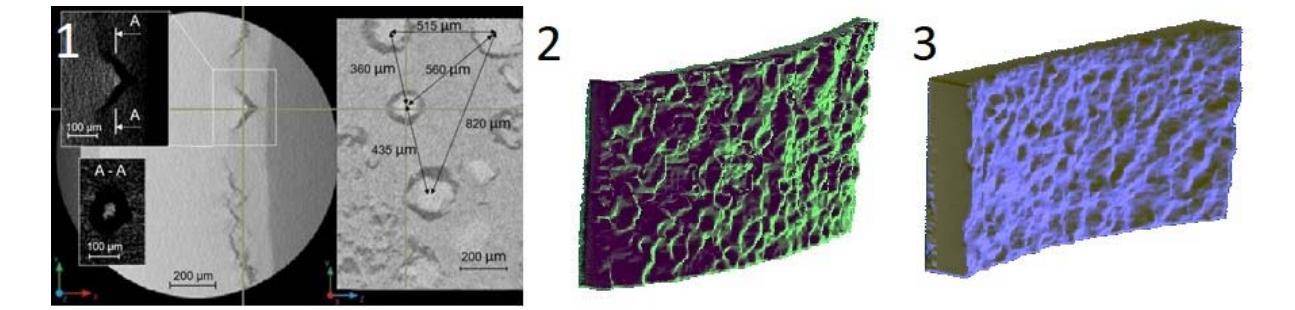
Fig. 10 shows a grey-level difference between the tops of the bright triangle-like deformations at the interface. Such bright areas are visible at the tops of most of the appearing voids.

Fig. 10. (1) Orthogonal view of 1.4 μm voxel size in the X-ray tomography image of Zircaloy-2 tube oxidized at 1373 K in air for 0.5 h; left – transversal slice showing inner oxide, substrate metal, voids and cracks at the metal/oxide interface, and void magnification; right – arrangement of voids at the metal/oxide interface. The right image is a rotation of the left image by 90° around the yellow vertical line. The cross-section A-A presents dimensions of the bright void zone. (2) 3D view of the metal/oxide interface, a green image is the oxide layer at the interface. Many dents are spotted in the area of voids present at the metal side. (3) 3D view of the metal/oxide interface, a blue image is a metal side at the interface with visible voids

The average size of the bright zone at the top is around 70  $\mu$ m, as shown in cross-section A-A. Based on analysis of the substrate surface under the internal oxide layer, about four such brighter zones can be found per 1 mm<sup>2</sup>. The voids are spaced apart by an average distance of around 550  $\mu$ m. Fig. 10 also presents an arrangement of bright deformations and cracks at the metal/inner oxide interface.

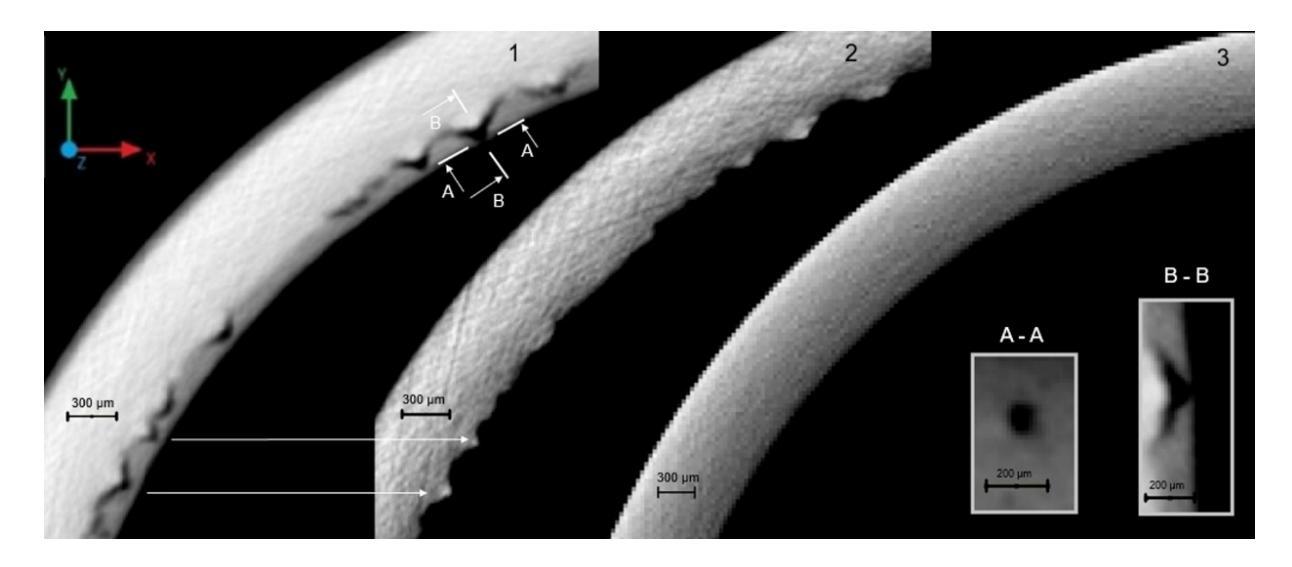
Figure 11 shows the X-ray tomography images of the oxidized tube (images 1 and 2) and the reference non-oxidized sample (image 3). Image 2, created by modifying the brightness and contrast of the image 1, presents the surfaces of the specimen after oxide removal. The arrangement of voids and cracks shown in image 1 corresponds to the bright zones in image 2. The top part of image 1 presents an open crack which exposes a base metal to the environment. Around 70% of all voids spotted on the inner surface of the tube caused the cracking of the oxide layer. The open crack created a hole of about 50  $\mu$ m.

**Fig. 11.** 14 μm voxel size X-ray tomography image of the Zircaloy-2 tube oxidized at 1373 K in air for 0.5 h: (1) a transverse slice of the oxidized sample showing outer oxide, base metal, and inner oxide layer; (2) edited image 1 showing base metal without any oxides; (3) a transverse slice of the non-oxidized sample. Cross-sections A-A and B-B present open crack area visible in image 1, at different magnification

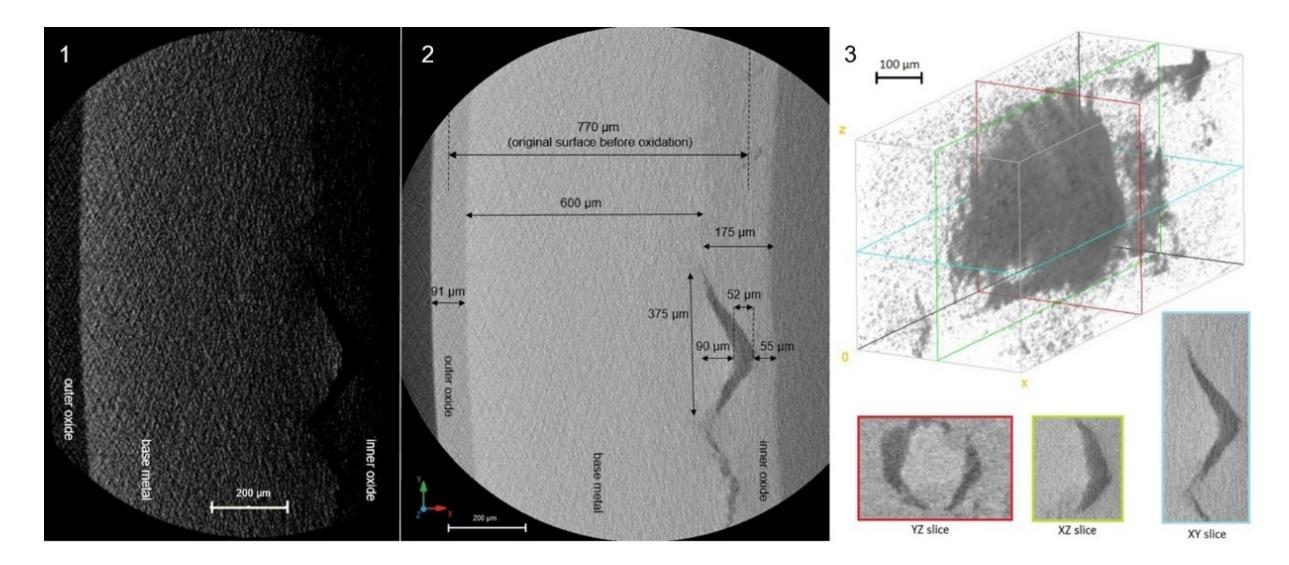
As illustrated by the image 2 in Fig. 12, the cracks along the metal/oxide interface correspond in length to the thickness of the inner oxide layers. The maximum cracks' openings are about 50  $\mu$ m. The 3D geometry of the cracks is shown in image 3. The original surface before oxidation is approximately marked in image 2.

**Fig. 12.** 1.4 μm voxel size X-ray tomography image of the Zircaloy-2 tube oxidized at 1373 K in air for 0.5 h: (1) geometry of oxidized sample with adjusted brightness and contrast; (2) oxidized sample with shown dimensions of inner oxide, base metal, outer oxide layer, and crack present at the metal/oxide interface; (3) geometry of crack appearing at the metal/inner oxide interface

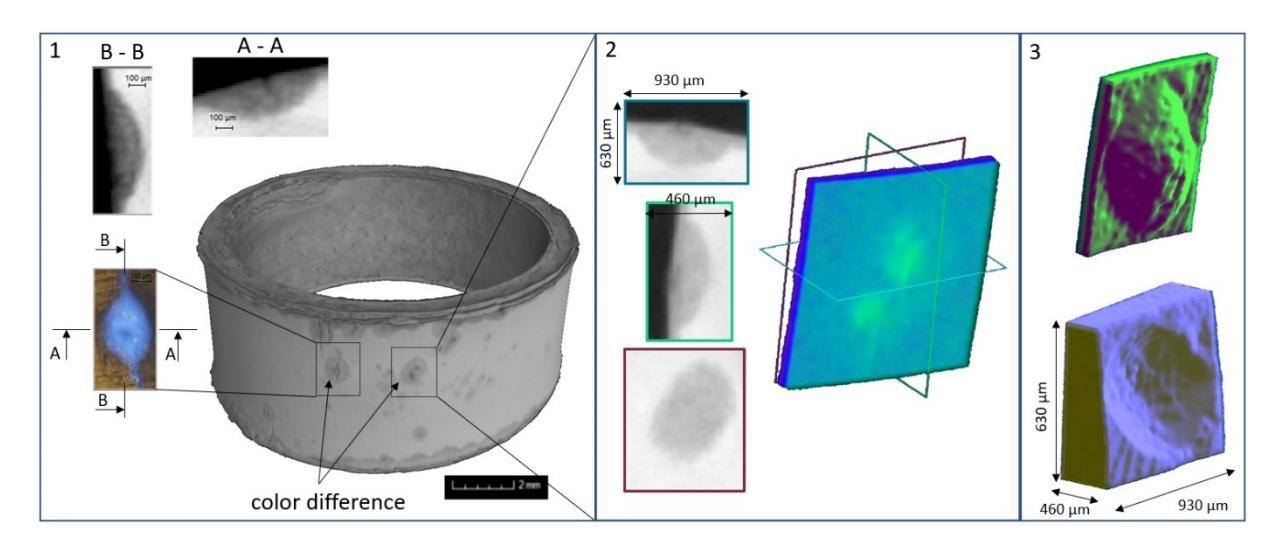
Nodular oxidation was observed only for samples oxidized at 1373 K on the outer oxide surface. Figure 13 illustrates the nodule within the oxide layer, which differs in color. The specimens oxidized at 1373 K demonstrated the black oxide layers with white oxides surrounding nodular corrosion area. That means that in this are the phase transformation has not been completed and both oxides, monoclinic (white) more prone to cracking and detachment, and tetragonal (black) less permeable to oxygen appear together.

Fig. 13. (1) overall 3D view of specimen oxidized at 1373 K in air for 30 min, cooled in air; arrows mark the white color oxides surrounding cracks; blue image on the left presents image of the crack and cross-sections A-A and B-B, obtained by polarized light microscopy; (2) 3D view of crack (nodular oxidation) on the overall 3D image; color framed pictures on the right represent cross-sections marked on the 3D model by color lines; (3) 3D illustrations of nodular type oxidation; green image shows oxide scale surrounding crack viewed on image 2; blue model represents cladding damage under nodular type oxide

Fig. 13 illustrates two areas marked as squares with shown nodular oxidation. The areas surround small cracks of length between 700  $\mu$ m and 800  $\mu$ m. Blue image on the left presents the marked cross-sections visualized by X-ray tomography. The crack is around 150  $\mu$ m deep and is surrounded by the oxide that highly exceeds in thickness the neighboring uniform black oxide layer. The oxide in the crack zone is around 310  $\mu$ m long, three times more than the thickness of a uniform oxide formed outside the crack zone. Images 2 and 3 in Fig. 13 represent a 3D model of the nodular oxide. The green model illustrates the oxide seen from ZrO<sub>2</sub>/Zircaloy interface. Blue image shows the damage in the cladding caused by nodular oxidation.
