Article

A Critical Reanalysis of Uncontrollable Washboarding Phenomenon in Metal Band Sawing

Abstract: The article analyzes the cutting process of hard bars. Investigations conducted in industrial conditions demonstrated the presence of surface errors in the machined workpieces in the form of washboard patterns. The purpose of this study was to analyze the results of cutting on band sawing machines with different band saw blades. The cutting processes were conducted on three different horizontal band sawing machine types. Analyzed material was an alloy steel Ø40 mm rod with a hardened surface covered with a thin layer of chromium. The hardness of the outer layer was 547 HV with a core hardness of 180 HV. The surface topography measurements of the processed workpieces were carried out with the 3D Optical Profiler, which supplied information on the irregularities of the processed material texture. In each of the analyzed cases, a corrugated surface was obtained after sawing, which is the effect of the occurrence of the washboarding phenomenon, despite the fact that the teeth of each band saw had variable pitches. The washboarding phenomenon when cutting rods with hard surfaces is c

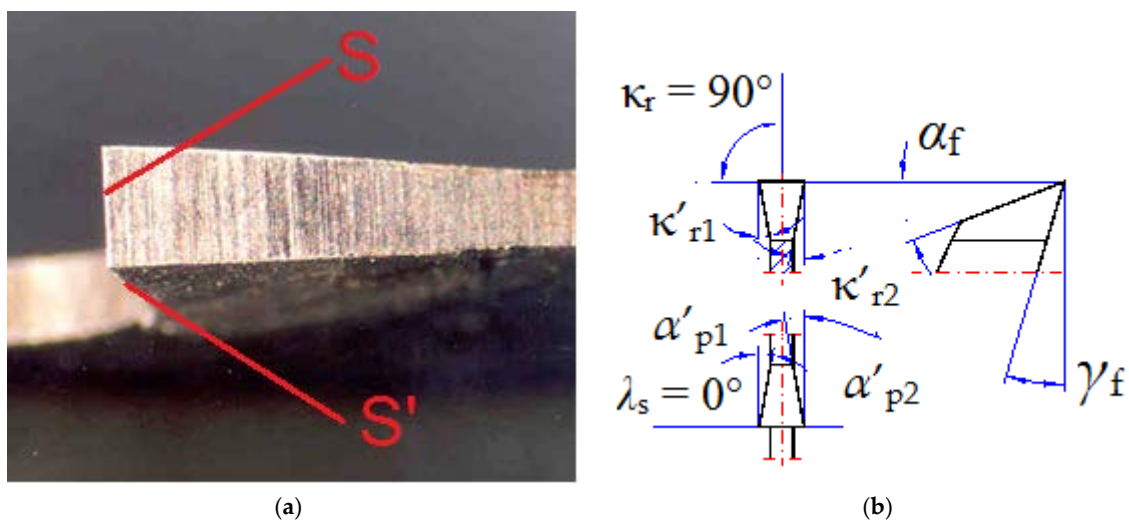
Figure 1. Band saw tooth general view from the top (a) and its geometry in the tool-in-hand system (b), where S—main cutting edge, S' —minor cutting edge, α_f the tool side flank, α'_p the tool back flank, κ_r tool cutting edge angle, κ'_r minor tool cutting edge angle, γ_f the tool side rake, and λ_s the cutting edge inclination angle.

It should be emphasized that chatter vibrations are the result of a number of phenomena during the cutting process occurring in the cutting zone on the main cutting edge [10,11]. On the other hand, when cutting with saws, three cutting edges are involved in cutting, for the simplest geometry, the main edge, and two minor cutting edges (Figure 1). The position of the minor cutting edges S' is defined by the minor tool cutting edge angles κ'_r (Figure 1b).

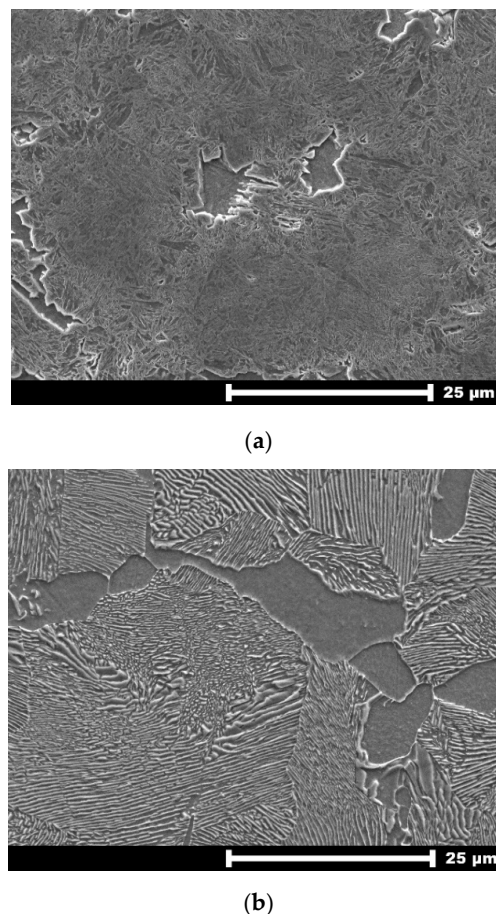
Figure 2. Rod metallographic structures: martensitic-ferritic outer layer (a) and pearlitic-ferritic core (b), obtained by SEM electron microscope (magnification 2000 \times).

In the analyzed cases, the cut material was a rod with a diameter of $\varnothing 40$ mm from alloy steel (grade of steel 66Mn4 (1.1260)) with a hardened surface. Moreover, its surface was covered with a thin layer of chromium. The hardness of the outer layer was 547 HV (about 52 HRC), while core hardness was 180 HV. HV hardness was determined on the Vickers-Brinell hardness tester HPO 250 (Hegewald & Peschke Meß- und Prüftechnik GmbH, Nossen Germany). The structure of the hardened layer (547 HV) of the workpiece (with a thickness of about 2 mm) was mainly made by martensite with a small amount of ferrite, as shown in Figure 2a. On the other hand, Figure 2b shows the structure of the rod core (180 HV), in which pearlite and ferrite are observed.
