Article

Advantages of the Application of the Temper Bead Welding Technique During Wet Welding

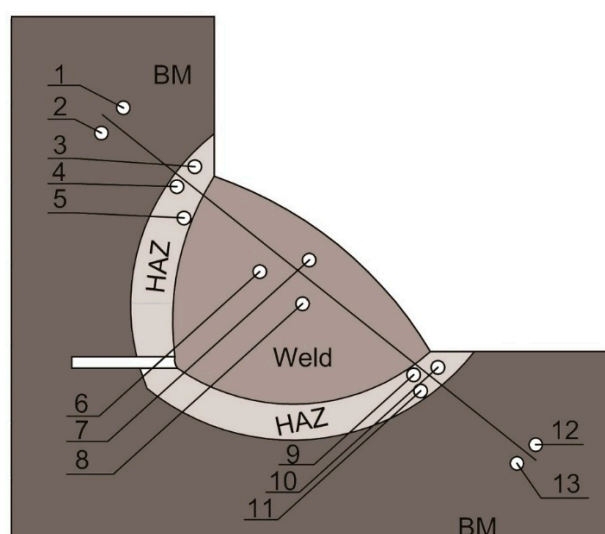
**Figure 2.** Hardness point distribution in the CTS specimens.

The hardness measurement scheme for CTS testing is presented in Figure 2. Figure 3 shows the regions of the TBW specimens in which the hardness was measured. The hardness measurements in the first padding weld of the normalization area of HAZ (HAZN) and the overheated area of the HAZ (HAZO) were located in the HAZ at the axis of the first bead.

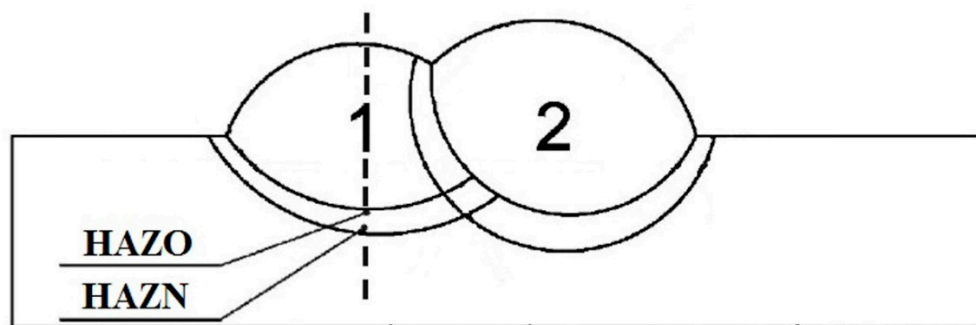
Figure 3. Hardness measurement areas of the heat affected zone (HAZ)—TBW specimens, overheated area of HAZ (HAZO) of the 1st padding weld in the weld axis, normalization area of HAZ (HAZN) of the 1st padding weld in the weld axis.

The hardness measurements were performed on cross-sections of each specimen with all ranges of pitch. The hardness was measured at points in two specific areas of the HAZ (overheated and normalized) of the first tempered weld (Figure 3). The results of the hardness measurements are presented in Figure 7. When the pitch between two beads increased, the hardness in the HAZO of the first padding weld decreased. The HAZO area in the specimens with low pitch values was characterized by the presence of the coarse-grained brittle structures created by the highest cooling rate in the welded joint (Figure 6b). These types of structures are one of the factors responsible for cold cracking. Thus, the HAZO area has a crucial influence on the formation of cracks.

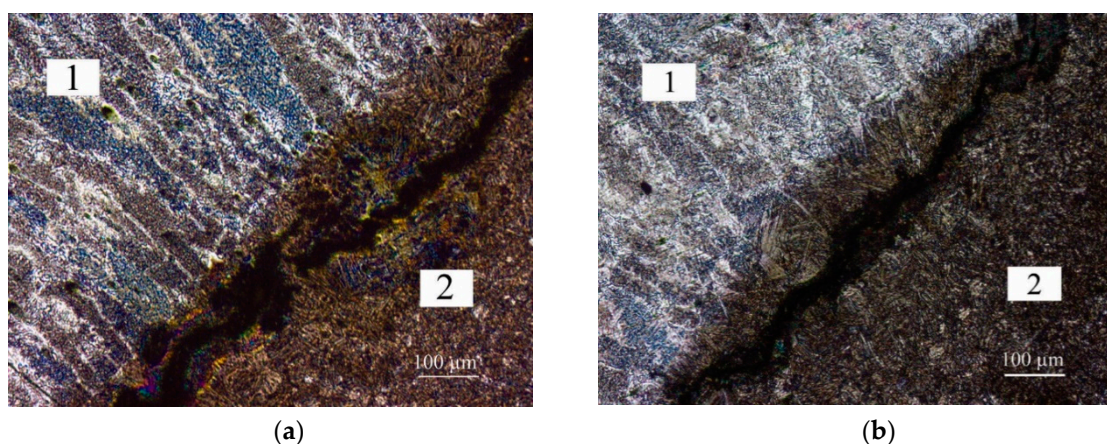
Figure 4. Cont.

Figure 4. Results of CTS microscopic testing shows cracks in HAZ, 1—weld metal, 2—HAZ, (a) Specimen 1; (b) Specimen 2; (c) Specimen 3; (d) Specimen 6. Etch. Nital 4%.

After non-destructive testing, second welds from specimens 1, 2, 5 and 6 were rejected from further examinations due to significant imperfections. The remaining welds were capable of undergoing further examinations. In the HAZ of each specimen, acicular and martensitic structures were found, which are a result of rapid cooling during welding in the water. The short cooling time also caused high residual stresses and limited the extraction of diffusible hydrogen in the welding environment. The weld metal structure was built of dendrites. The results of the microscopic examination of CTS specimens are presented in Figure 4. During macroscopic testing, cracks in the HAZ of the two specimens (the first weld in specimen 4 and specimen 6) and in weld of one specimen (first weld in specimen 4) were observed. The cracks in the HAZ were initiated in the weld root and propagated along approximately 50% of the length of the fusion line. This area was characterized by an overheated, coarse grain, martensitic structure as is shown in Figure 4a,b. The cracks were observed in the welded joints that were made with the lowest value of heat input (ql). Microscopic examination of S460ML steel showed that cracks occurred in all joints welded in the water environment. These cracks were located in the HAZ, along the fusion line. It was estimated that the total length of these cracks were 30%–40% of the total length of the fusion line. Cracks in the weld also were revealed.
