## Analysis of the Load-Bearing Capacity of Historical Foundations in the Context of the Quality of Mortar Used

**Keywords:** historical foundations, mortar modeling, stone foundation, FEM, material models

**Cytowanie / Citation:** Przewłócki J., Grębowski K., Zielińska M. Analysis of the Load-Bearing Capacity of Historical Foundations in the Context of the Quality of Mortar Used. *Wiadomości Konserwatorskie – Journal of Heritage Conservation* 2021, 66:92–105

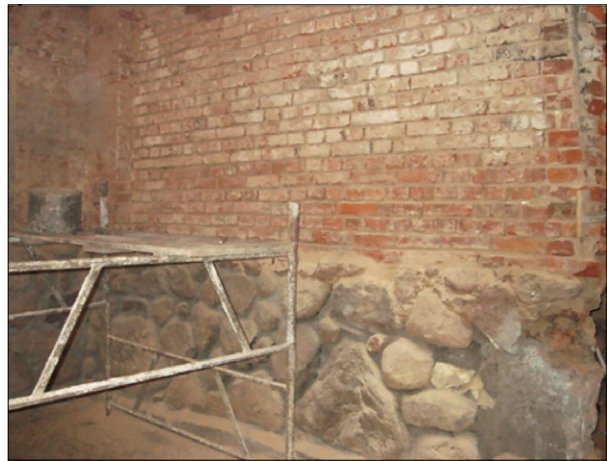
**Ryc. 2.** Widok fundamentu badawczego budynku zlokalizowanego w Olsztynie przy ul. Staromiejskiej: a) na zewnątrz budynku, b) wewnątrz budynku; fot. M. Zielińska 2012.

*Fig. 2. View of the position of research foundation of the building located in Olsztyn at Staromiejska Street: a) outside the building, b) inside the building; photo by M. Zielińska 2012.*

The stone foundations (Fig. 2) had a width of about 60 cm and a varied height due to differences in the ground level. The foundation was damp from

the outside and showed significant mortar losses, which had not been refilled so far. Considerations on strengthening the foundations were focused on mortar, as it was usually the weakest part of the stone foundations. Figure 2 shows a fragment of the foundations analyzed here. The foundations were analyzed numerically, to determine whether the mortar was capable of carrying additional loads. The previously minor loads transferred to the foundation, estimated at about 200 kN/m, increased to 280 kN/m because of the new steel and reinforced concrete structure and the new function of the building.
