Article

Analysis of the Possibility of Using New Types of Protective Coatings and Abrasion-Resistant Linings under the Operating Conditions of the Spiral Classifier at KGHM Polska Miedź S.A. Ore Concentration Plant

Abstract: A study was carried out to select the appropriate coatings for corrosion protection of the spiral classifier working at KGHM Polska Miedź S.A. Ore Concentration Plant. The abrasion resistance of selected protective coatings and wear-resistant linings was investigated using a DT-523 rotary abrasion tester with Taber CS-10 rubber abrasive discs. The average weight loss of the coatings after a cycle of 2000 revolutions was determined. Tests of protective coatings using the electrochemical impedance spectroscopy (EIS) technique were carried out to determine the suitability of coatings in the highly saline environment of the aqueous suspension of ground copper ore. During the measurements, changes in resistance, polarising current and capacitance were determined as a function of time for the tested coatings. The linings selected on the basis of laboratory tests were also tested under industrial conditions. Their degrees of wear were characterised. The results obta

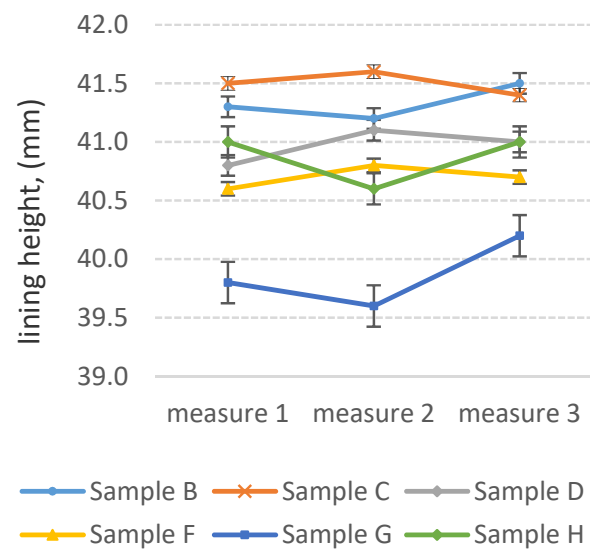
Figure 21. Lining height at three measurement points (front part).

An analysis of the degrees of wear of the tested linings based on the wear measurements shown in Figures 20 and 21 shows that linings made of polyurethane and polymer produced on the basis of MDI and PTMG achieved some of the lowest wear values, which is particularly evident for measurement numbers 4, 5 and 6 (Figure 21).

The elastic structure of both materials means that they are able to absorb some of the energy from the pressure force generated by the slurry in the classifier. Additionally noteworthy is the lining made of ultra-high-molecular-weight polyethylene with anti-stick additives, which achieved the lowest wear according to measurement numbers 1 and 2 (Figure 20), which may indicate the low coefficient of friction of this material. The remaining samples achieved a wear (relative to baseline values) above 1 mm for measurements 1, 2 and 3 (Figure 20) and above 23 mm for measurements 4, 5 and 6 (Figure 21).
