APPLICATION OF ACUSTIC EMISSION FOR DETECTION OF FATIGUE MICRODEAMAGE IN MAIN AND CRANK BEARINGS FOR DIESEL ENGINES

Jerzy Girtler

Abstract

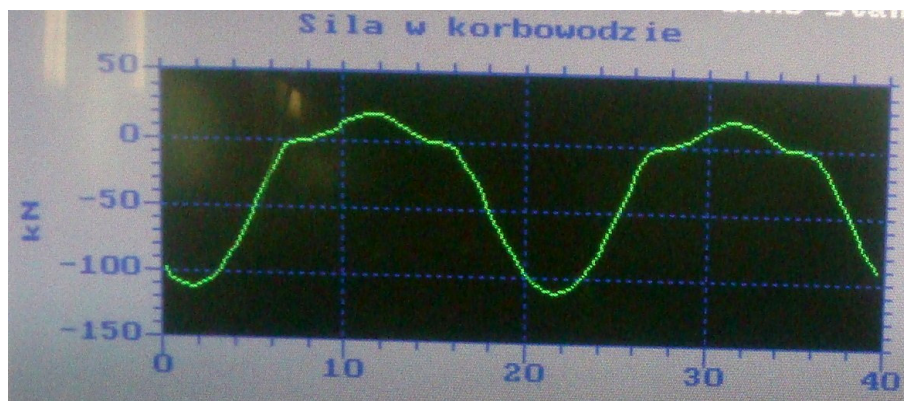
Fig. 1 Load during a test, applied to a bush made of MB58 alloy [9]

During the research, the bearings were subjected to loads which were dynamic as for the value and reverse, in the wide frequency range. Gradients of the load reached up to 3 kN per 1° OWK (crank angle degree) and induced the nominal pressure on the surface of the sliding layer, exceeding 120 MPa. The frequency of load changes was adjusted for the range from 20 Hz to 73 Hz. The dynamic load of almost constant direction, which was put on the bearing bushes of alloy AlSn20CuMn1 (MB58), tested in the SMOK rig, is depicted in Fig. 1

During the tests the recorded values included: loads (Fig. 1), temperature of the tested bearing and supporting bearings (Fig. 3), journal rotational speed, oil pressure, lubricating oil temperature and the ambient temperature.

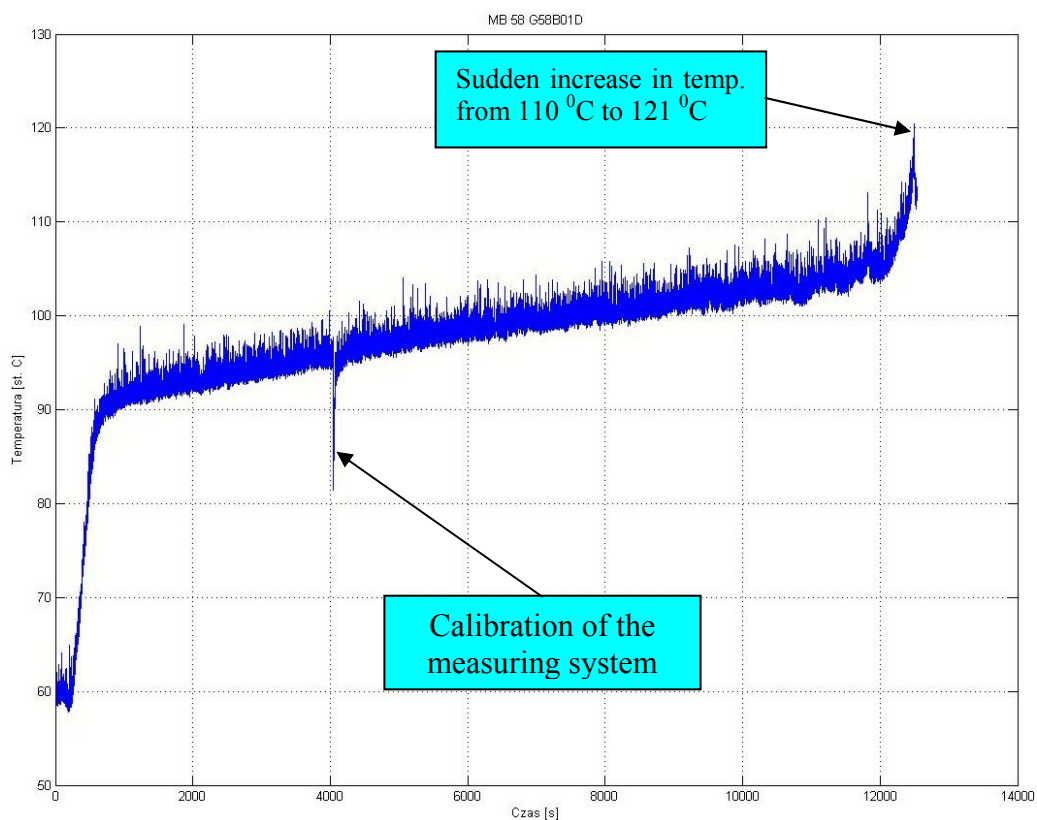
Fig. 6. Temperature of the bush of MB58 alloy during testing, at the pressure of 71 MPa [9]

The test was continued afterwards until recording another significant increase in the amplitude-frequency values of AE signals, and thereby the temperature of the bush to 121° C (Fig. 6). At this moment the bush was demounted again and its sliding layer was subject to examination.

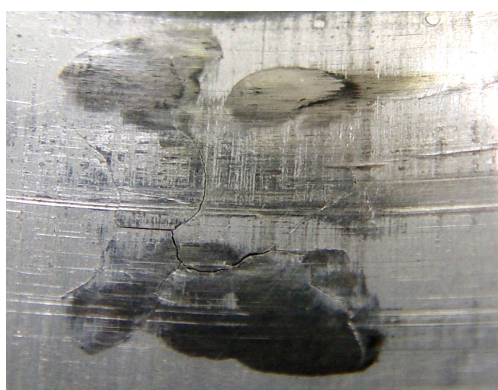
Fig. 8. Net of cracks on the sliding surface of the MB58 bush (zoom out of the part of the sliding surface shown in Fig. 7b) [9]

The existence of a standard net of fatigue cracks was recorded on the tested bush of MB58 alloy, as shown in Fig. 7a and b, and Fig. 8.

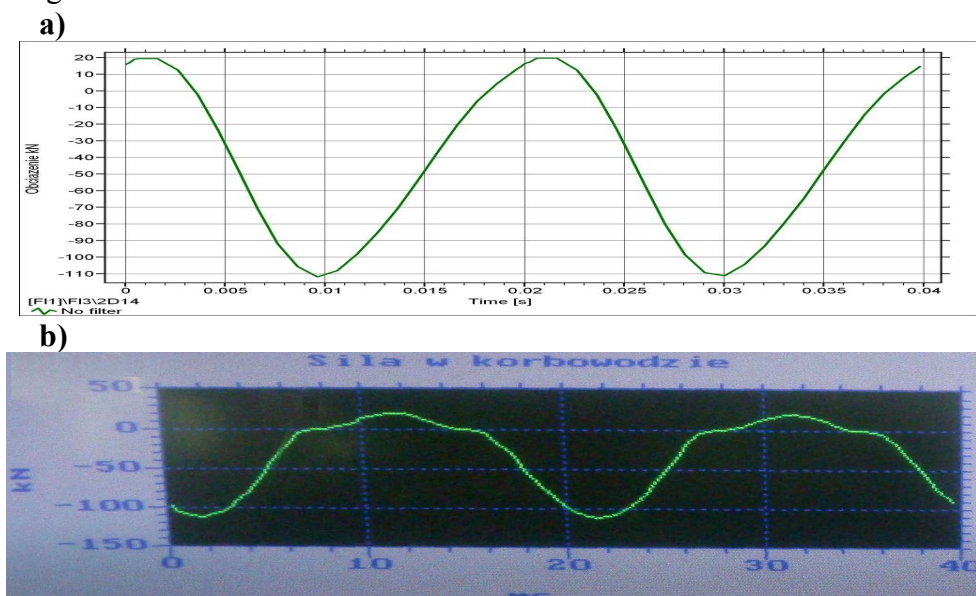
Fig. 9. Run of load on the slide bearing and the tested MB58 bushes:
a) averaged curve recorded by the AMSY-6 equipment, b) real curve resulting from the operation of the SMOK rig [9]

Comparison of the curves, averaged and real, of the load cycles for the tested bearing is shown in Fig. 9.

Fig. 9a demonstrates a curve of averaged load for a slide bearing, in a longer period of sampling and updating of its changes by the AE testing system. On the other hand, the curve shown in Fig. 9b shows the real load on the bearing, resulting from the operation of the SMOK rig.
