# As- built inventory of the office building with the use of terrestrial laser scanning

**Abstract.** Terrestrial Laser Scanning (TLS) is an efficient tool for building inventories. Based on the red-laser beam technology it is possible to provide the high accuracy data with complete spatial information about a scanned object. In this article, authors present the solution of use a TLS in as-built inventory of the office building. Based on the provided data, it is possible to evaluate the correctness of built details of a building and provide information for further construction works, for example an area needed for Styrofoam installation. The biggest problem in this research is that an error which equals over 1cm could generate costs, which could be a problem to cover by a constructor. Based on a complicated place of the construction works (centre of a city) it was a challenge to maintain the accuracy.

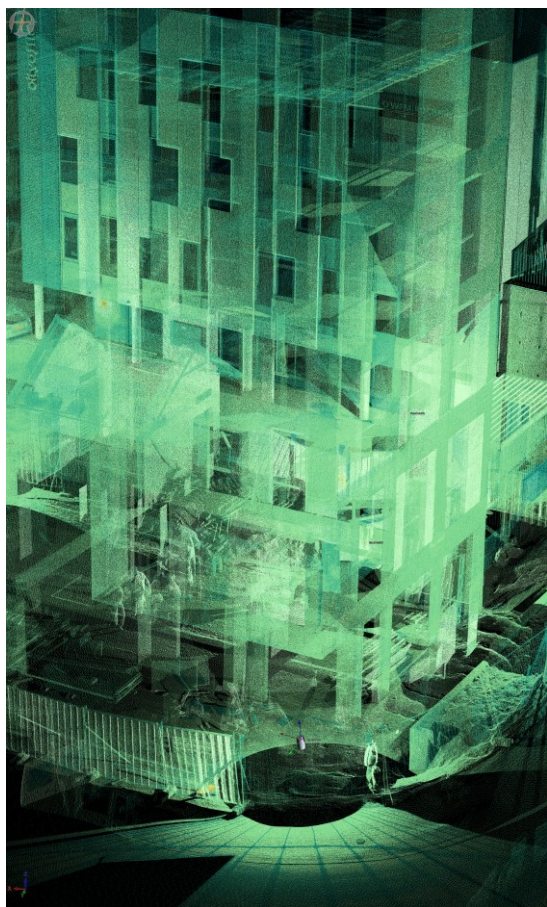
Fig. 2. The view of a scanned object.

Unfortunately, the situation was different from presumed. The whole object was enclosed by metal plates, preventing from enter into the construction site. Also, a close neighbourhood of road and other buildings was a problem for data acquisition. It was not possible to cover assumptions. It was a need to create a lot more scan stations. Authors placed 15 scan positions. The alignment of that positions and estimate the perfect, according to the project place of walls for deviations calculations was crucial. The Fig. 2 is presenting the scanned object.

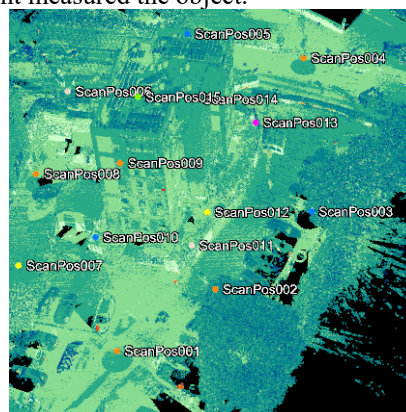
Fig. 3. Positions of the instrument.

The Fig. 3 is presenting the places where the instrument measured the object.

First, scan positions number 1, 2 and 7 was assigned to the North wall. Scan positions number 2, 3, 11, 12 and 13 was assigned to the West wall. Scan positions number 4, 5, 14, 15 was assigned to the South wall and 5, 8, 9, 10 to the East wall. The alignment results were presenting below in Fig. 4 for the North wall, Fig. 5 for the West wall, Fig. 6 for the South wall and Fig. 7 for the East wall. Every of standard deviations results for each wall are presenting in meters.

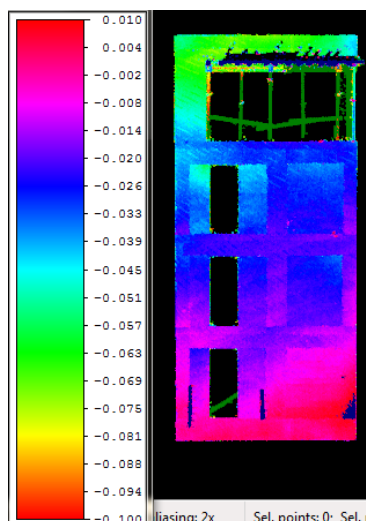
Fig. 12. Angular deviations for West wall in meters.
