CAUSES OF DEFECTS AND DAMAGE TO BRICK MASONRY ELEMENTS IN HISTORIC BUILDINGS

Maciej NIEDOSTATKIEWICZ¹, Tomasz MAJEWSKI²

¹Gdansk University of Technology, Faculty of Civil and Environmental Engineering,
Department of Engineering Structures

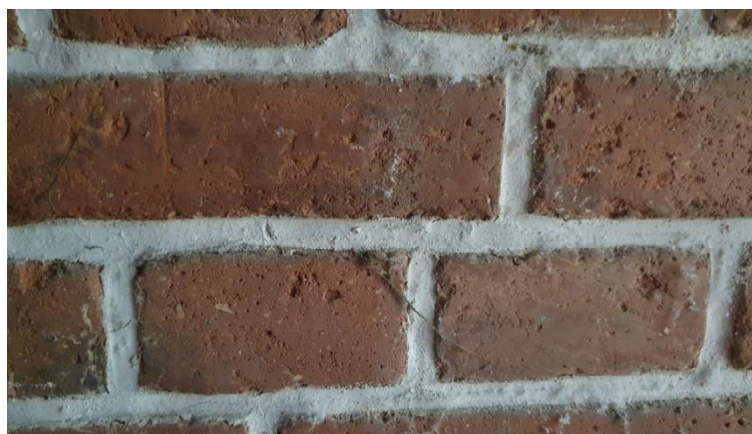
Fig. 1. Open pores and capillaries of the exterior masonry of solid ceramic brick, visible cement mortar tight joint improperly executed in the past period during renovation work (photo: Maciej Niedostatkiewicz)

The destruction and deformation proceeds the faster the brick masonry elements' greater structural irregularities are (Fig. 1), the weaker the adhesion of mortar and the more voids, caverns, fissures and cracks there are in the masonry section.

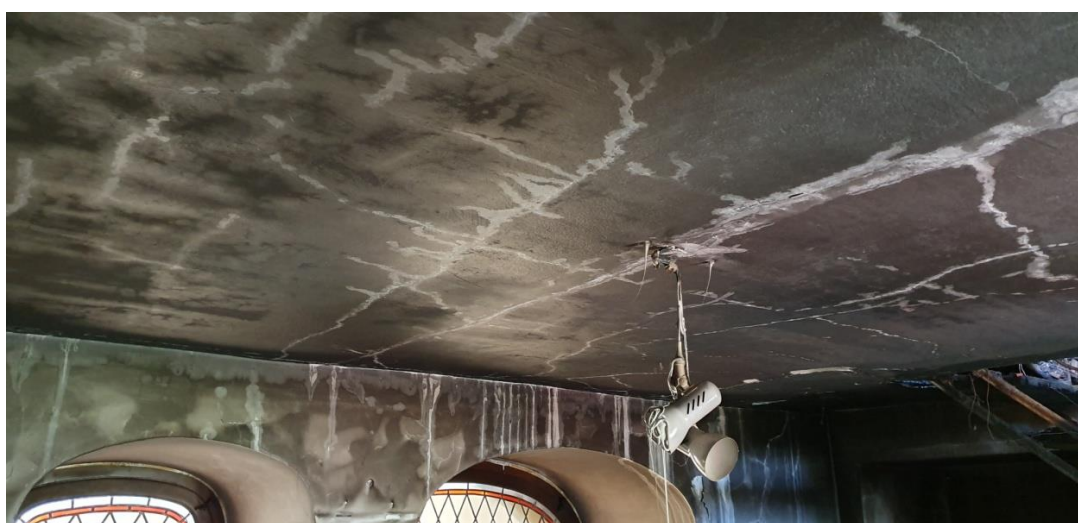
Fig. 5. Fire damage to solid ceramic brick wall and ceiling on wooden beams, visible cracks in plaster on wall and ceiling (photo: Maciej Niedostatkiewicz)

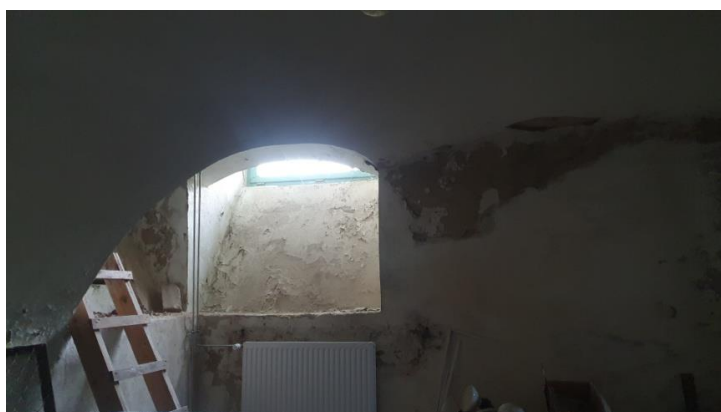
Fig. 7. Dampness of the external wall made of solid ceramic brick caused by the lack of vertical damp proofing in the part sunk in the ground (photo: Maciej Niedostatkiwicz)

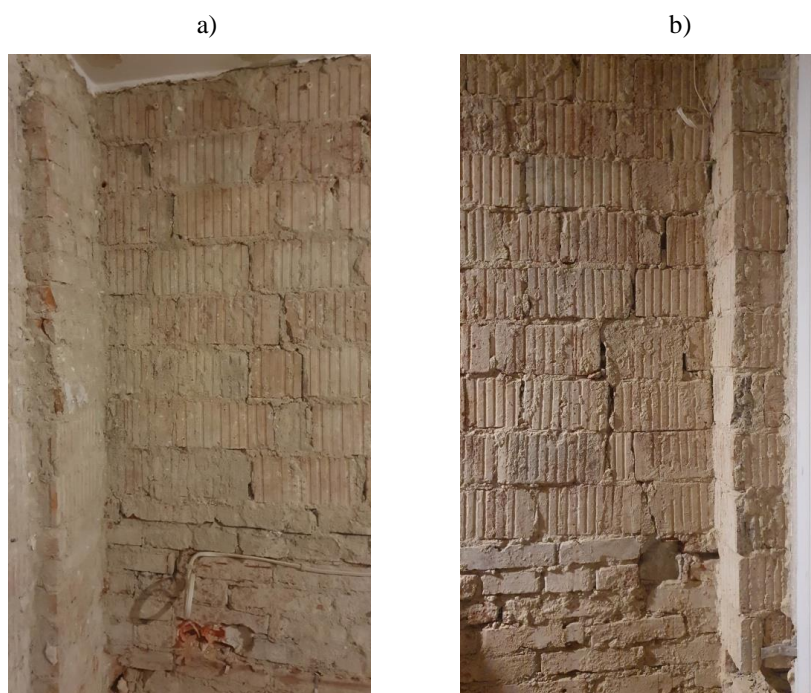
Fig. 10. Thorough cracking of the interior transverse wall made of ceramic grid brick at the point of connection with the exterior longitudinal wall made of ceramic solid bricks in a building with wooden beam ceilings not having frontal and lateral anchoring (photo: Maciej Niedostatkiwicz)

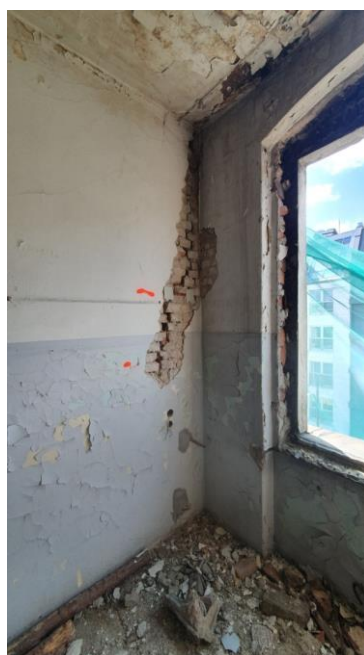
Fig. 11. Cracking of the internal transverse wall made of solid ceramic bricks at the point of connection with the external longitudinal wall in a building with ceilings on wooden beams that do not have frontal and lateral anchoring (photo: Maciej Niedostatkiwicz)

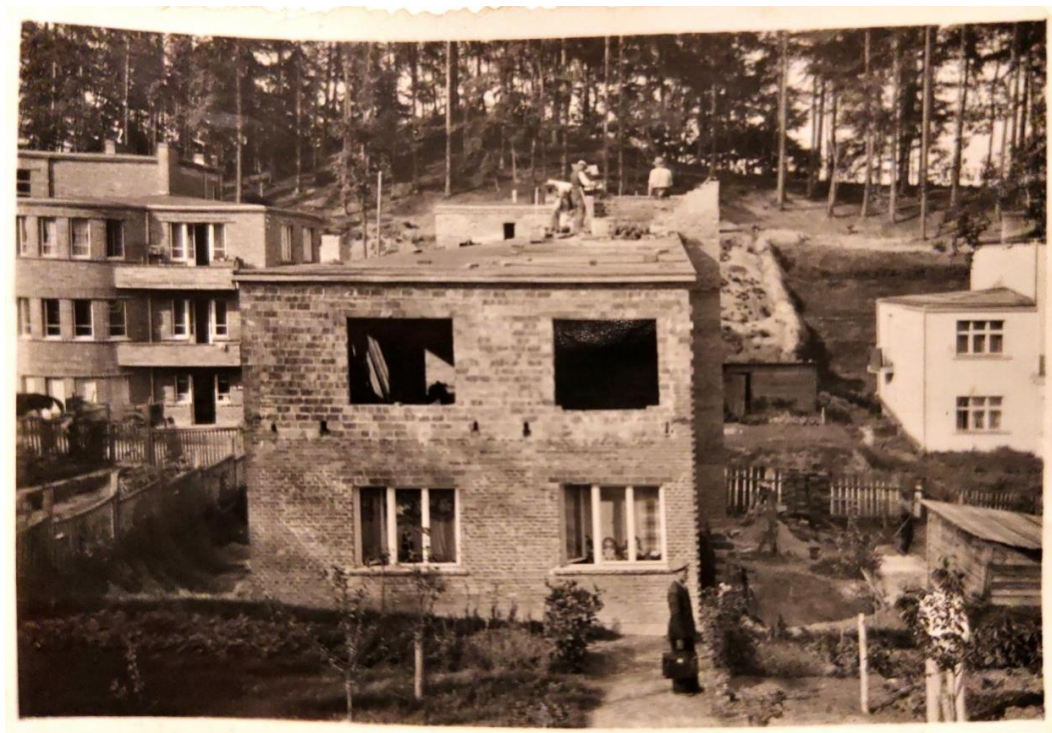
Fig. 12. Building with layered exterior walls (with air cavity), made of ceramic bricks: a) solid, at the level of the ground floor, b) trusses, at the level of the first floor (photo: Jan Niedostatkiewicz)

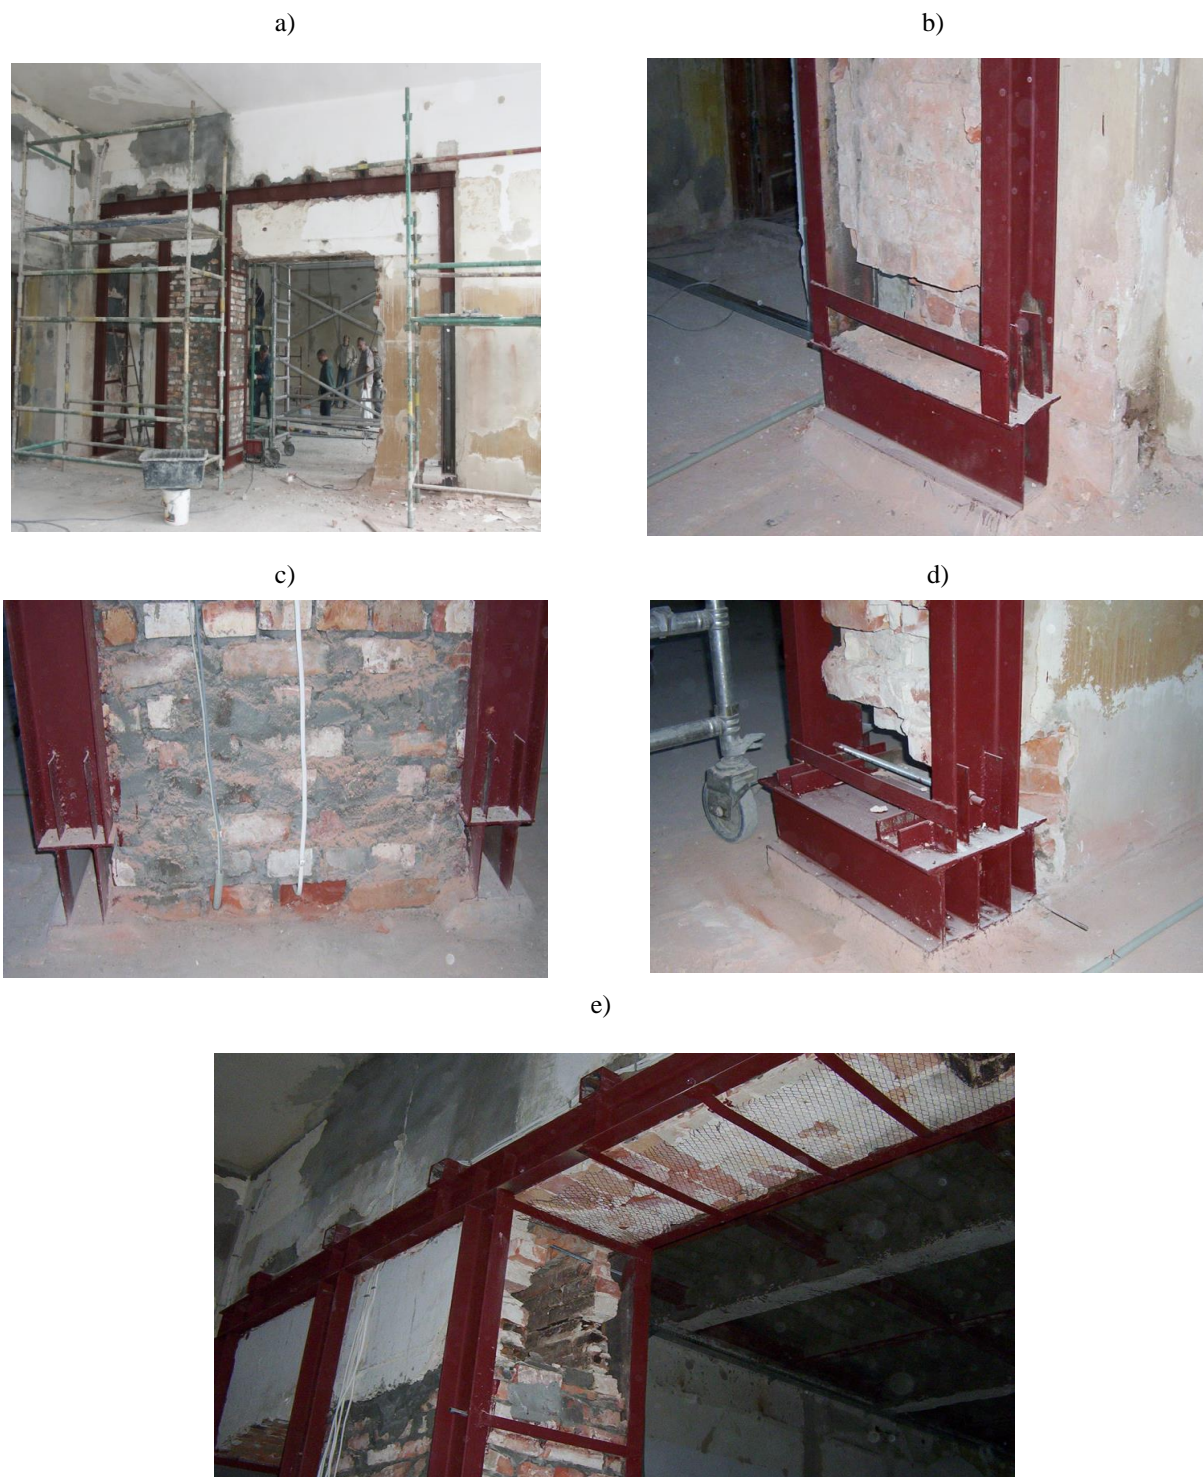
Fig. 17. Making door openings in the inner wall of solid ceramic brick: a) view of the steel frame, b), c), d), e) construction details (photo: Tomasz Majewski)

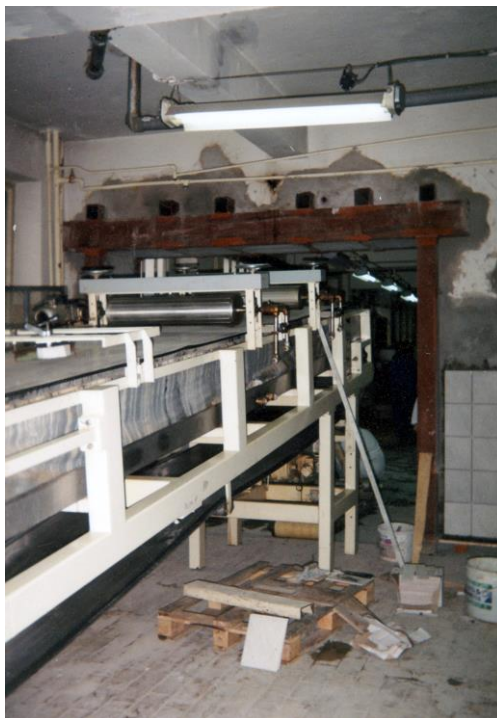
Fig. 18. Widening of the door opening in the inner wall of solid ceramic brick
– view of the steel frame construction
(photo: Maciej Niedostatkiwicz)

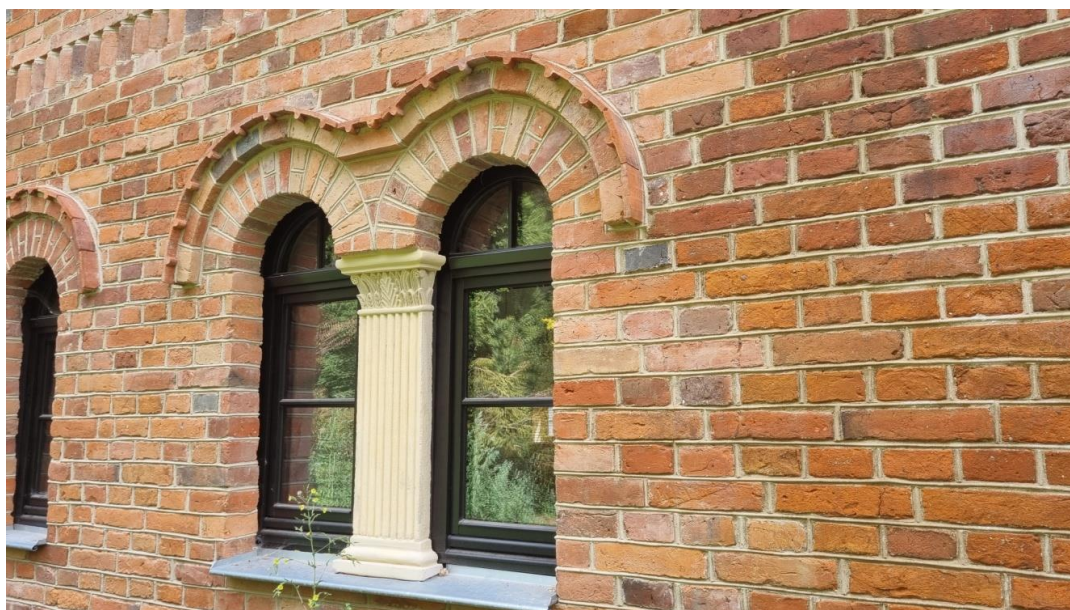
Fig. 19. Revitalization of historic solid ceramic brick wall using contemporary brick
and ceramic tile and limestone details
(photo: Maciej Niedostatkiwicz)
