Ł. Bolewski, M. Szkodo, M. Kmieć

Gdańsk University of Technology, Faculty of Mechanical Engineering, Department of Materials and Welding Engineering, 11/12 Narutowicza, 80-233 Gdańsk, Poland

CAVITATION EROSION DEGRADATION OF BELZONA[®] COATINGS

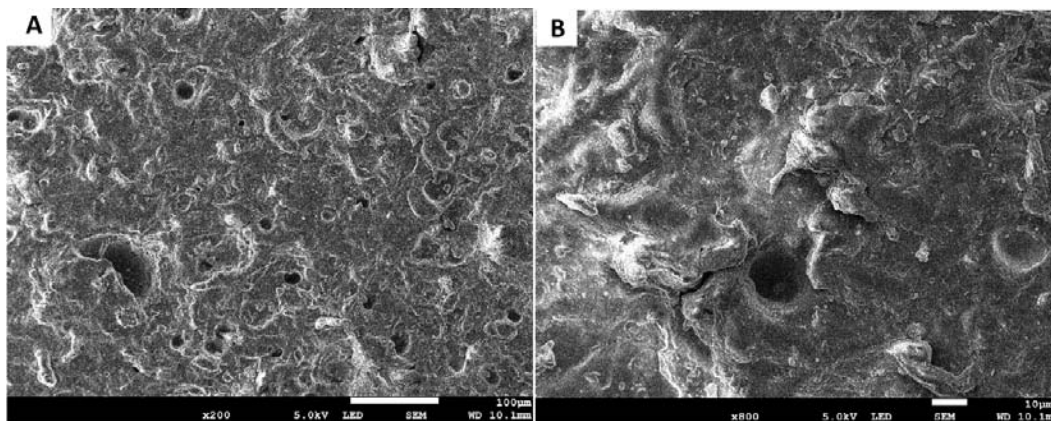
Fig. 12. SEM photos of coating 2141 samples after end of cavitation in distilled water

Material 2141 coating of two-component polyurethane is characterized by high plasticity behaviour reminiscent of elastomer. SEM results shown in Fig. 12 the essence of the impact of cavitation erosion on the material. Fig. 12 A) shown a cavities of spherical shapes, which have causes of micro-jet impact generated during implosion of cavitation bubbles. Fig. 12 B) shows one of such voids and cavitation impacts in the traces formed on the sample surface. Also visible cracks formed in the area near cavitation craters, cavitation load initiate fracture that develop on surface of the eroded material and leading to loose of thin flakes of material (delamination). However, the weight loss was unnoticeable, the accuracy of scales not captured changes in the mass of the coated sample. The outstanding observed results can be attribute of the strong adhesive connection of coating.

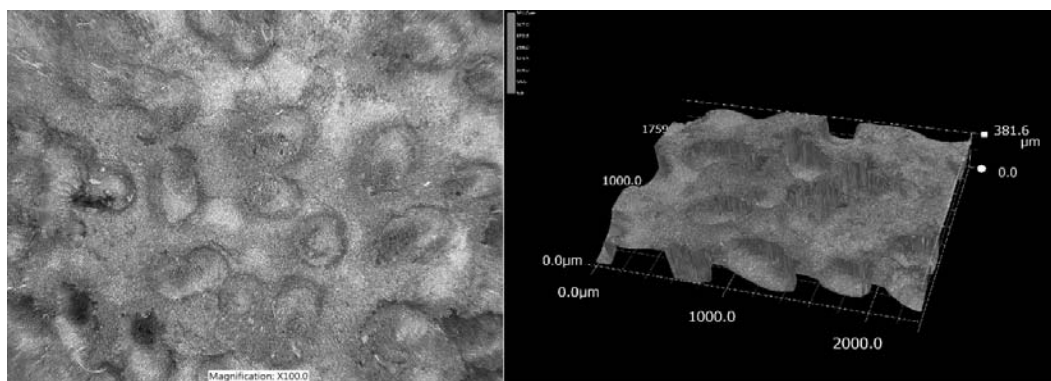
Fig. 13. Optical microscope photos of eroded surface of P110 sample tests in distilled water

Fig. 13 shows micrographs of tested surface steel P110 sample. Two mechanisms of mass removal were observed. Formation of deep micro-cavities due to micro-jet action and cracking of the material from slip line or grain boundaries.
