Characterization of corrosion in reinforced concrete beams using destructive and non-destructive tests

Gdansk University of Technology, Faculty of Civil and Environmental Engineering, Poland

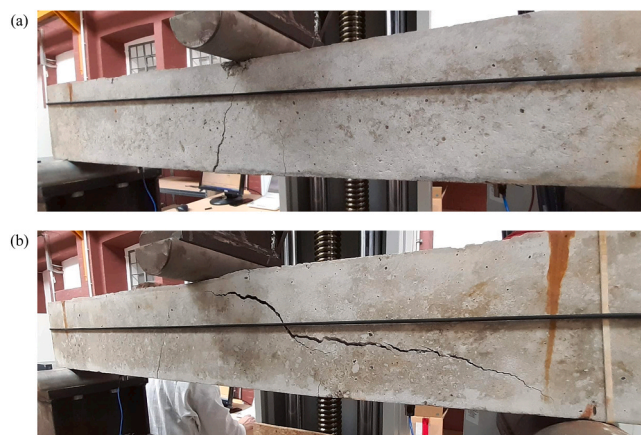
Fig. 13. Two types of failure modes: (a) type A – flexural failure, (b) type B – shear failure.

During experiments, the first cracks started to appear in the middle of the length of the specimen, in the bottom areas of the cross-section. Two types of failure modes can be distinguished for different specimens. The first one, designated as “type A”, is typical for concrete structures reinforced with a single bar known as a flexural failure. In this mode, the cracks propagated together with the increase of their width. From a certain point, only a single steel bar carried the internal bending moment caused by the applied force until the stress level reached its yield point. The second failure mode, designated as “type B” also known as a shear failure, was characterized by cracks appearing at an angle of about 45° or less. This means that it was not the bending moment but the shear force that determined the achievement of the load capacity. While the level of the applied load increased, the width of cracks increased, until the specimens failed, which occurred when the steel rod lost adhesion to the concrete and detached. The specimens subjected to corrosion for more days showed type B of failure mode (shear failure), i.e., specimens C6-C9 (Table 4). This proves that the presence of corrosion weakens the bond between the concrete and steel reinforcement. The examples of both types of failure modes are presented in Fig. 13. Moreover, Fig. 14 shows the specimen after destruction according to type B, where the rebar detached from the concrete.

- Two failure modes were observed in a three-point bending test, i.e., “type A” (flexural failure) and “type B” (shear failure). For specimens that were kept in the solution for a shorter time, type A was dominant, in which damage to the specimens was caused by the stress level that was equal to the yield point of the rebar. However, for the specimens that were kept in the solution longer, a different scheme was observed (type B), in which the diagonal and longitudinal cracks occurred as a result of the loss of adhesion of the bar to the concrete and, then, detachment. The lowest capacity was obtained for specimen C9, which was immersed in the NaCl solution for the longest time.
