# Chemical, Physical, and Mechanical Properties of 95-Year-Old Concrete Built-In Arch Bridge

**Abstract:** This research aimed to determine the durability and strength of an old concrete built-in arch bridge based on selected mechanical, physical, and chemical properties of the concrete. The bridge was erected in 1925 and is located in Jagodnik (northern Poland). Cylindrical specimens were taken from the side ribs connected to the top plate using a concrete core borehole diamond drill machine. The properties of the old concrete were compared with the present and previous standard requirements and guidelines. The laboratory testing program consisted of the following set of tests: measurements of the depth of carbonated zone and dry density, water absorption tests, determination of concrete compressive strength and frost resistance, determination of modulus of elasticity, measurement of the pH value, determination of water-soluble chloride salt and sulfate ion content, and X-ray diffraction analyses. Large variations in the cylindrical compressive strength (14.9 to 22.0 MPa), modulus of elasticity (17,900 to 26,483 MPa), density (2064 to 2231 kg/m<sup>3</sup>), and water absorption

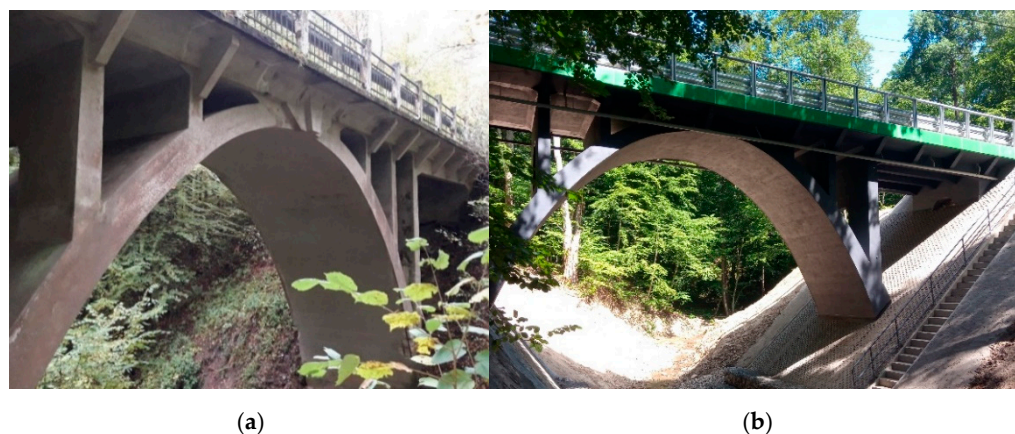
**Figure 1.** Jagodnik arch bridge before (a) and after (b) reconstruction.

The arch bridge investigated in this study is located above a forest canyon and the Kumieli river (watercourse) (see Figure 1). The structure of the center span bridge (about 12.95 m) is a reinforced concrete slab, monolithically connected to reinforced concrete shields supported on a plate arch. The arch bridge was built in 1925 in Jagodnik (Poland) by Karl Metzger & Co. building company (see p. 181 in [24], where a photo of the investigated arch bridge is inserted). In 1925, Jagodnik (Berendshagen) was part of the district of Elbing in Germany (present-day Elbląg in Poland). The arch bridge was erected under the guidelines of the German Committee for Structural Concrete issued in January 1916 [25] for structural use of concrete, design, and construction. This guideline was in force until September 1925, when the German standard DIN 1045 [26] was introduced.

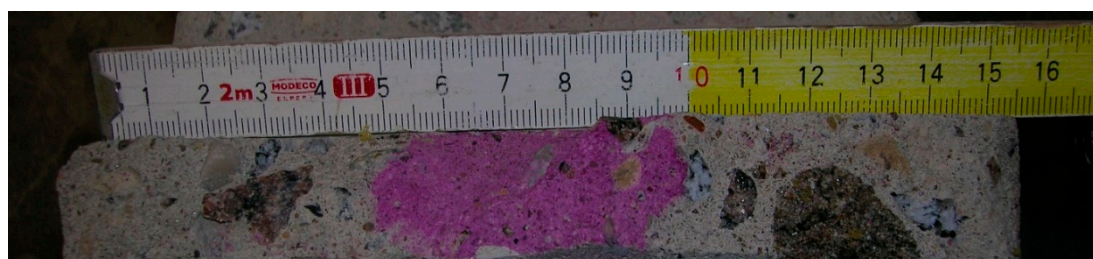
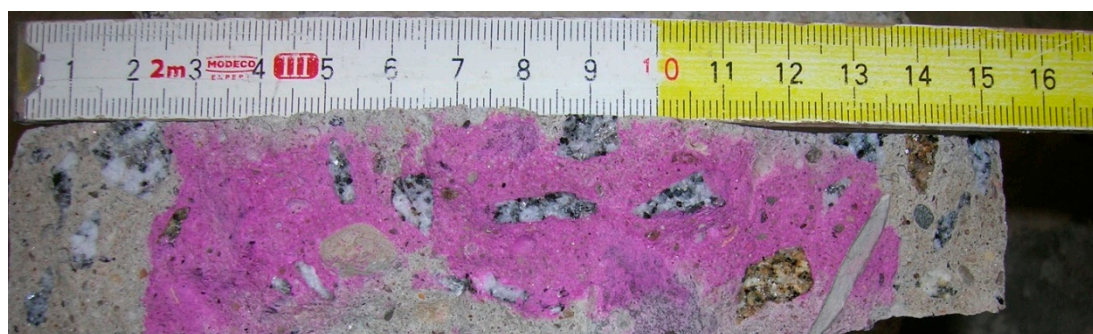
Figure 2. Depth of carbonated zone: (a) about 5 cm; (b) about 2.5 cm.

The chemical reaction of calcium hydroxide dissolved in pore water with atmospheric carbon dioxide (conversion into calcium carbonate, which is then mainly calcite [36]) is called carbonation of concrete. Carbon dioxide in the air penetrates into concrete and diminishes the pH value and also causes shrinkage in the concrete [37]. The depth of the carbonated zone measured with the phenolphthalein solution is illustrated in Figure 2. Freshly fractured surfaces of all specimens reacted with the alcoholic solution of phenolphthalein, immediately turning to pink/purple color, indicating the presence of calcium hydroxide, except at the thin, already carbonated external layers. Large variations in depth of the carbonated zone was observed in the investigated specimens of old concrete, ranging approximately 20 to 55 mm (see Table 1). The average depth of carbonation of the old concrete was  $36 \pm 2$  mm. The result of the mean value is presented as the sum of mean values and standard error of the mean of the specified range.

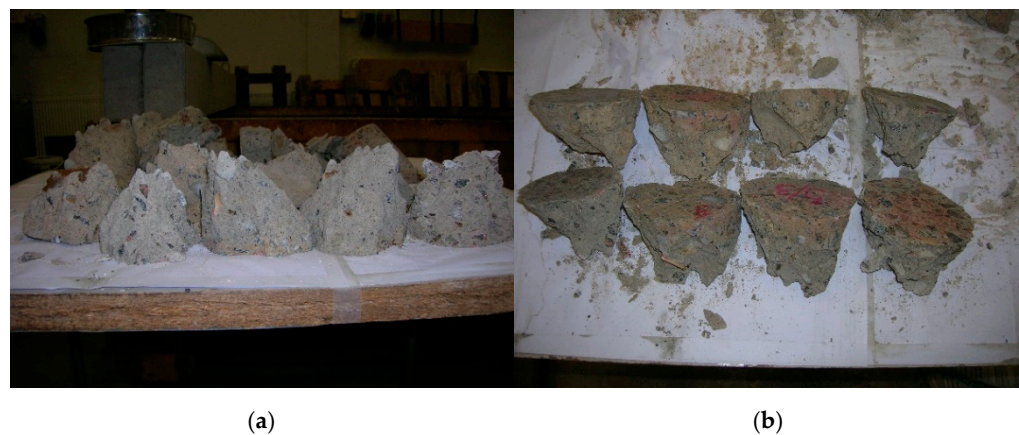
Figure 3. Concrete specimens after uniaxial compressive tests: (a,b) views of the form of failure.

Uniaxial compressive experimental tests were carried out using the Advantest 9 C300KN mechanical testing machine. Experiments were performed on the failure of the concrete cylinder specimens (see Figure 3). The uniaxial tensile test results of compressive strength for cylindrical samples  $f_{c,cycl\ 100}$  is presented in Table 3. The mean value of compressive strength of cylindrical samples  $f_{c,cycl\ 100}$  was  $18.8 \pm 0.7$  MPa. The strength results of the cylindrical samples  $f_{c,cycl\ 100}$  with length/diameter ratio of 1.0 were comparable to the cube strength  $f_{c,cube}$  of  $15 \times 15 \times 15$  cm concrete specimens according to the EN 12504-1 standard [27], i.e.,  $f_{c,cycl\ 100} = f_{c,cube} = 18.8 \pm 0.7$  MPa. The variation in compressive strength values of the 95-year-old concrete (see Table 3) can be explained by the production technology, which was probably based on portable concrete mixers with handmade proportions of concrete components. Portland cement was used as a binder in ordinary old concrete mixes. It should be noted that the new cementitious materials, e.g., geopolymer concrete (called alkali-activated materials, see e.g., [42–46]), have higher compressive strength and better durability compared to concrete mixes containing Portland cement.

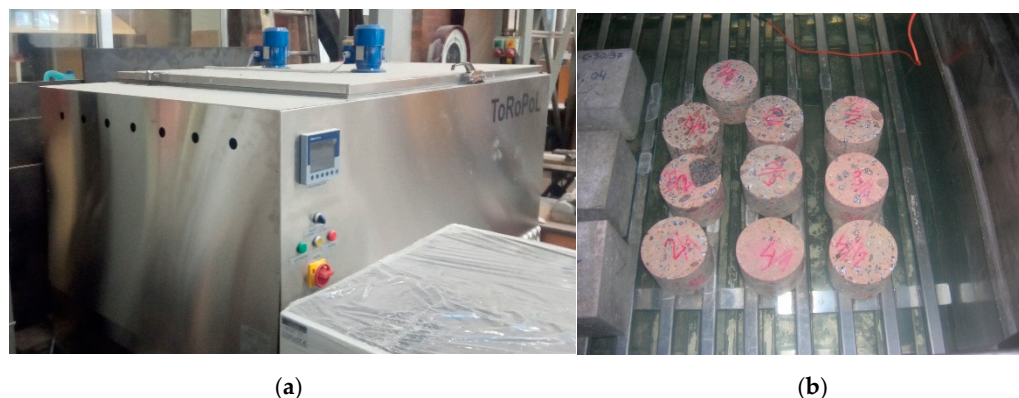
**Figure 4.** Frost resistance tests: (a) view of freezing chamber; (b) view of concrete specimens inside the freezing chamber.

With regard to evaluation of freezing resistance, according to the PN-B-06250 standard [33], the compressive strength should not decrease by more than 20% in comparison to the base samples and the specimens should not show cracks [47]. In this study, we started the test by saturating the concrete samples with water. Then, 10 concrete samples were placed in a freezing chamber with a temperature- and time-controlled refrigerating and heating system (see Figure 4). The concrete samples were placed in the freezer com-

partment with a minimum 20 mm gap. A total of 50 freezer cycles were carried out consisting of freezing at  $-18 \pm 2$  °C for 4 h and thawing by total immersion in water at  $18 \pm 2$  °C for 4 h. After the last defrosting, a strength test was carried out. The frost resistance assessment was based on measuring the change in compressive strength. The mean value of compressive strength of the cylindrical samples after 50 freezer cycles  $f_{c,cycl 100}^{50 \text{ freezer cycles}}$  was  $17.9 \pm 1.0$  MPa, which was about 5% lower than the compressive strength of cylindrical samples  $f_{c,cycl 100}$  without freezing (base samples). The difference between compressive strength  $f_{c,cycl 100}$  and  $f_{c,cycl 100}^{50 \text{ freezer cycles}}$  was small (<20% according to PN-B-06250 [33]); therefore, it could be stated that the 95-year-old concrete possessed freezing resistance.
