Condition of reinforced concrete structures and their degradation mechanism at the former Auschwitz concentration and extermination camp

The paper presents the results of investigations on reinforced concrete structures present in the former Auschwitz I and Auschwitz II-Birkenau concentration and extermination camp. Field inspection employing non-destructive method of reinforcement potential measurement according to the ASTM-C 876-15 standard, followed by laboratory investigations performed on genuine historic reinforced concrete samples collected from the former Auschwitz camp allowed assessment of the actual condition of this 70-year old construction material. Electrochemical potential measurements allowed mapping of the regions characterized by enhanced reinforcement corrosion risk and the regions of its immunity. Composition of concrete, water absorbency, content of detrimental salts, degree and profile of carbonation as well as mechanical properties were evaluated. The obtained results revealed the most common and probable mechanism responsible for degradation of the reinforced concrete structures in the former Auschwitz camp.

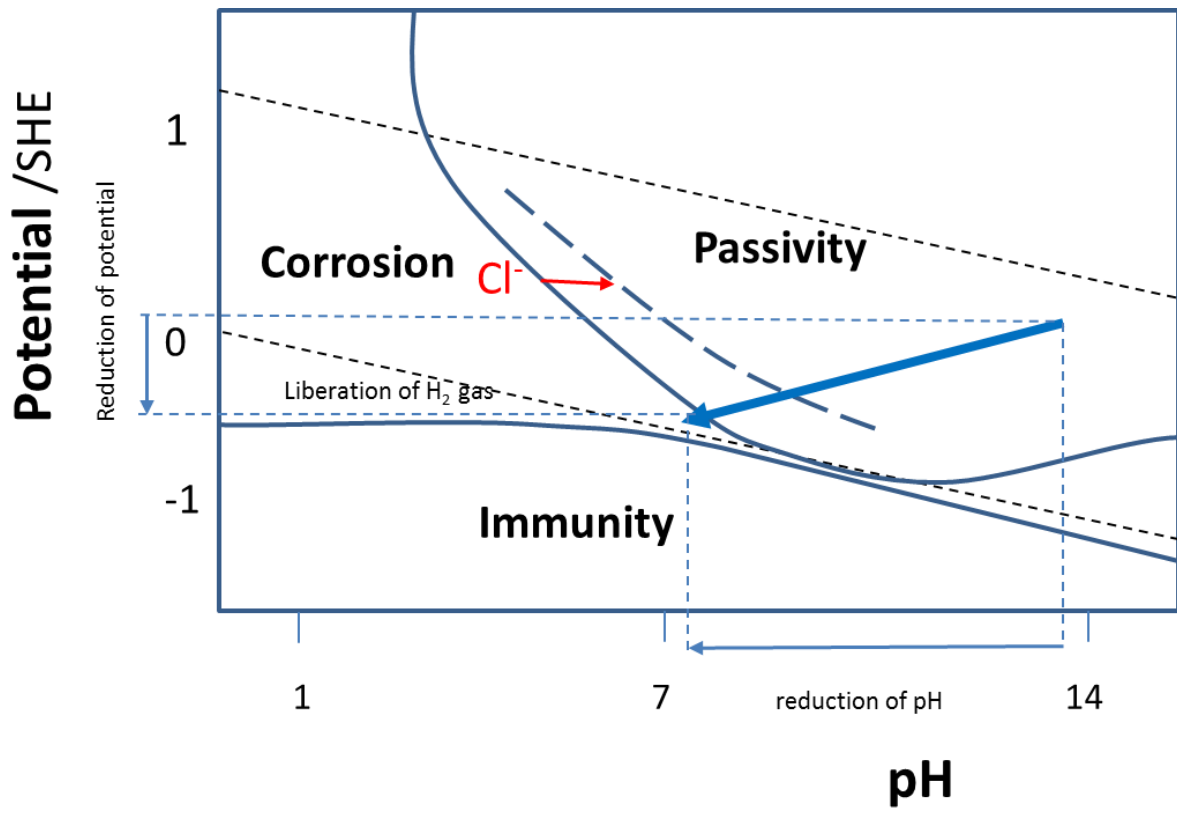
Figure 3

presence of promoters of corrosion in the environment, such as e.g. Cl⁻ ions, change the position of the borders of the corrosion area. Thick arrows mark the carbonation process leading to a gradual reduction of the pH of the concrete environment and a transition from the passive to the corrosion area. This can occur more quickly if the environment contains e.g. Cl⁻ ions. All these processes are reflected in bringing down the potential. Hence, by monitoring the potential changes in time, we can draw a conclusion about corrosion of the reinforcement or lack thereof. Monitoring and inspection of concrete structures with regard to reinforcement corrosion can be performed in combination with other non-destructive techniques, e.g. polarization resistance testing or concrete resistivity testing (Polder *et al.*, 2000).

Fig. 3. Simplified Pourbaix diagram for iron with the indicated course of carbonation process (blue thick arrow). SHE – Standard Hydrogen Electrode.

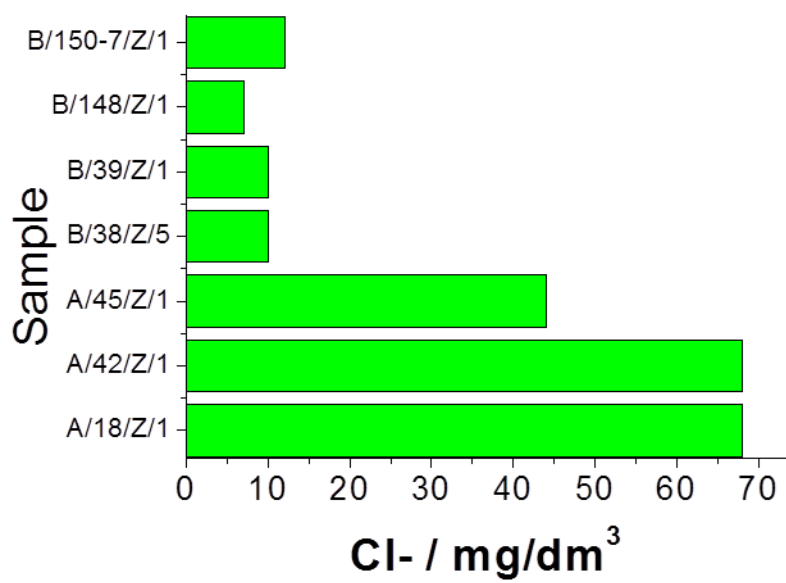
Figure 11

The presence of chloride ions (Cl^-) and sulphate ions (SO_4^{2-}) in concrete is a factor contributing to corrosion onset of reinforcement steel due to destabilization of the protective passive layer. Accordingly, it is important to determine the content of particular ions as well as their depth profile in order to verify if they impose a hazard to reinforcement passivity. The concentration of chloride ions in the investigated samples is from $7\text{mg}/\text{dm}^3$ to $68\text{mg}/\text{dm}^3$ (Fig. 11). These values are relatively low as for instance $800\text{mg}/\text{dm}^3$ is accepted level of chlorides in fresh concrete (Chloride resistance report, 2009). The origin of these ions could be soil (capillary suction via the pores of concrete cover, especially in the lower parts of structures neighbouring soil), air (chlorides carried by the aerosol, possibly from the Sola River located nearby, and deposited on concrete elements) and batched water (intrinsic content of chlorides in water used for preparation of mortar). A higher content of chlorides was detected in the samples collected in the former Auschwitz I camp, due to the fact that the Auschwitz II-Birkenau is located on open, flat area, where wind and precipitation cause partial removal of chlorides from the concrete material.

Fig. 11. Concentration of chloride ions in analysed concrete samples collected at former Auschwitz I and Auschwitz II-Birkenau camp.

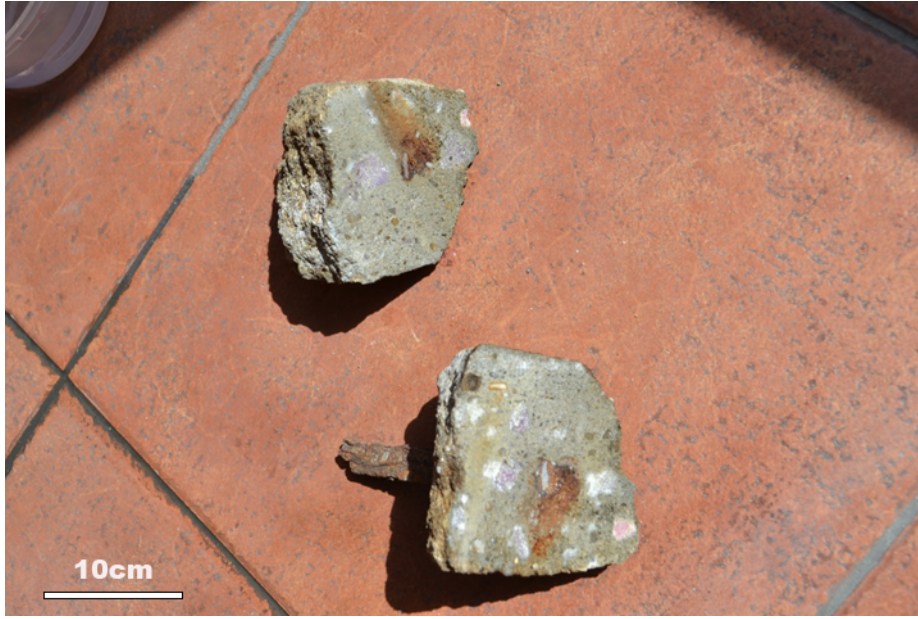
Figure 18

Elements that are smaller and thinner in cross-section suffer from complete carbonation after 70 years of atmospheric exposure. The phenolphthalein test (Fig. 18) as well as pH of aqueous extracts maintained within the range 8-11 suggest significant carbonation. This does not guarantee a passive state of the reinforcement, contributing to reinforcement corrosion and causing concrete to crack and spall.

Fig. 18. Smaller fragments of a ceiling of ruins of gas chamber subjected to phenolphthalein test. Lack of pink colour is the evidence of complete carbonation of the samples.
