Michał Kwasek*

Conservation aspects of cast-iron platform shelters on the example of Vistula Pomerania railway stations

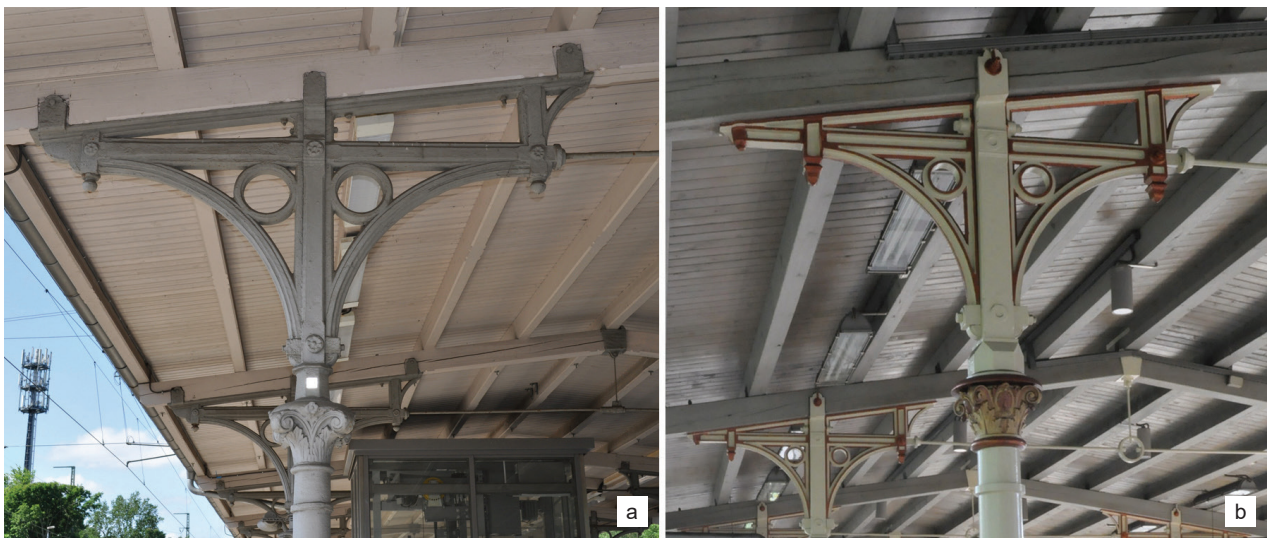
Fig. 4. Comparison of the upper parts of cast-iron columns supporting platform shelters: a) Berlin S Wannsee Bahnhof, 2019, b) Sopot, 2020 (photo by M. Kwasek)

At the Sopot railroad station, there are about 200 m long cast-iron platform shelters. Their form is resembling the ones implemented in numerous S-Bahn stations in Berlin, among others in Yorkstraße, Ostkreuz, Schönhauser Allee, S Wannsee Bahnhof, Potsdam Griebnitzsee and many others (Fig. 4). Occasionally they differ in dimensions, details – the form of decorative capitals or bases, the way of suspension, and the fastening of metal ties¹⁶. However, structurally and architecturally, they are similar solutions. As in the Berlin's stations mentioned above, the Sopot shelters are characterized by a significantly reduced roof inclination compared to the later construction in Gdańsk – only about 6 degrees. These structures are much lower than in Gdańsk (4.5–4.7 m) and have a shorter span of the metal and wooden frames (5.2–5.5 m). Nonetheless, only one of the presented Sopot shelters is an original structure (Fig. 5). It is located on the platform currently used by suburban trains (SKM). During the 2008–2010 modernization and restoration works, the cast-iron pillars were repositioned, the historic character of the floor was reconstructed, and based on the stratigraphy examination of the pillars, their cream-golden coloration, dating back to the 1870s, was restored¹⁷.
