Case study

Electrolytic corrosion of water pipeline system in the remote distance from stray currents—Case study

The paper presents a case of corrosion of DN 300 underground water pipeline made of steel belonging to the water supply system of the city of Krakow and describes the methodology of undertaken corrosion diagnosis. Corrosion damage was caused by the effects of stray currents. The failure occurred despite a considerable distance (nearly a kilometer) from the crossing the tram and train with pipeline.

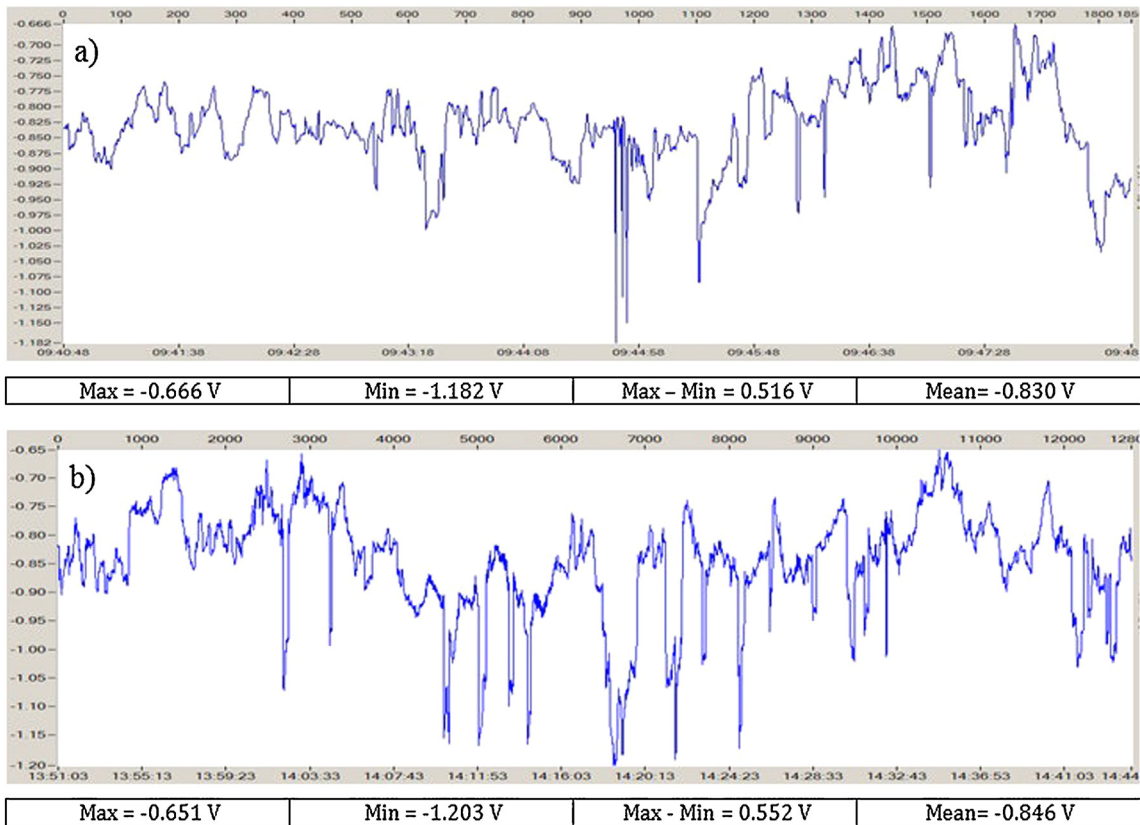
Fig. 3. Changes of pipeline potential caused by influence of railways.

Records of potential of water supply system at various times a day at the point of passing under railways is shown in Fig. 3(a) and (b), and passing under the tramway tracks—Fig. 4(a) and (b).

The mean value of the potential of water supply system at the site of underpasses railroad at various times a day was -0.830 V and -0.846 V , and underpasses tram traction -0.804 V and -0.785 V vs. CSE. A typical value of the corrosive potential of the freely corroding pipeline, without the impact of stray currents, is much more positive and is mostly about -0.5 V [20]. As a result of such negative potential the section of the pipeline between the railway and tramway is cathodic zone affected by stray currents related to both the railway tractions. On the basis of records of potentials can therefore be concluded that in this region there is stray currents flow from the ground to the pipeline in the places of insulation defects. The consequence is a cathodic polarization of pipeline, reflecting the change of the potential of pipeline towards more negative values.

The mean value of pipeline potential at this point in time of measurements was equal to -0.526 V. This value is approximately 300 mV more positive than at the cathodic zone in the vicinity of pipeline crossing under railways and tram (Figs. 3 and 4). The obtained results of the measurements indicate that the test site is the anodic zone of stray currents interference.

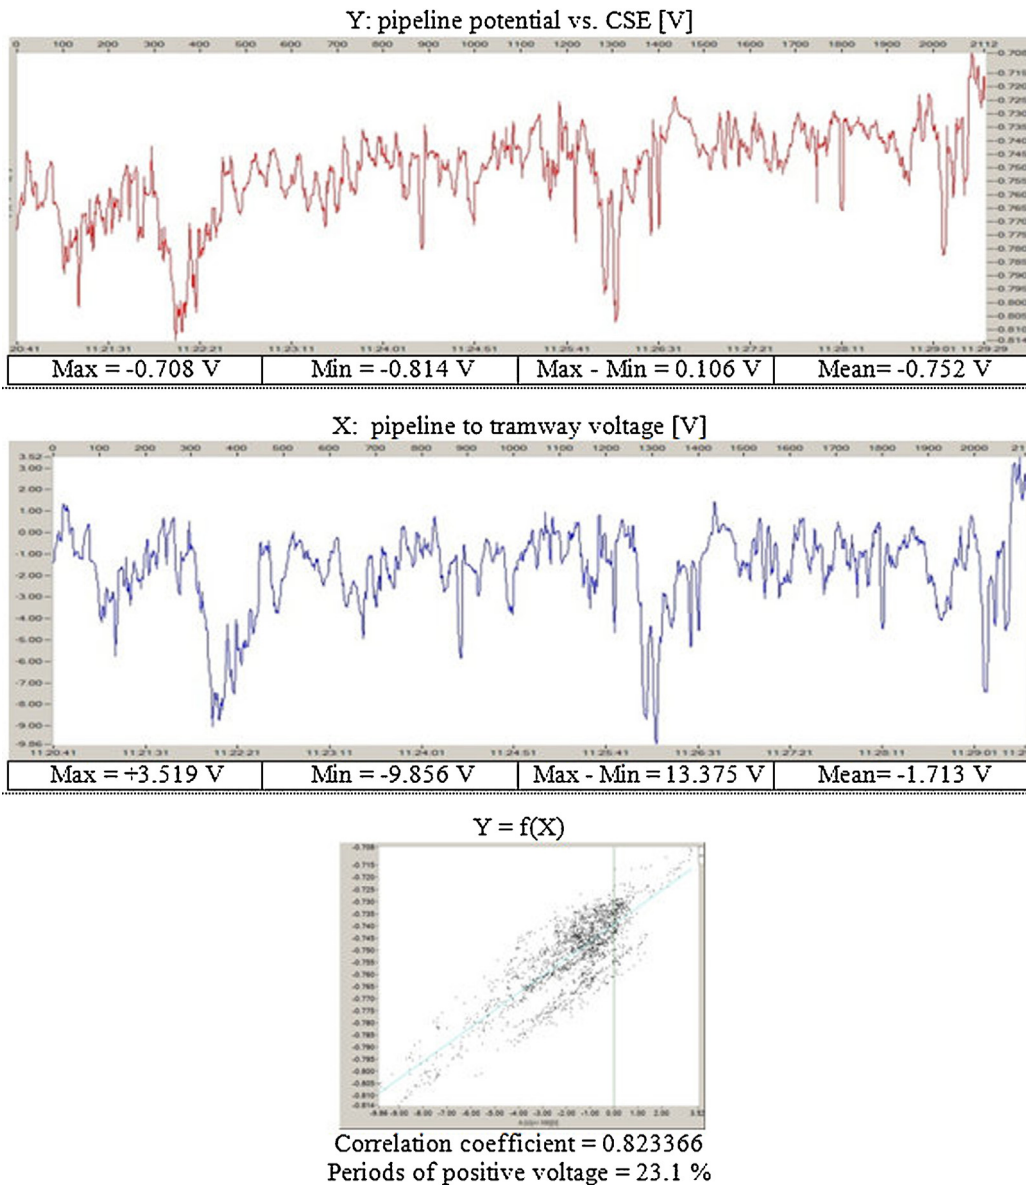
In order to confirm the above conclusions the correlations between potential of pipeline and pipeline to tram rails voltage (Fig. 5) and pipeline to train rails voltage (Fig. 6) were examined.

Voltage of pipeline relative to tram rails were predominantly negative in the most of time (periods of positive voltage was only 23%). The mean value of voltage between the pipeline and the rail was equal to -1.7 V , and the instantaneous minimum value reached almost -10 V . The negative value of this voltage means that the flow of stray current is directed from the rails through the ground to the pipeline. Currents flowing into the pipeline polarize it cathodically. In the area of measuring point there is a pipeline cathodic zone. The correlation coefficient of 0.82 and diffuse shape of the graph of correlation suggests that changes of the potential of pipeline result from the interaction not only tram traction, but also other sources of stray currents—in this case railroad [21].

Fig. 5. Analysis of the tramway influence on pipeline.

The results of measurements indicate that in the section of pipeline passing under the railway line and a bit further under the tram tracks the stray currents flow into the pipeline. These currents flow further trough pipeline, but it must return to its source in order to close its electrical circuit. Therefore, currents must flow from the pipeline to the ground, and this is done in these areas, which are favored by the configuration of the water supply system and electric traction and the electric field
