# Experimental investigations of damage evolution in concrete during bending by continuous micro-CT scanning

Ł. Skarżyński and J. Tejchman

Faculty of Civil and Environmental Engineering, Gdańsk University of Technology, Poland

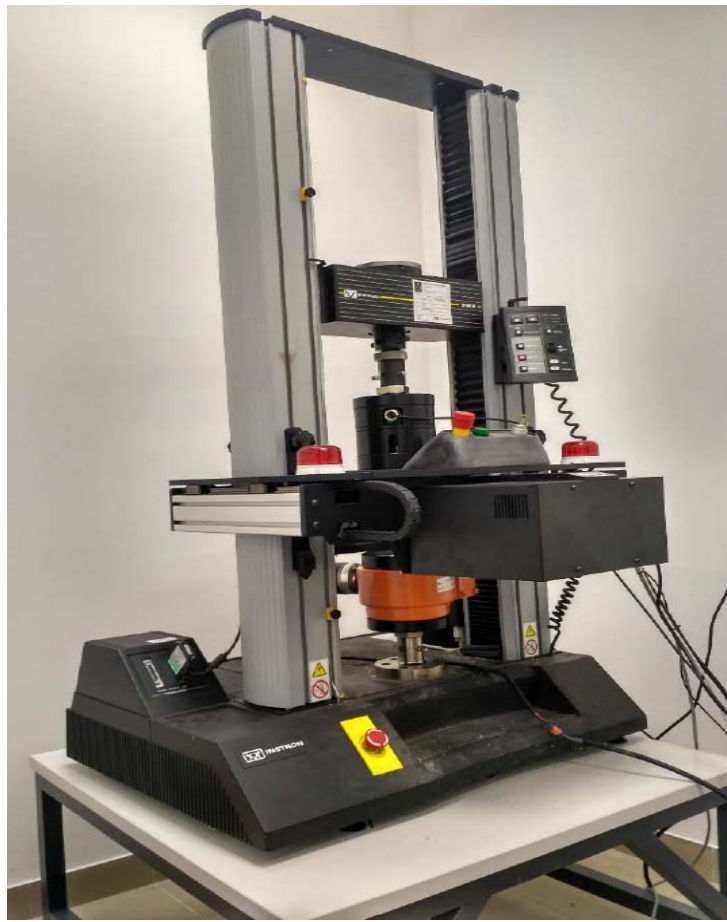
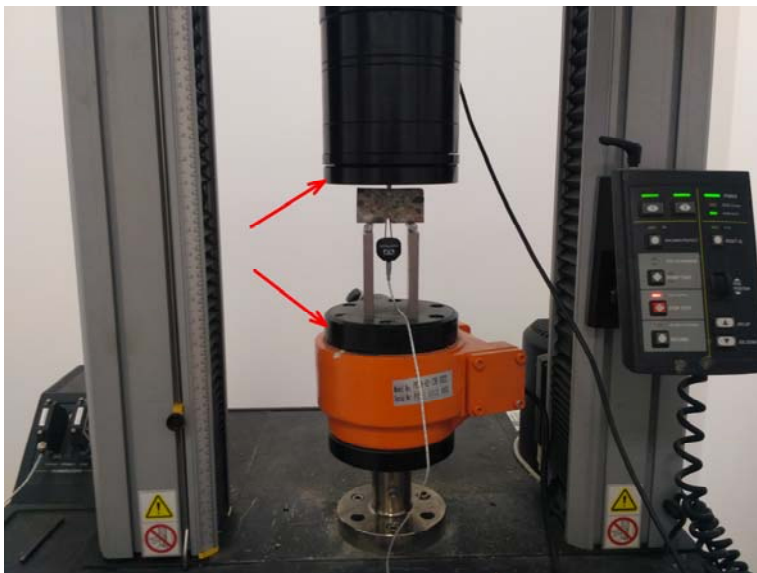
**Fig.2:** Views on micro-CT tomography system Skyscan 1173 mounted to loading machine Instron 5569: a) general view, b) rotating frame (marked with arrows) with concrete specimen prepared for bending and c) stepper motor

102 In the current paper, the scanning process was continuously performed during deformation without  
103 any unloading phases for concrete. The same tomography system SkyScan 1173 was used.  
104 However, it was directly connected now to the loading machine Instron 5569 (with the maximum  
105 loading capacity of 50 kN). The micro-CT scanner was mounted on the loading machine (Fig.2a).  
106 To rotate the specimen for scanning, a rotating frame was built and a stepper motor was used  
107 (Figs.2b and 2c) that were both fully controlled by the micro-CT software. Thus, the micro-CT  
108 scans might be shot during a very slow quasi-static deformation process without any breaks. The  
109 disadvantages of our extended prototype micro-CT system were two: 1) reduced scanning  
110 resolution (the pixel size was now between 39  $\mu\text{m}$  and 46  $\mu\text{m}$ ) and 2) reduced maximum size of the

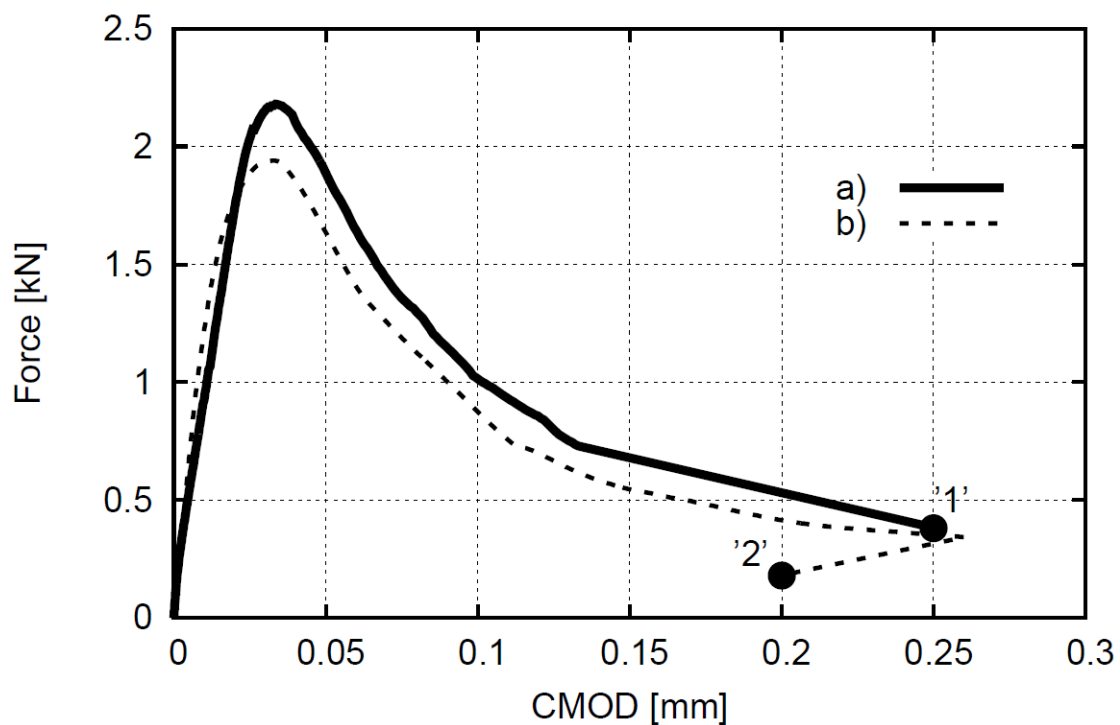
228 Two experimental curves of the vertical force  $F$  versus CMOD for the concrete beams '1' and '2'  
229 are shown in Fig.6. The experimental curves are typical for concrete. They include an elastic range,  
230 hardening region, peak and softening region. The beam '2' was unloaded. The maximum vertical  
231 force  $F$  was equal to 1.94-2.18 kN (the tensile strength was 3.37-3.79 MPa).

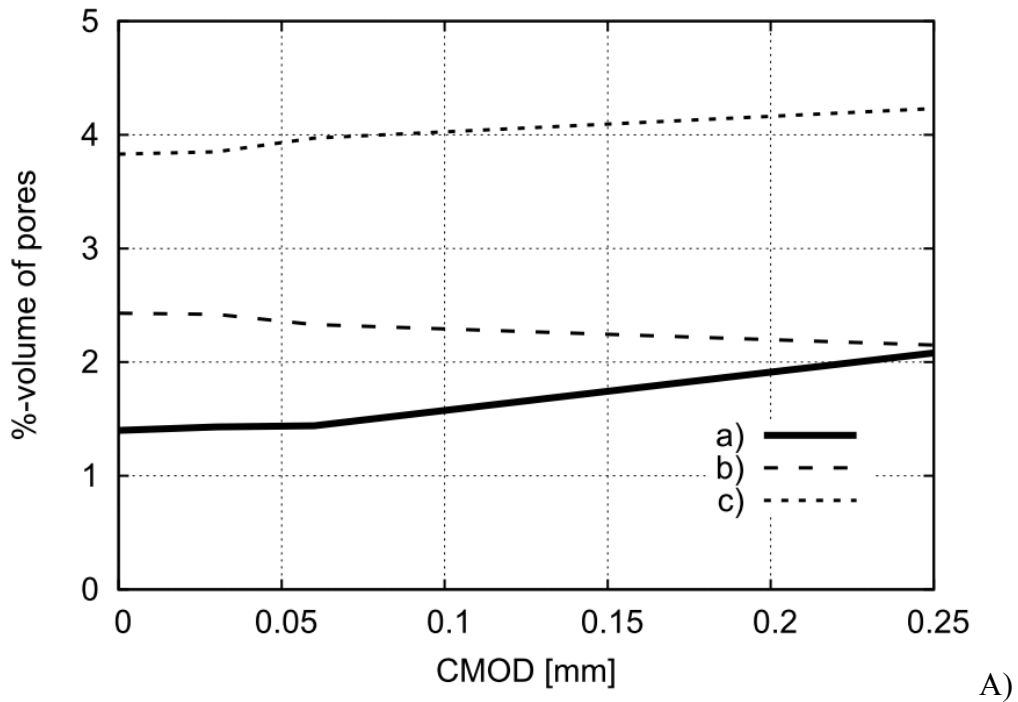
384 **Fig.13:** Relationship between %-volume and CMOD during bending for beam '3': A) pores (a)  
385 open pores, b) closed pores and c) total pores) and B) cracks

3 Figure 13 presents the evolution of the %-volume of pores and cracks (Tab.4). The evolution of  
 4 fracture volume of cracks against CMOD (that was linearly prescribed) was composed of three clear  
 5 linear regions with the different intensity: 1) region of micro-cracks (CMOD=0-0.03 mm),  
 6 2) transitional region (CMOD=0.03-0.06 mm) and 3) region of the macro-crack formation

377 (CMOD=0.06-0.25 mm). The largest normalized crack volume's growth (expressed by %-volume  
378 divided by CMOD) was in the transitional region.  
379
