EXPERIMENTAL RESEARCH ON INSUFFICIENT WATER LUBRICATION OF MARINE STERN TUBE JOURNAL BEARING WITH ELASTIC POLYMER BUSH

Agnieszka Barszczewska
Gdańsk University of Technology, Poland

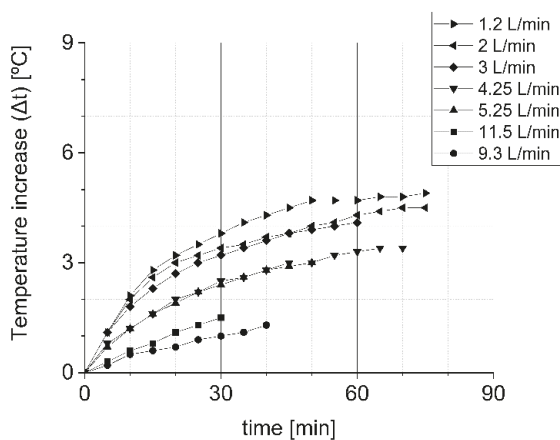
Fig. 4. Temperature increase diagram for bearing with elastic polymer bush. Test conditions: pressure=0.2 MPa, shaft revolution speed =10 rev/s, water flow=1.2~11.5 L/min.

Fig. 4 presents the temperature increase for the bearing operating at the water flow of 11.5 to 1.2 L/min and Fig. 5 presents the results for the bearing operating at the no-water flow condition.

During the operation of the bearing at the water flow intensity of 11.5 to 1.2 L/min, no sudden changes in motion resistance levels were observed, and each of the eight temperature sensors indicated the same rise in temperature. Therefore, the indications of only one sensor are presented and the level of friction torque is omitted (Fig. 4).

It may be noticed in Fig. 4 that the maximum temperature increase was recorded for the water flow of 1.2 L/min, amounting to 5°C after 60 minutes of bearing operation. Additionally it can be observed that the temperatures inside the bearing are stabilising and the bearing unit is moving towards thermal equilibrium.
