Experimental Study on Ultrasonic Monitoring of Splitting Failure in Reinforced Concrete

Abstract This paper investigates inspection of reinforced concrete elements sensitive to the splitting failure. The behaviour of a reinforced concrete specimen subjected to a tensile stress is considered. The damage detection procedure is based on the ultrasonic wave propagation technique. The piezoelectric transducers are located on both ends of the specimen and the measurements are taken periodically during the incrementally increased loading. The features of measured signals in time and frequency domains as well as wavelet transforms before and after the splitting failure are studied. The experimental results show that proposed method can be used for monitoring of damage evolution in concrete elements. The method makes possible detection of the moment just before the splitting failure occurs.

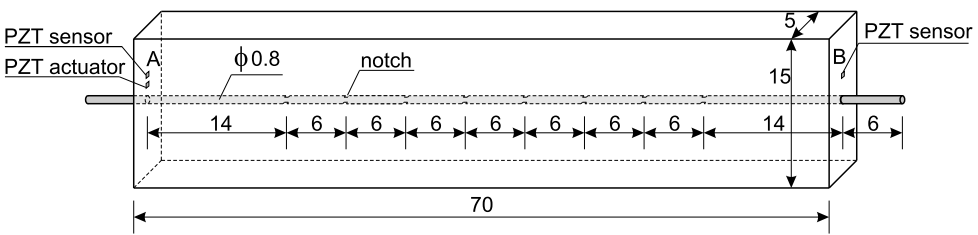
Fig. 2 Geometry and dimensions of the tested reinforced specimen (dimensions shown in cm)

The concrete specimen with cross-section of $5 \text{ cm} \times 15 \text{ cm}$ and length of 70 cm was considered as the testing element. Figure 2 presents the geometry and dimensions of the tested specimen. The ingredients of concrete were: Portland cement type CEM I 42.5R, sand (0–2 mm), fine aggregate (2–8 mm), coarse aggregate (8–16 mm), ash and superplasticizers. The proportion of concrete mix is outlined in Ta-

ble 1. The specimen was reinforced in longitudinal direction with one deformed steel bar of diameter 8 mm. Eight notches were cut on the bar at the distance of 6 cm (Fig. 2). The notches were applied to ensure that the splitting failure occurred within the concrete part of the specimen and to avoid damage of the bar outside of the concrete prism. The large number of notches was cut to cause relatively homogeneous damage zone that can be easily detected by ultrasonic methods.

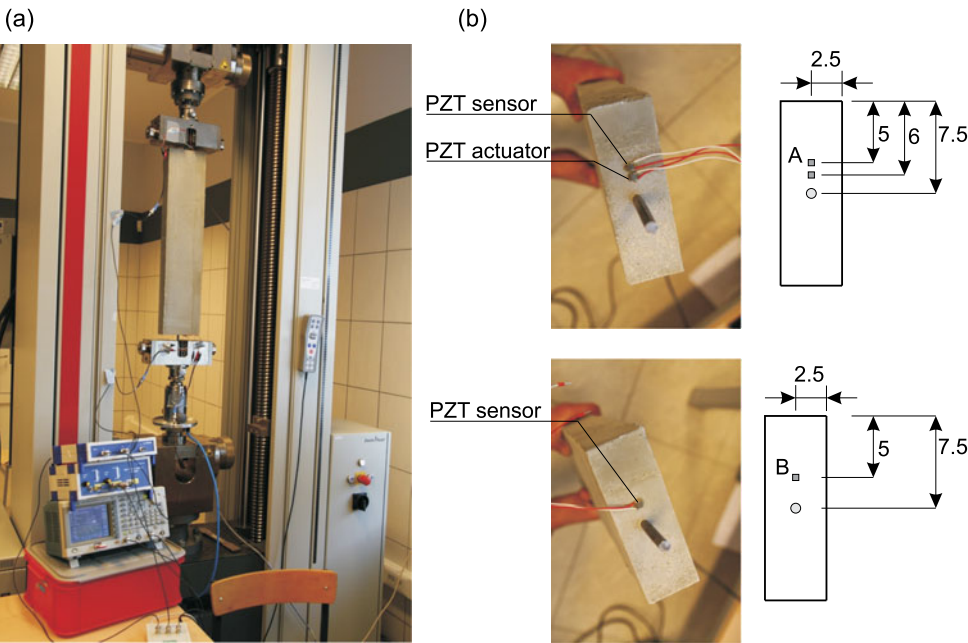
Fig. 3 Experimental set-up for measurements of ultrasonic waves in the reinforced specimen under tensile loading: (a) photograph of instrumentation; (b) details showing location of PZT actuator and PZT sensors on the specimen (dimensions shown in cm)

The concrete specimen was subjected to axial tensile loading applied at both exposed ends of the embedded bar. The tensile tests were carried out in a testing machine Zwick/Roell Z400 using displacement control with the speed of the cross-head of 0.5 mm/min. The photo of the experimental set-up is shown in Fig. 3a.

During the tensile test, ultrasonic elastic waves were generated and propagated through the specimen. The ultrasonic waves were excited in the longitudinal direction by means of a plate PZT actuator Noliac CMAP11 of dimensions 5 mm × 5 mm × 2 mm bonded at the end of the concrete specimen by wax. Two PZT sensors bonded on both ends of the concrete specimen (sensors A and B, as depicted in Fig. 2 and Fig. 3b) were utilized for wave sensing. An arbitrary waveform generator (Tektronix AFG 3022) with a high voltage amplifier (EC Electronics PPA 2000) created an excitation voltage signal applied next to the PZT actuator, which converted it into a mechanical force. As a result of application the voltage amplifier the measured signal was amplified ten times. A digital oscilloscope (ScopeDAQ) was used to collect the A-scan signals with a sampling frequency of 1 MHz. During the tensile test, the ultrasonic wave signals were excited and acquired every 15 s, until the speci-

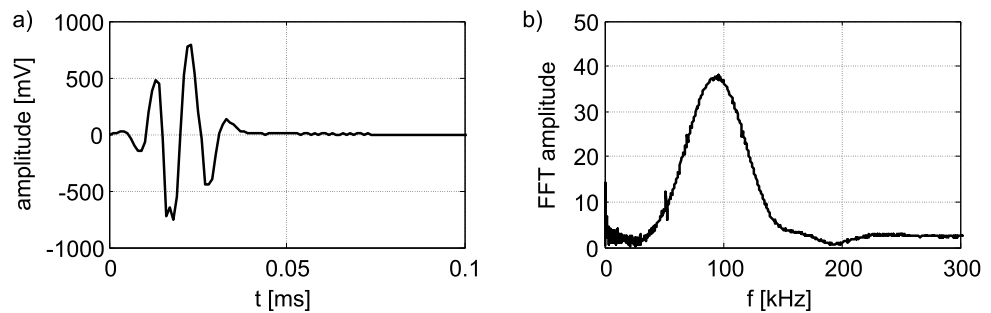
Fig. 4 Excitation signal: (a) in time domain; (b) in frequency domain

The excitation signal considered in this study was chosen as a single-frequency smoothed tone burst (also known as a wave packet) obtained from the multiplication of a sinusoidal function of established frequency by a Hanning function. The Hanning window provides smoothed tone burst in order to reduce the excitation of side frequencies [17]. This aspect of excitation of coherent single-frequency waves is important in the context of ultrasonic diagnostics. The number of cycles in the tone burst has a strong influence on the bandwidth of the input signal. For the established frequency of the sine wave, a large number of cycles is advantageous to obtain a narrow band in the frequency domain. On the other side, too many cycles causes increasing of wave packet length in the time domain. In this study, a four-peak sinusoidal signal with a central frequency of 96 kHz modulated by the Hanning window (Fig. 4) was chosen as a compromise between acceptable level of resolution in the time and frequency domains.

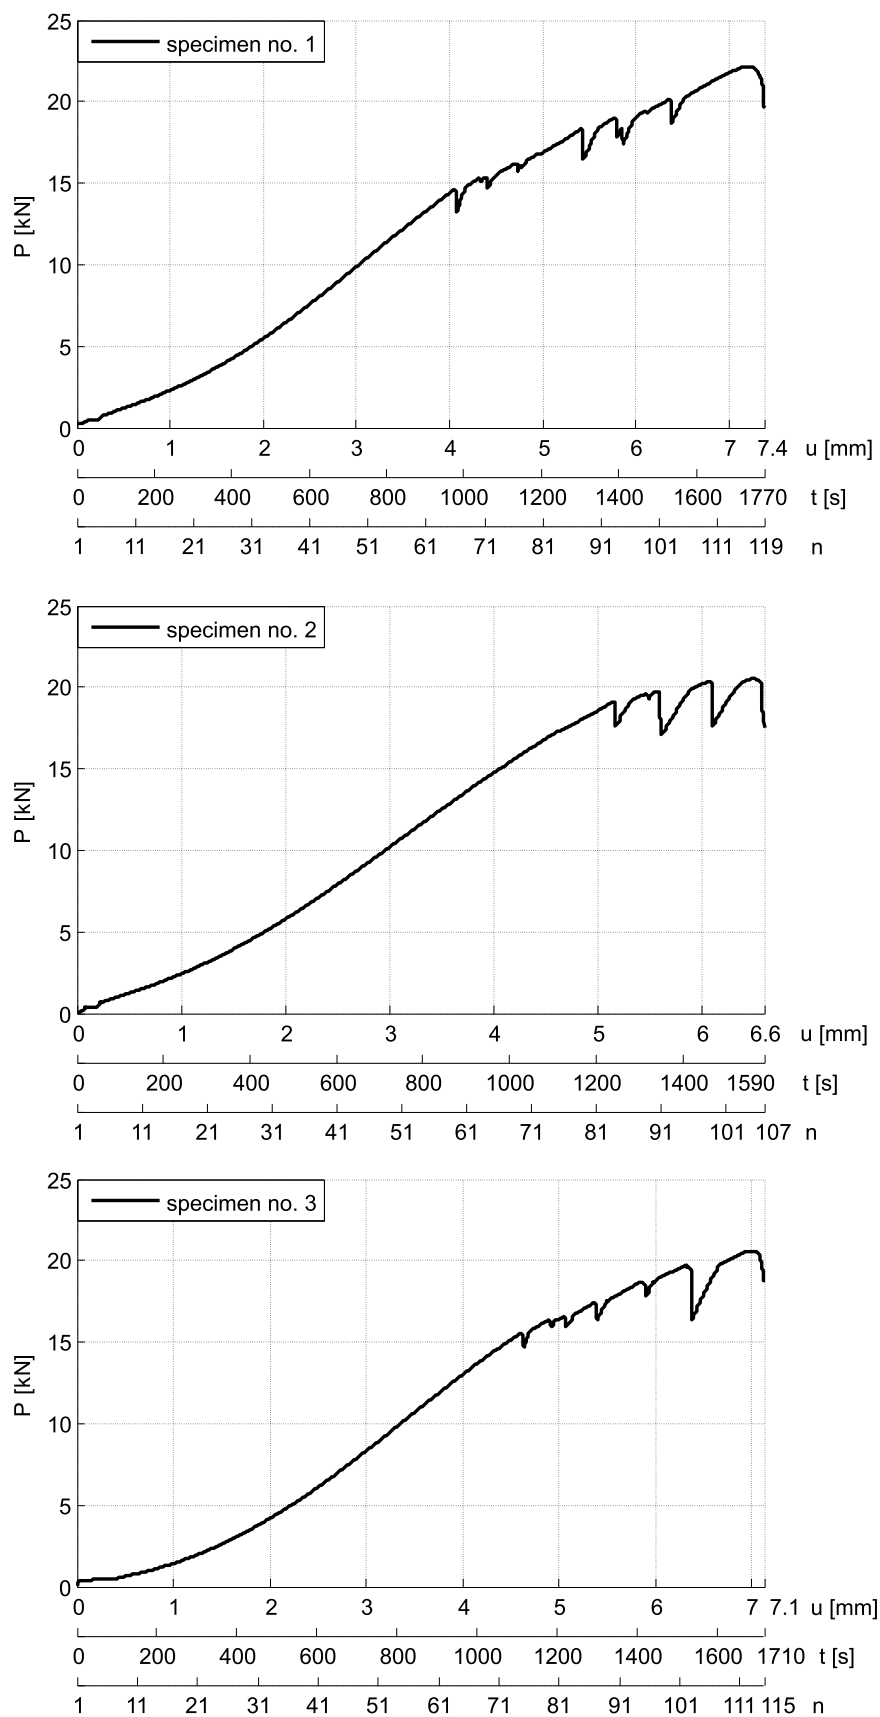
Fig. 5 Experimental load-deflection ($P-u$) and load-time ($P-t$) curves of three reinforced concrete specimens

During the tensile tests, the displacement of the cross-head and the force level were recorded. Figure 5 shows the force-displacement ($P-u$) and the force-time ($P-t$) curves for the tested specimens. There are sudden drops of the force at the moments when the major splitting cracks appear and the load distribution within the specimen alters in time. It was noted that the sizes of the notches were not identical within the given element since they were cut by hand. The time of duration of the tensile test was 1770 s, 1590 s and 1710 s for specimen no. 1, no. 2 and no. 3, respectively. The maximum displacement u_{\max} of the cross-head in the longitudinal direction was 7.38 mm, 6.6 mm and 7.12 mm for specimen no. 1, no. 2 and no. 3, respectively. During the tensile test, wave propagation measurements were conducted. Time signals were taken each 15 seconds and each signal was assigned ordinal number n . Parameter n started from $n = 1$

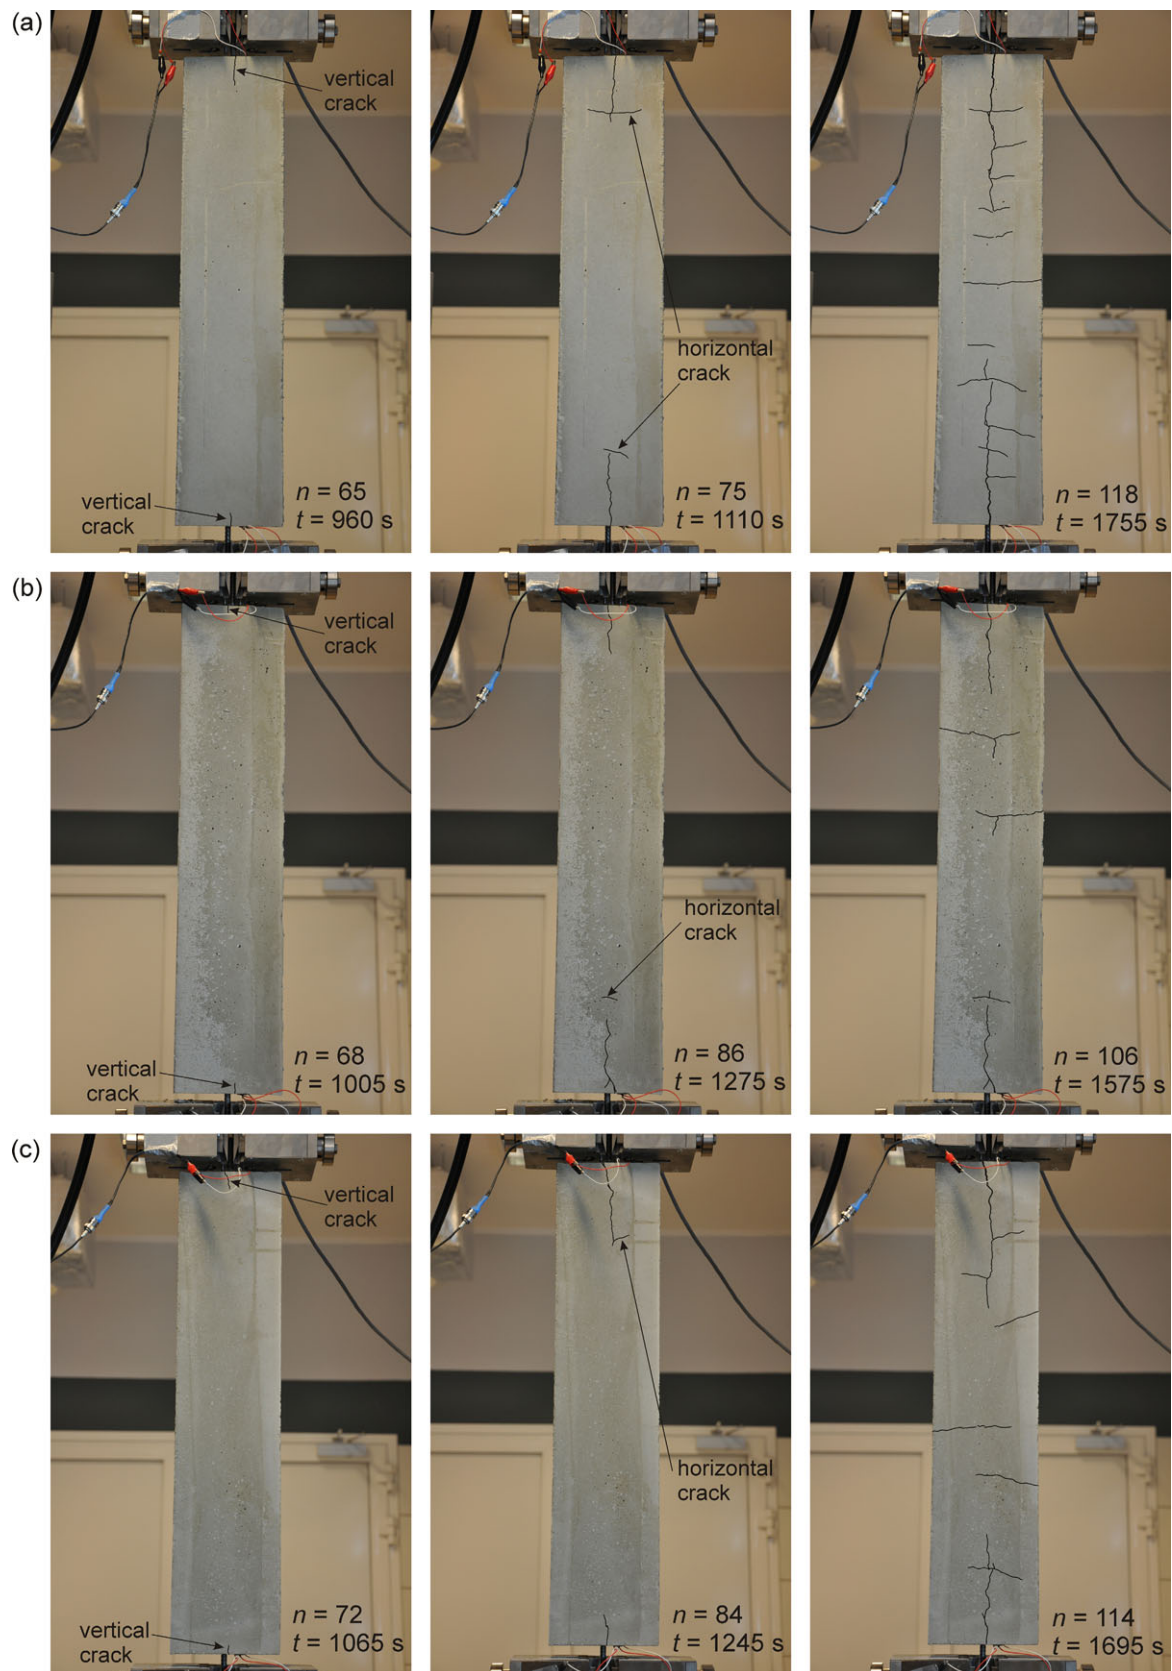
Fig. 6 Experimental damage evolution and crack patterns of three tested specimens (state of initiation of vertical cracks, state of initiation of horizontal cracks, penultimate stage of damage): (a) specimen no. 1; (b) specimen no. 2; (c) specimen no. 3

Figure 6 presents the crack formation and damage evolution in the tested specimens at the increasing load levels. At the first stage of the fracture process, two vertical cracks started to develop at the top and the bottom of the specimen. These cracks were initiated at $t = 960$ s ($n = 65$, $u = 0.54u_{\max}$) for specimen no. 1, at $t = 1005$ s ($n = 68$, $u = 0.63u_{\max}$) for specimen no. 2 and at $t = 1065$ s ($n = 72$, $u = 0.62u_{\max}$) for specimen no. 3 (the first column of photographs in Fig. 6). Next the horizontal splitting of the concrete prism appeared at $t = 1110$ s ($n = 75$, $u = 0.62u_{\max}$) for specimen no. 1, at $t = 1275$ s ($n = 86$, $u = 0.80u_{\max}$) for specimen no. 2 and at $t = 1245$ s ($n = 84$, $u = 0.73u_{\max}$) for specimen no. 3. This stage of damage is illustrated by the second column of photographs in Fig. 6. The penultimate stage of damage is given in the third column in Fig. 6. It occurred at $t = 1755$ s ($n = 118$, $u = 0.99u_{\max}$) for specimen no. 1, at $t = 1575$ s ($n = 106$, $u = 0.99u_{\max}$) for specimen no. 2 and at $t = 1695$ s ($n = 114$, $u = 0.99u_{\max}$) for specimen no. 3. The tensile tests were stopped as a result of the tension failure of the steel bar. Figure 7 shows the details of the concrete specimen after the splitting failure. The prints of the lugs of the reinforcing bar are clearly seen on the piece of damaged concrete. Therefore, the slipping of the steel bar and damage of the bar surrounding concrete by the tips of the rebar lugs did not take place.

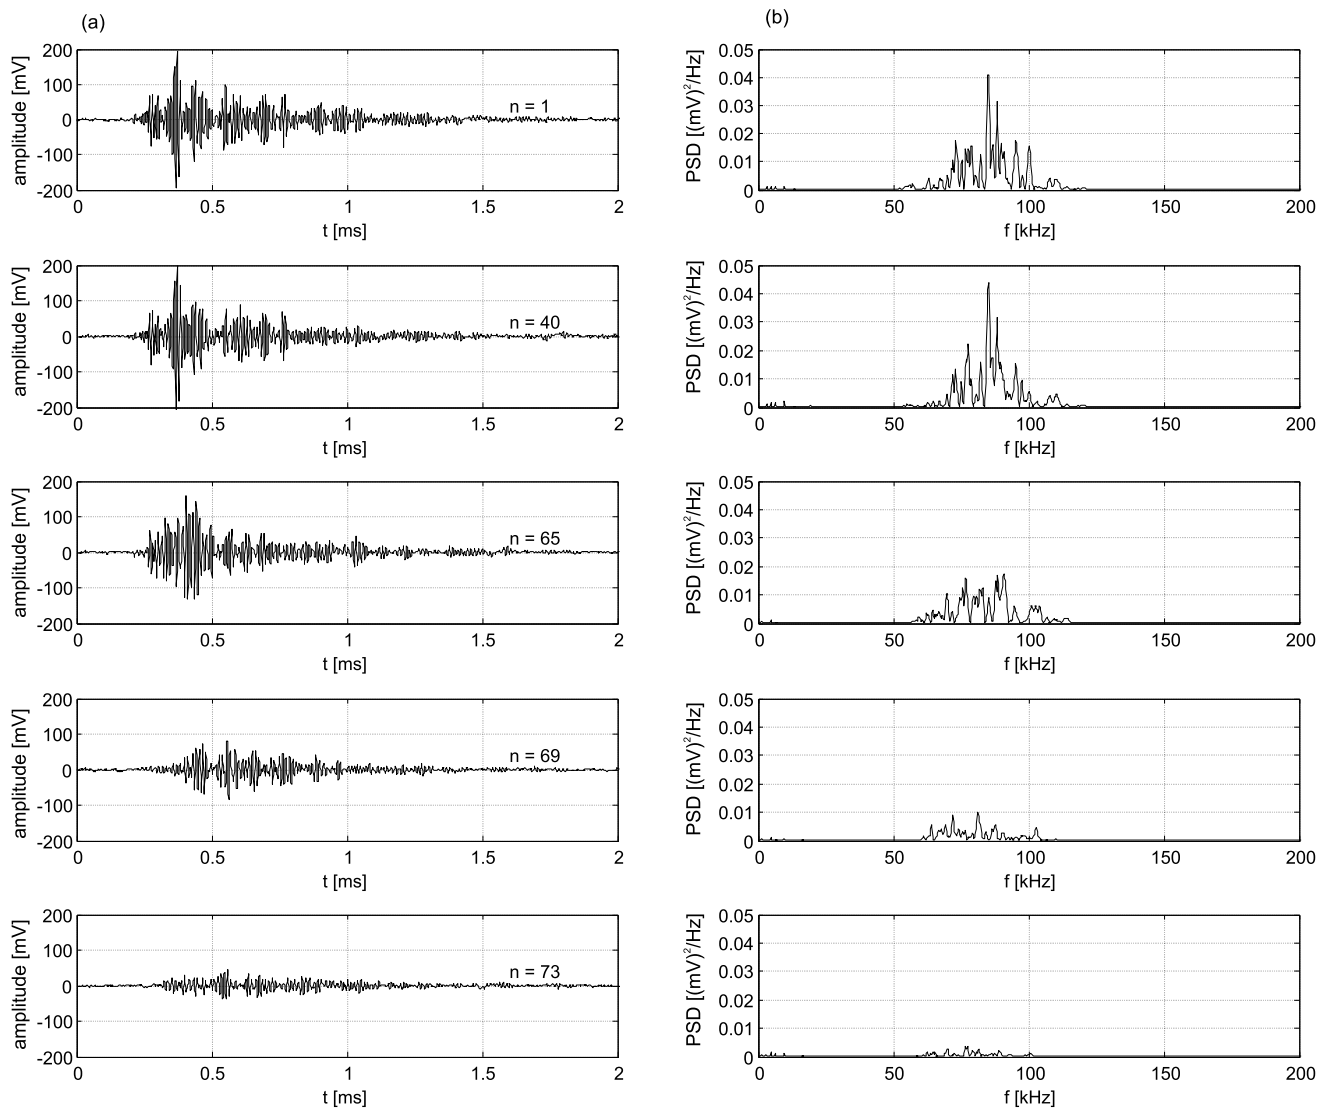
Fig. 8 Ultrasonic signals registered at point B in specimen no. 1 for different load levels: (a) A-scan signals in time domain; (b) power spectral densities of time waveforms

The interpretation of measured signals in the frequency domain was performed by the power spectral density (PSD). The PSD function was used since it shows the signal power that better displays the changes in the wave propagation signals due to material degradation than Fourier transform. The PSD was computed using MATLAB®. The examples of the ultrasonic signals acquired at point B for specimen no. 1 and their power spectral densities are shown in Fig. 8. It can be seen that at the initial stage, no significant differences were visible in the measured time signals (e.g. $n = 1$ and $n = 40$).

The maximum amplitudes of the signals acquired at point B (on the opposite side then the PZT actuator) were practically the same for the signals from $n = 1$ to $n = 65$ and, then they decreased with the increase of the external tensile loading.

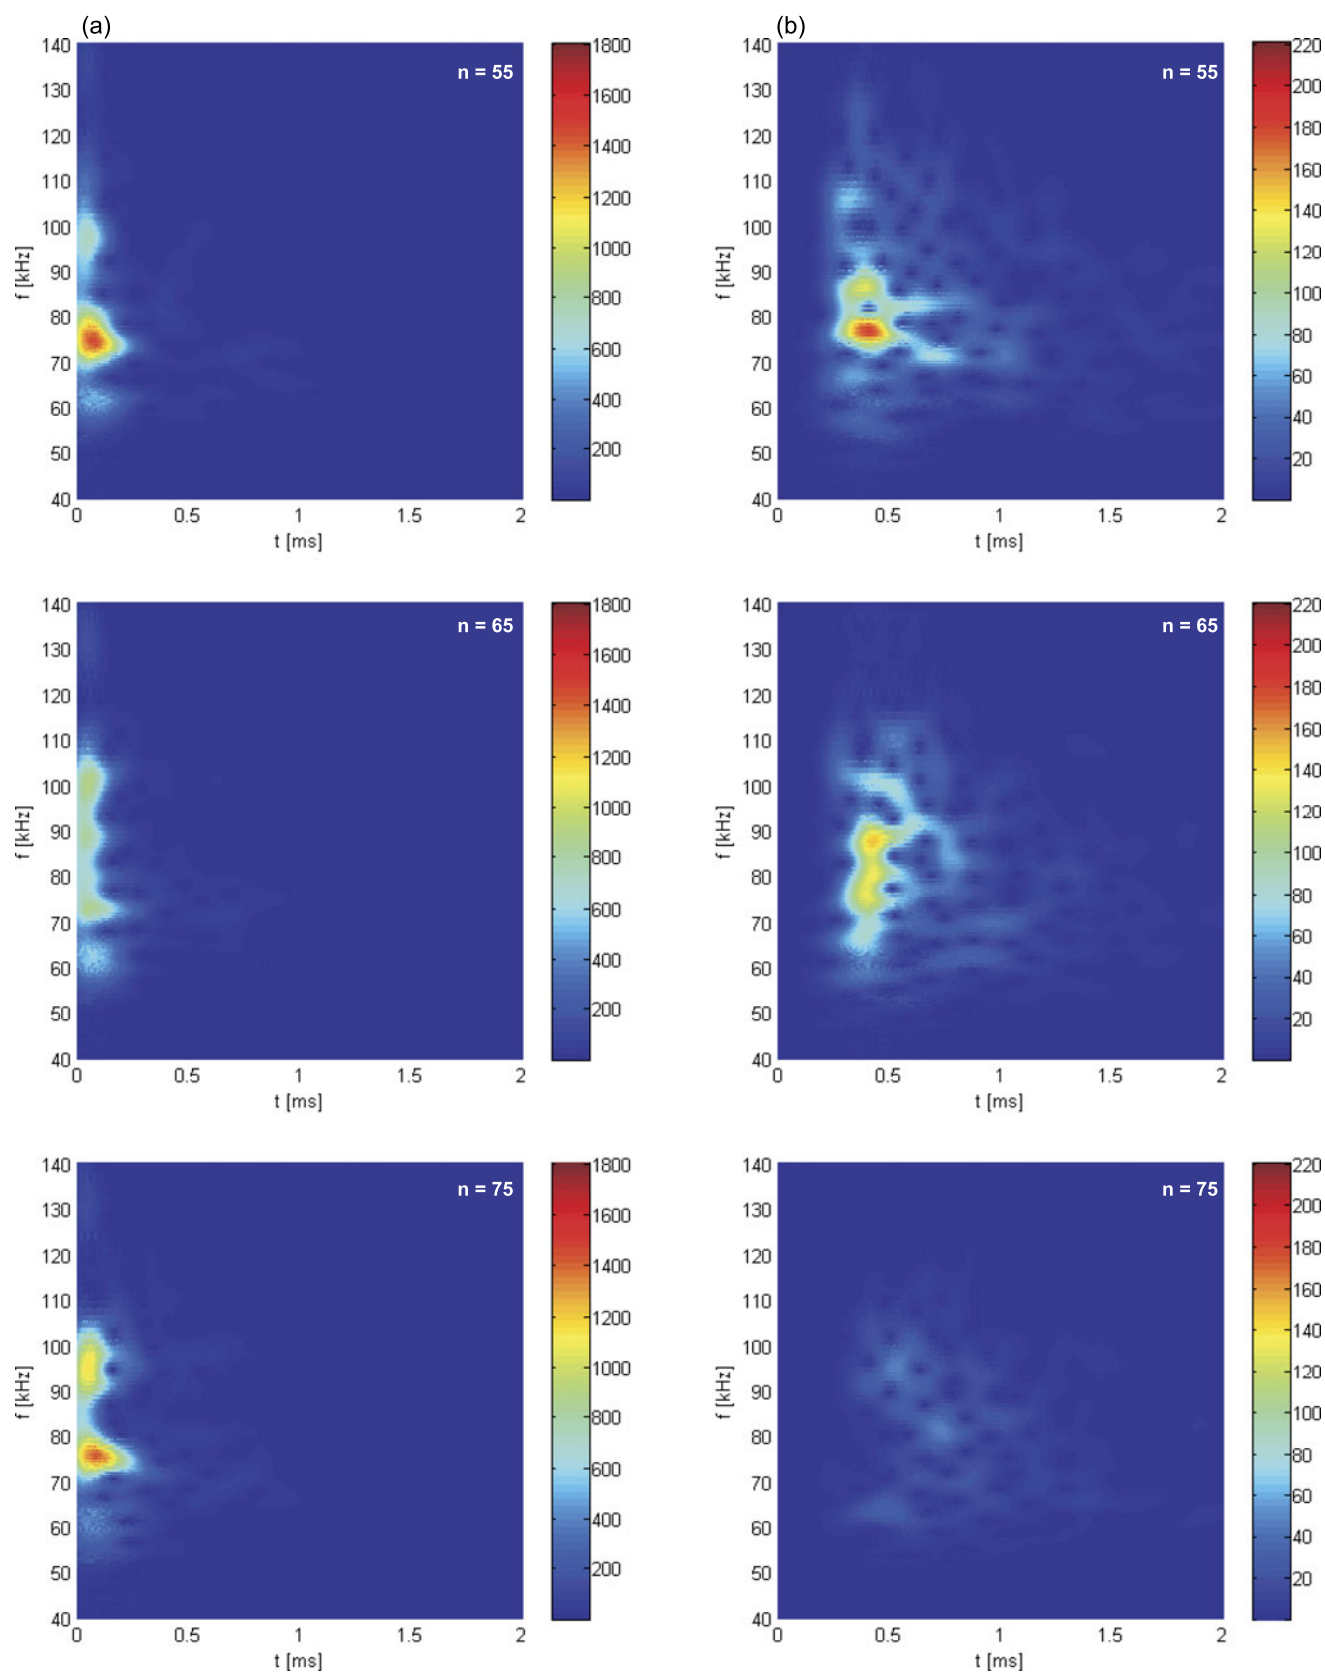
Fig. 11 Wavelet transforms for specimen no. 1 for different load levels: (a) signals registered at point A; (b) signals registered at point B (wavelet transforms are in units of mV)

The wavelet transform results for the selected A-scan signals for specimen no. 1 are presented in Fig. 11. The left column of Fig. 11 shows the wavelet coefficients of the signals registered at point A and the right column depicts the wavelet coefficients of signals registered at point B for time steps corresponding to $n = 55$ (stage before splitting), $n = 65$ (appearance of the first vertical splitting crack) and $n = 75$ (after the splitting failure). For $n = 55$, the elastic waves of frequency 76 kHz travelled through the concrete specimen and they can be observed in both signals measured at points A and B. At the beginning of development of the first splitting crack ($n = 65$), the micro-crack zones were the biggest, causing a significant reduction of the amplitudes of ultrasonic waves at points A and B. Wave packets had frequency range from 70 kHz to 100 kHz. Further increase of

the external loading (e.g. $n = 75$) resulted in the appearance of several large splitting crack and yielding of the steel bar. Plastic deformation of the bar near the notch changed the longitudinal load distribution. Largest deformations were in the areas near the notches. The internal forces in the specimen in the region from its top (the location of point A) to the first horizontal splitting crack were reduced. Therefore, the micro-crack zone became smaller and the waves generated in the neighbourhood of the measurement point A could travel with relatively small damping. Figure 11a (left column) shows large wavelet coefficients at frequency 76 kHz and 96 kHz for the specimen after splitting failure ($n = 75$). The right column of Fig. 11b shows the wavelet coefficients of the signals at point B ($n = 75$). There are no large values of the wavelet coefficients since the specimen have been destroyed by the horizontal splitting cracks that prevented propagation of ultrasonic waves from point A to point B through the concrete.
