Experimental ultimate strength assessment of stiffened plates subjected to marine immersed corrosion

Krzysztof Woloszyk^a, Yordan Garbatov^{b,*}, Jakub Kowalski^a

ABSTRACT

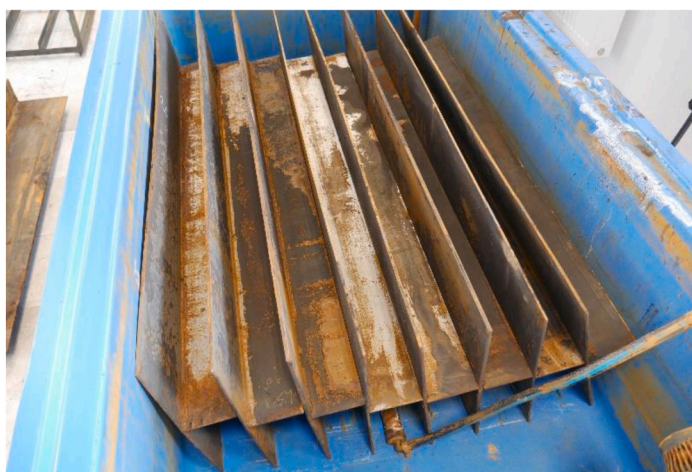
Fig. 2. Corrosion test tank (Woloszyk et al., 2021b) (1- linear diffuser, 2 – aeration pump, 3 - heaters, 4 – circulation pumps) (left) and corrosion tank with placed specimens (right).

The corrosion degradation has been controlled by generating appropriate: temperature (heaters), water circulation (circulation pumps) and aeration (aeration pump with linear diffuser). The testing tank with the placed specimens (without water inside) is presented in Fig. 2, right. The main advantage of the performed testing was that it avoided using the acceleration of corrosion rate by connecting the specimens and water to DC power, and only natural factors were controlled. This led to environmental conditions closer to the real one. It needs to be also noted, that for some period of operation, the structural elements are effectively

The accelerated corrosion tests have been discussed in detail in Woloszyk et al. (2021b), but some main aspects are given herein. The nine stiffened plates have been subjected to the laboratory indoor accelerated corrosion testing, and the set-up is presented in Fig. 2, left.

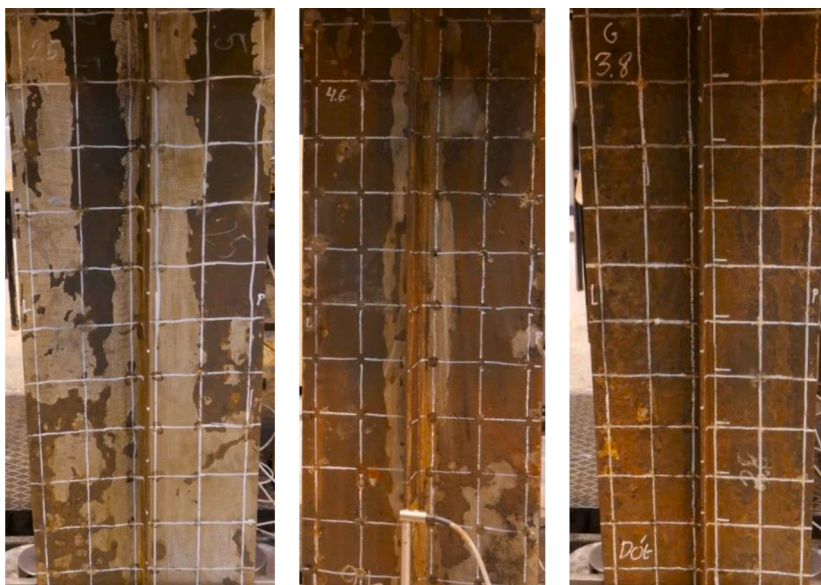
Fig. 3. Corroded stiffened plates: 2.5 mm (left); 4.6 mm (mid); 3.8 mm (right) (Woloszyk et al., 2021b).

The examples of corroded specimens are presented in Fig. 3. The thickness distribution of each specimen was measured using an ultrasonic thickness gauge in the grid points, as is visible in Fig. 3. The detailed maps with thickness distributions can be seen in Woloszyk et al. (2021b). The mean value corrosion rate was between 0.75 up to 1.15 mm/year, which shows a significant acceleration of the corrosion degradation process concerning typically observed values in the natural sea corrosion environment (Zayed et al., 2018).

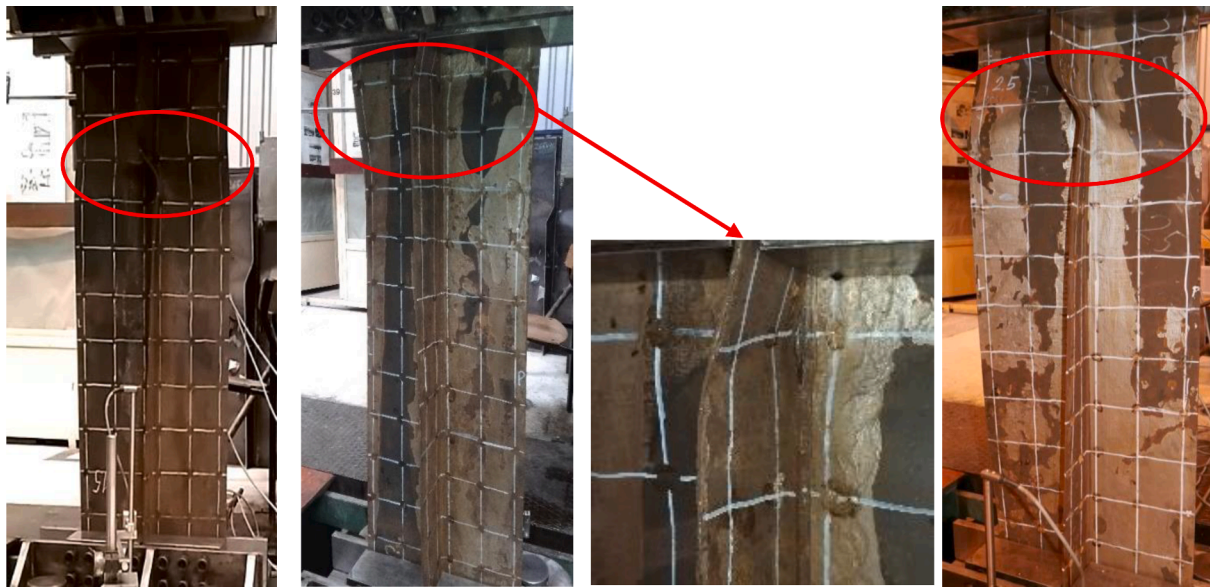
Fig. 9. Post-collapse shapes for 5 mm specimens with degradation level of 7% (left), 14% (mid) and 21% (right).

The post-collapse shapes for 5 mm specimens are presented in Fig. 9. In specimens with *DoD* of 7 and 21%, the collapse has been caused by the local plate buckling followed by stiffener tripping, like the intact specimens. Primarily, the plate buckled locally, which initiated the collapse of the stiffened plate. However, due to the loss of in-plane stiffness, the stiffener also started to buckle in a very localized mode. The cross-section of the highest plastic deformations was away from the mid-length of the specimen due to the uneven distribution of the corroded thickness of the plate and the stiffener for each degradation level. In the

case of 5 mm specimens, the regions of high corrosion diminutions were closer to the upper support, which caused a similar position of a critical cross-section. Further, in the specimen with a *DoD* of 14%, the region of high plastic deformations was not that localised and has been more extended along with the specimen, which indicates that the local plate buckling occurred together with the lateral-torsional buckling of the stiffener.

The stiffened plate region, where the highest plastic deformations occurred, was somewhat away from the middle due to uneven thickness distribution (the regions are marked in red envelopes in Figs. 9–11). In many cases, it was very close to the support. In the case of electrochemically corroded plates (Garbatov et al., 2017), these regions were much closer to the middle cross-section in most cases, even for much higher degradation levels. This was caused by a more uniform thickness distribution (although non-uniform) compared to the present research.
