# Failure Monitoring and Condition Assessment of Steel-Concrete Adhesive Connection Using Ultrasonic Waves

Magdalena Rucka

Department of Mechanics of Materials and Structures, Faculty of Civil and Environmental Engineering, Gdansk University of Technology, Narutowicza 11/12, 80-233 Gdansk, Poland; magdalena.rucka@pg.edu.pl or mrucka@pg.edu.pl; Tel.: +48-58-347-2497

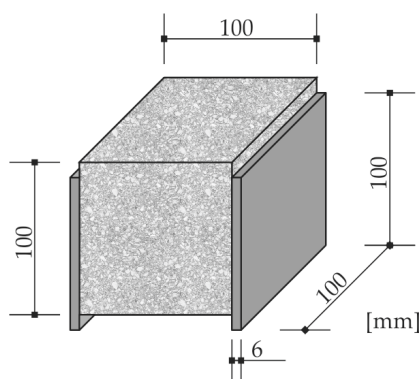
Figure 1. Geometry of push-out specimen.

Nine steel-concrete specimens (#1 to #9) were tested in this study. Each push-out specimen consisted of two steel plates and a concrete cube (Figure 1). The plates of dimensions  $6 \times 100 \times 100 \text{ mm}^3$  were made of structural steel S235. The cube of dimensions  $100 \times 100 \times 100 \text{ mm}^3$  was made of concrete including the following ingredients: Portland cement type CEM I 42.5R ( $325 \text{ kg/m}^3$ ), sand 0–2 mm ( $764 \text{ kg/m}^3$ ), fine aggregate 2–8 mm ( $573 \text{ kg/m}^3$ ), coarse aggregate 8–16 mm ( $573 \text{ kg/m}^3$ ) and water ( $175 \text{ kg/m}^3$ ). The adhesive connection at the steel-concrete interface was made with the use of high-strength, two-component structural epoxy paste adhesive SIKADUR 30. The bonded area was  $100 \text{ mm} \times 90 \text{ mm}$  on each surface of the concrete cube and the lap-joint thickness was about 1 mm.

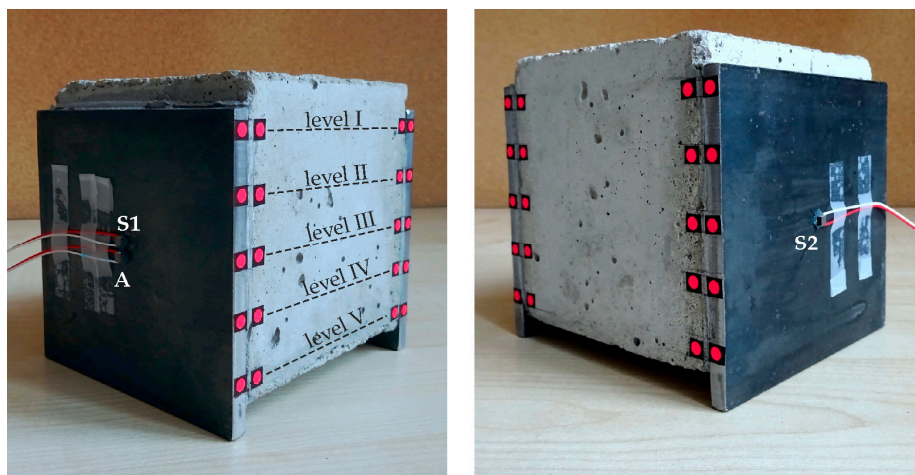
Figure 2. Steel-concrete specimen with attached piezoelectric actuator (A) and sensors (S1, S2).

Experimental procedure included simultaneous push-out and wave propagation testing. Push-out tests were performed in the testing machine Zwick Z400 equipped with a compression test kit. The force and the displacement of the cross-head were recorded. The preload applied to the specimen was equal to 100 N. Then, each steel-concrete specimen was loaded with the speed of the crosshead of 0.1 mm/min up to the failure. Additionally, photographs were taken every 2 s on the front side of the specimen by the Canon EOS 5D III digital camera to observe the damage evolution and to determine the slip between steel and concrete. At each specimen, 10 pairs of magenta points with a diameter of 4 mm were attached at five levels (levels I to V, as indicated in Figure 2).

piezoelectric actuators NAC2024 manufactured by Noliac were used for both excitation and registration of wave propagation signals. They were adhesively bonded to the steel plates using petro wax (PCB 080A109). The configuration of piezoelectric transducers is given in Figure 2. The actuator (A) was bonded at the center of the left steel plate. The first sensor (S1) was attached next to the actuator, while the second one (S2) was attached at the center of the right steel plate. An arbitrary waveform generator (Tektronix AFG3022C) created an excitation signal in the form of a wave packet composed of a 5-cycle sine with a central frequency of 60 kHz modulated by the Hanning window (Figure 4). Then the signal was amplified 20 times by a high voltage amplifier (FLC Electronics AB A400DI). A digital oscilloscope (PicoScope 4824) was used to collect time signals of propagating waves with a sampling frequency of 20 MHz.

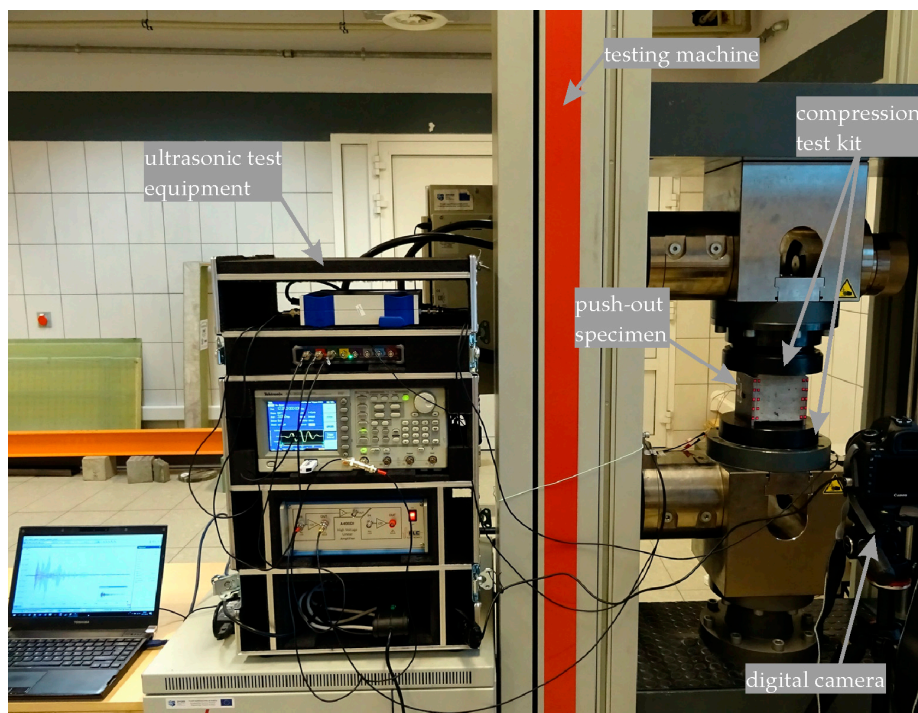
Figure 3. Experimental setup for push-out and ultrasonic tests.

During the mechanical degradation in the testing machine, ultrasonic waves were induced and acquired every 2 s, until the specimen failure. Figure 3 shows the experimental setup. Three multilayer

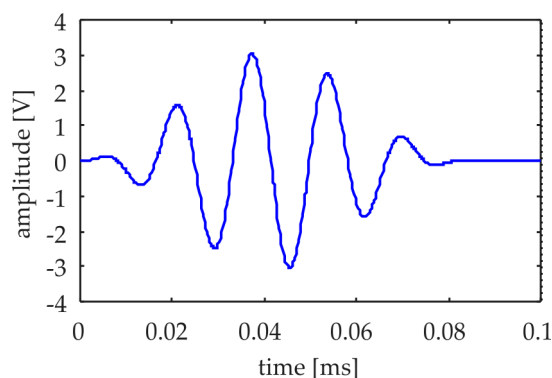
Figure 4. Excitation signal.

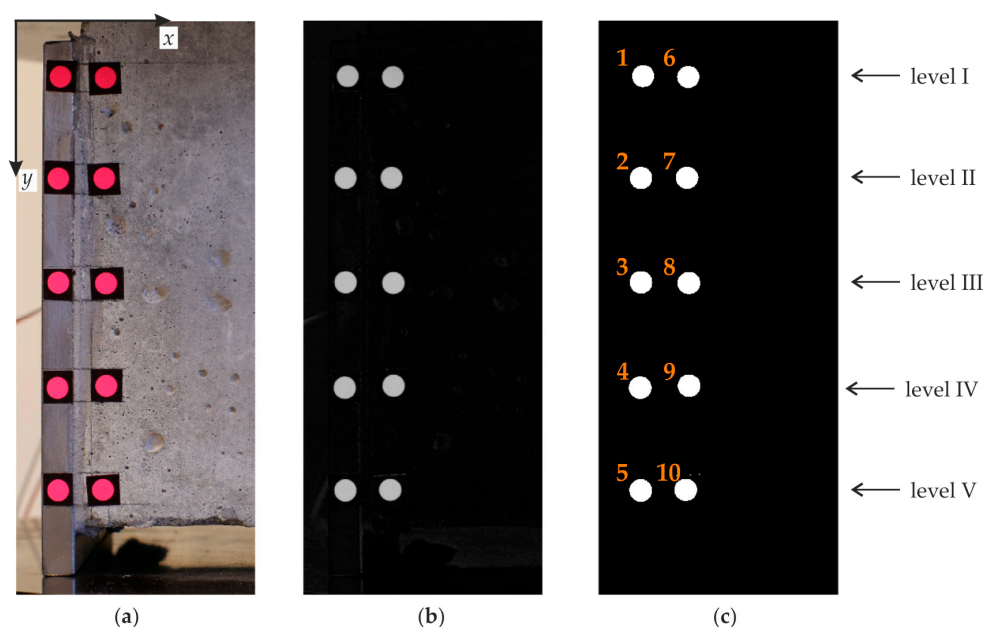
Figure 5. Digital photograph of the left adhesive joint: (a) RGB photograph; (b) magenta component; (c) binary image.

The interface slip between the steel plate and concrete cube was determined using a photogrammetric technique (c.f. [34]). The digital RGB photograph (Figure 5a) was transformed into the CMYK space according to the formula

where colors are marked as follows:  $c$ —cyan,  $m$ —magenta,  $y$ —yellow,  $k$ —black,  $r$ —red,  $g$ —green,  $b$ —blue. From the CMYK space, a component connected with magenta color was chosen for further processing (Figure 5b) in which the photograph was converted into a binary image with a threshold of 0.25 (Figure 5c). Then, for given points, the centers of gravity were calculated and the interface slips in  $x$  and  $y$  directions were determined at five levels (levels I to V).

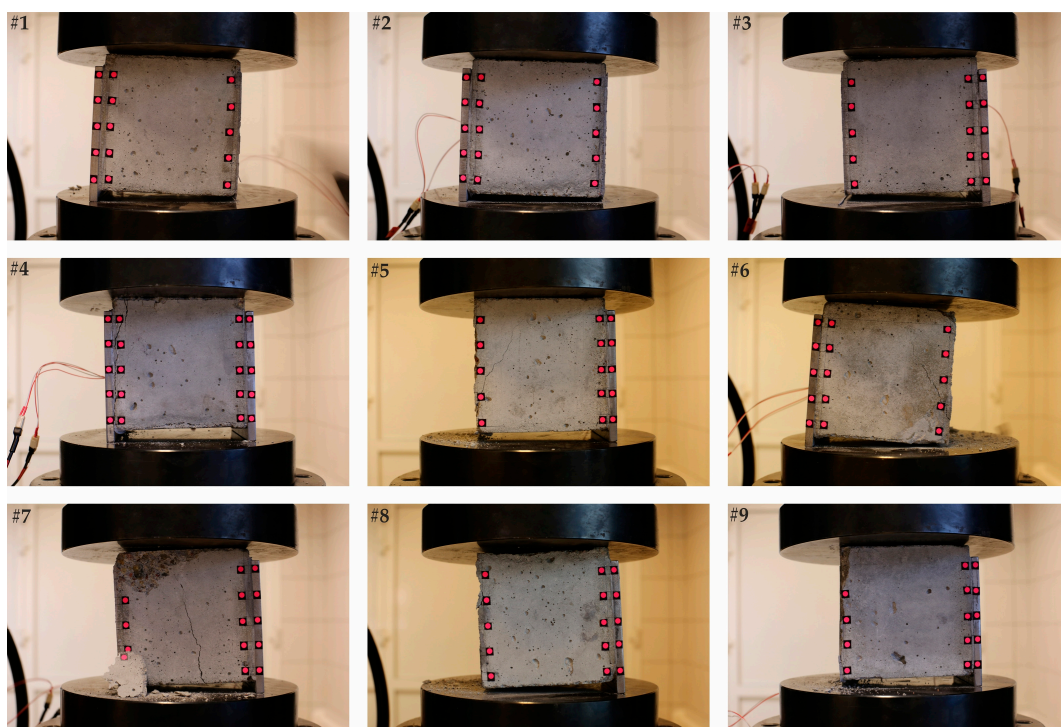
**Figure 6.** Failure modes of tested steel-concrete specimens (last stage in the testing machine): mode I including specimens #1 to #3—adhesive failure and mode II including specimens #4 to #10—cohesive-type failure or mixed cohesive-adhesive failure.

Figures 6 and 7 illustrate all push-out specimens after failure. The specimens were divided into two sets according to observed failure modes. Mode I (specimens #1–#3) was an adhesive-type failure occurring at the interface between the steel plate and the adhesive layer. No damage was observed in the concrete cube. The entire adhesive layer remained on the concrete. Mode II (specimens #4–#10) included a cohesive-type failure or mixed cohesive-adhesive failure. In mode II, three sub-groups were distinguished: mode IIa (specimens #4–#6), mode IIb (specimen #7) and mode IIc (specimens #9–#10). The damage in modes IIa and IIb included two phases. In the first phase, the damage was mainly cohesive with a failure in the bulk of the concrete cube. The second phase was a separation of the steel plate from the concrete. In mode IIa, a single diagonal crack originated from the interface between steel and concrete, and then the cohesive (specimen #6) or mixed cohesive-adhesive failure (specimens #4, #5) occurred in the bulk of the adhesive layer. In mode IIb, a crack appeared in the middle of the concrete cube and then the adhesive failure occurred. The failure in mode IIc was cohesive (specimen #8) and mixed adhesive-cohesive (specimen #9) with a separation in the bulk of the adhesive layer.

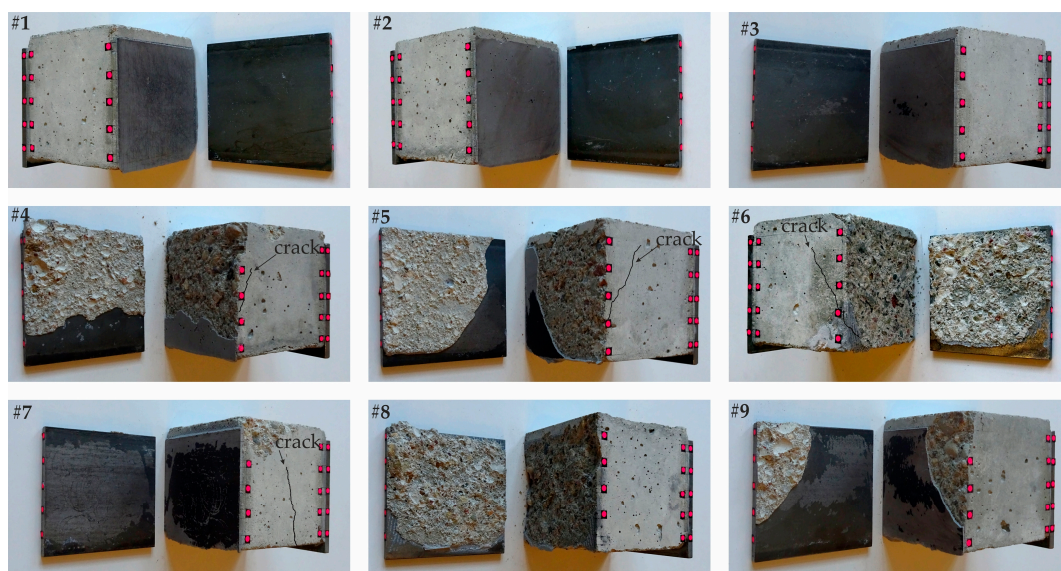
**Figure 7.** Failure modes of tested steel-concrete specimens (photographs of the damaged steel-concrete interface after removing from the testing machine): mode I including specimens #1 to #3—adhesive failure and mode II including specimens #4 to #10—cohesive-type failure or mixed cohesive-adhesive failure.

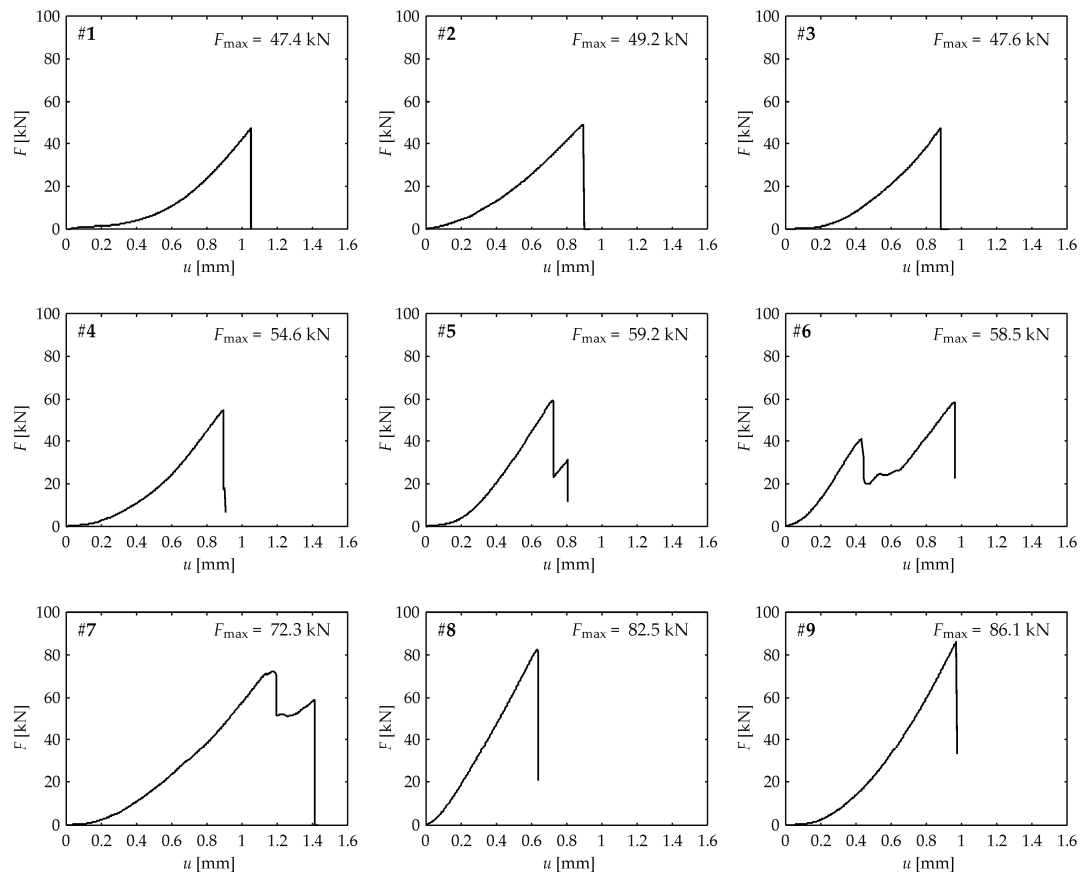
**Figure 8.** Experimental force-displacement ( $F$ - $u$ ) curves of tested push-out specimens (#1–#9).

Figure 8 shows the force-displacement curves for all tested specimens. In mode I, the shape of curves for each specimen is similar. The sudden drop of the force at the moment of the adhesive failure can be observed. The maximum force was 47.4 kN (specimen #1), 49.2 kN (specimen #2) and 47.6 kN (specimen #3). The curves for the specimen failures categorized as modes IIa and IIb exhibited two drops of the force. The first drop is associated with the appearance of the crack in the concrete,

while the second is associated with the separation of the steel plate. In the case of specimens with diagonal cracks, the maximum force was 54.6 kN (specimen #4), 59.2 kN (specimen #5), 58.5 kN (specimen #6). For the specimen with the crack in the middle of the concrete cube (specimen #7), the maximum force was 72.3 kN. The last two curves corresponding to mode IIc are characterized by the sudden drop of the force at the moment of the cohesive or mixed adhesive-cohesive failure. The maximum force was 82.5 kN (specimen #8) and 86.1 kN (specimen #9).

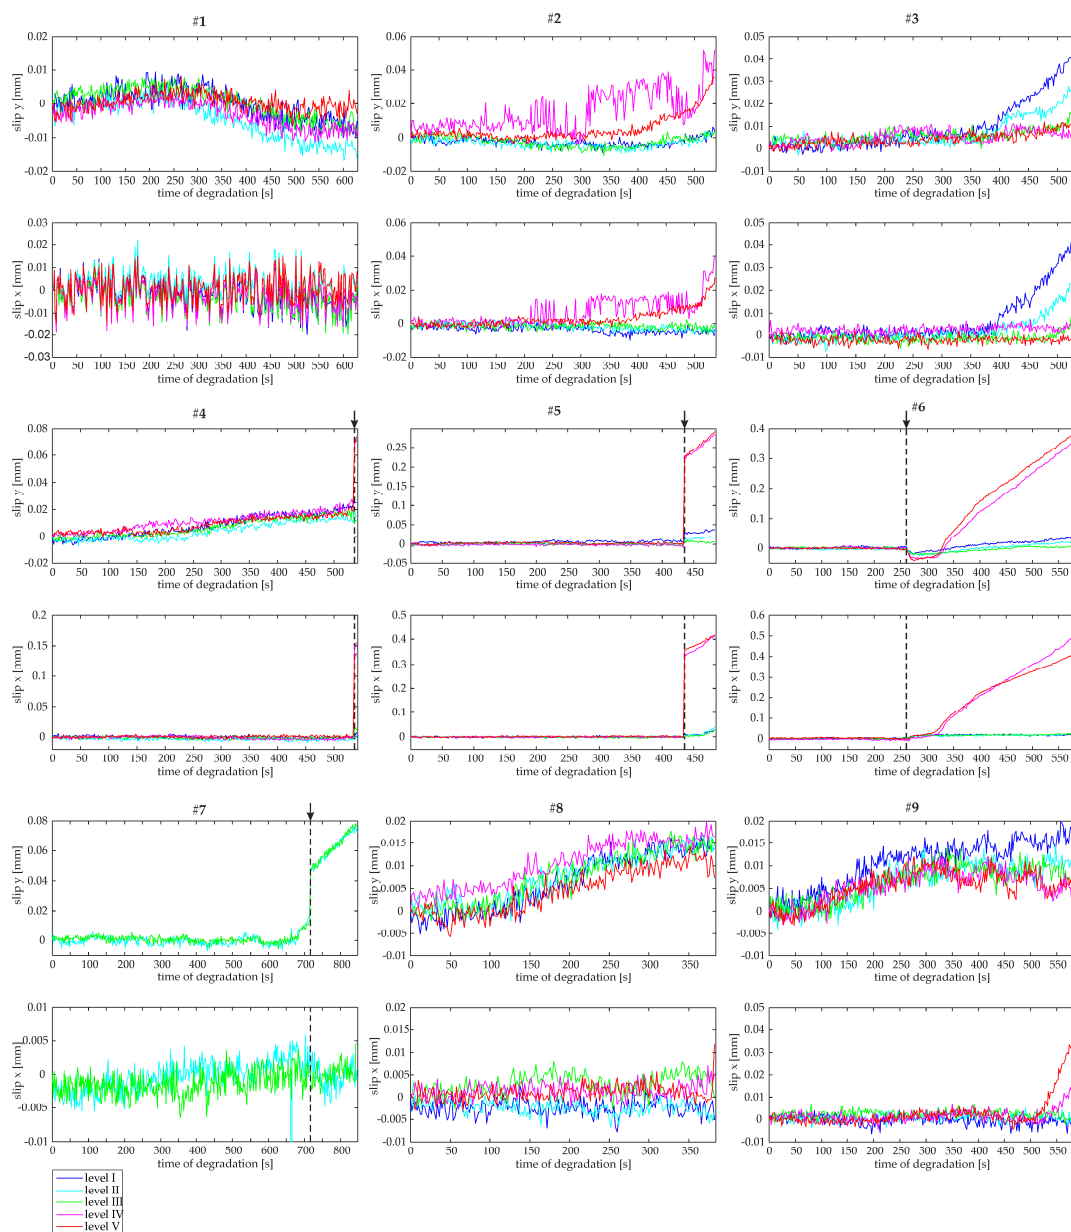
**Figure 9.** Interface slip between steel and concrete for tested push-out specimens (#1–#9).

Results of the interface slip between the steel and concrete in both vertical and horizontal directions are presented in Figure 9. For each specimen, the slip values are given for this interface at which the failure occurred (i.e., the right interface for specimens #1, #2, #6 and the left interface for specimens #3, #4, #5, #7, #8, #9). The moment of initiation of the crack in the concrete cube was indicated by the dashed lines (specimens #4–#7). In the case of the adhesive or mixed adhesive-cohesive failure, the measured slip varied around zero almost to the end of the degradation process. For specimens #2, #3 and #9, the monotonic increase of the slip was observed at the end of the test. The maximum values of the slip for the specimens representing mode I and mode IIc was about 0.05 mm. In the case of specimens with the cohesive failure in the bulk of the concrete cube, a sudden increase of the slip was observed in specimens #4, #5 and #7. A different behavior can be seen for specimen #6 for which the monotonic increase occurred after the cracking of concrete cube. The maximum values of the slip for specimens representing modes IIa and IIc were about 0.4 mm.

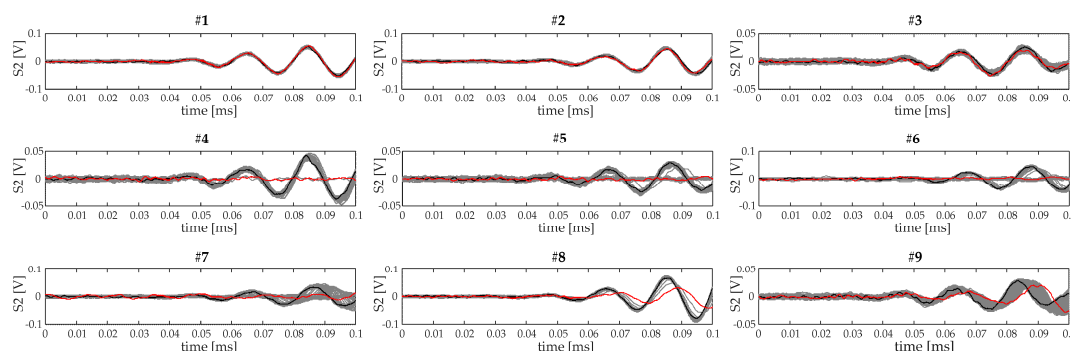
**Figure 10.** Wave propagation signals registered during monitoring of steel-concrete push-out specimens (#1–#9); the first signal (reference) is given in black, the last registered signal in given in red, all other signals are given in grey.

The ultrasonic waves were registered automatically every 2 seconds during push-out testing. All signals acquired by sensor S2 for specimens #1 to #9 are illustrated in Figure 10. Only an initial part of the signal with a length of 0.1 ms was analyzed to reduce the influence of interactions of waves with the compression test kit of the testing machine. The reference signal, i.e., the signal registered at the beginning of the push-out test is marked in black and the last acquired signal is marked in red. For specimens #1–#3, representing the adhesive-type failure (mode I), signals relating to successive states of mechanical degradation are similar and no significant changes in the magnitude or phase can be observed. In the case of push-out specimens #4–#10, for which the cohesive or mixed adhesive-cohesive failure occurred (mode II), experimental waveforms changed considerably during mechanical degradation.

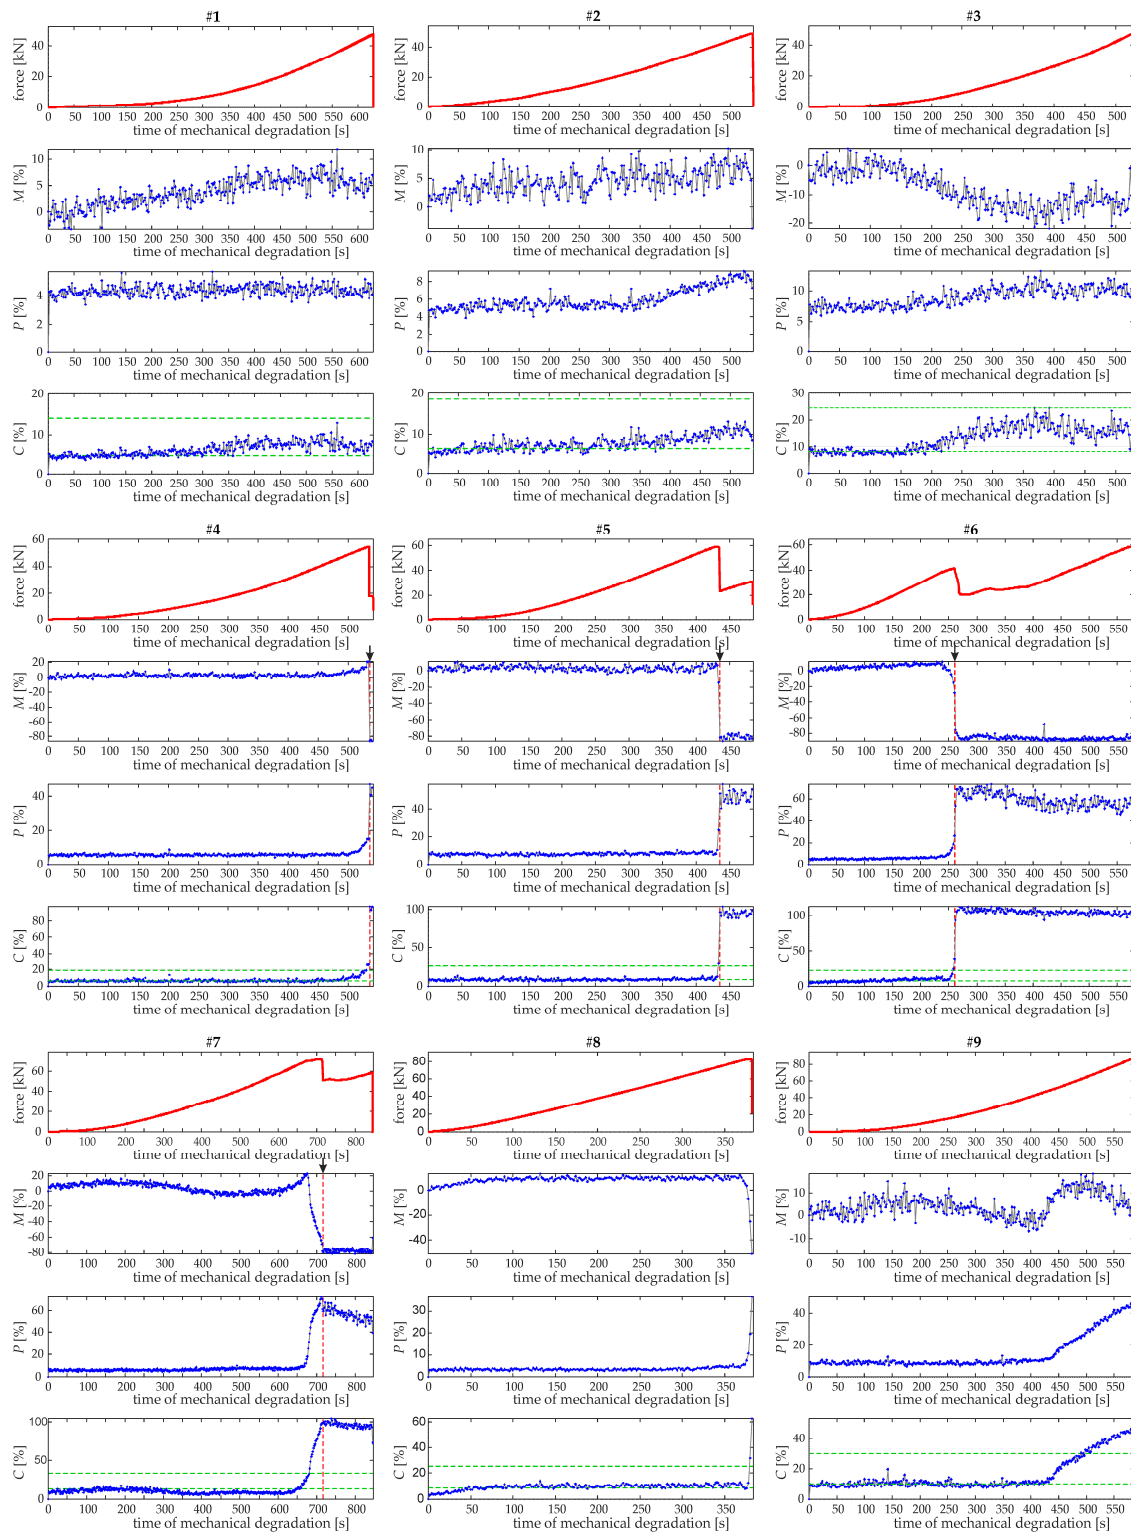
**Figure 11.** S&G metric errors (magnitude error  $M$ , phase error  $P$ , comprehensive error  $C$ ) during subsequent phases of degradation of push-out specimens (#1–#9).

The results of applying the Sprague and Geers metric to all signals registered during the monitoring of the push-out test are presented in Figure 11. For clarity of observation, the load-time curves were provided for each specimen. Additionally, for specimens #4–#7, red dashed lines were drawn at the moment of initiation of the crack in the concrete cube. The S&G metric expresses the difference between the reference signal and the other signals registered during the push-out test. The error measures can range from 0 to 1 or more. The perfect agreement of time histories results in a zero value of the error measures, while the value of unity indicates a difference of 100%. The value of the  $P$ -error is always positive while the value of the  $M$ -error can be positive or negative, depending on whether the monitored signal has higher or lower amplitude than the reference signal. At the beginning of the process, the  $P$ -error fluctuated around the value of about 5% and the  $M$ -error around the value of about 0%. These values resulted from the presence of measuring noise in the subsequently triggered measuring signals.

Considering the specimens with the adhesive-type damage (the first row in Figure 11), all error measures are rather constant during the entire push-out test. A slight increase in the  $P$ -error value was observed for specimen #6; however, based on these errors it was not possible to detect incoming damage before the failure.

The second group are specimens belonging to failure modes IIa and IIb, for which the separation between the steel plate and concrete was preceded by the cracking of concrete. For specimens #4, #5 and #6, the increase in the  $P$ -error can be observed before the initiation of the diagonal cracks. This increase was quite sudden for specimen #5, but for specimens #4 and #6 it was gradual signaling incoming damage. Moreover, for specimen #6, the  $M$ -error gradually decreased before the initiation of the diagonal cracks. In the case of specimen #7, for which the crack appeared in the middle of the concrete cube, the gradual increase of the  $P$ -error and the decrease in the  $M$ -error can be seen, enabling detection of the micro-crack zones in the concrete long before the appearance of the macro-crack.

The last two specimens represented the failure of mode IIc. For the specimen #8, the detection of the cohesive failure was possible based on both the  $M$  and  $P$ -errors. In the case of specimen #9, the gradual increase of the  $P$ -error was observed (similarly as for specimen #2) indicating the increase in the load but not the appearance of the failure. This was because, the failure of specimen #9 was mainly adhesive, with a small area at which the cohesive failure occurred.

As a damage indicator, the  $C$ -error is proposed because it contains both the magnitude and phase errors. For each specimen, two horizontal lines were drawn in the plots of the comprehensive error (Figure 11). The first line is a mean of the 100 first values of the  $C$ -error and it determines a baseline. The second line is the baseline multiplied by a coefficient and it represents the state of possible damage. In this study, the value of the coefficient was set a priori as 3, however, in potential applications of structural monitoring, it should be verified based on comprehensive experimental data. Based on the indicator, it was not possible to recognize the upcoming separation between steel and concrete in any specimen with the adhesive failure (specimens #1–#3). In the case of specimens exhibiting the cohesive

or mixed adhesive-cohesive failure, the gradual increase of the C-error enabled earlier detection of potential damage.
