## Finite element modelling of a historic church structure in the context of a masonry damage analysis

The paper includes a case study of modelling a real historic church using the finite element method (FEM) based on laser scans of its geometry. The main goal of the study was the analysis of the causes of cracking and crushing of masonry walls. An FEM model of the structure has been defined in ABAQUS. A non-linear dynamic explicit analysis with material model including damage plasticity has been performed. A homogenization procedure has been applied to obtain the material parameters used in the modelling of masonry. In the numerical analysis, the interactions between the church structure, the foundations and the ground were taken into account.

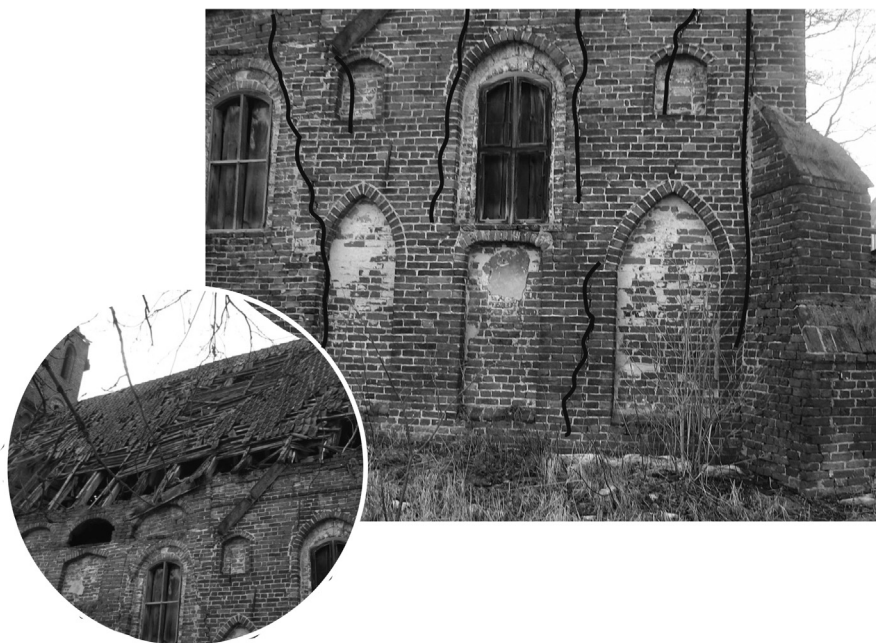
Fig. 5. View of the south wall and roof over the wall.

The roof of the church is made of wood (see Figs. 5–7). The main destroyed roof timber truss is considered in analysis here (see Fig. 7). The roof of the tower is omitted. The material of the truss is modelled in a simplified manner as elastic and isotropic even if wood is known as an anisotropic material. Because the church is a structure that was built centuries ago, the material may also have

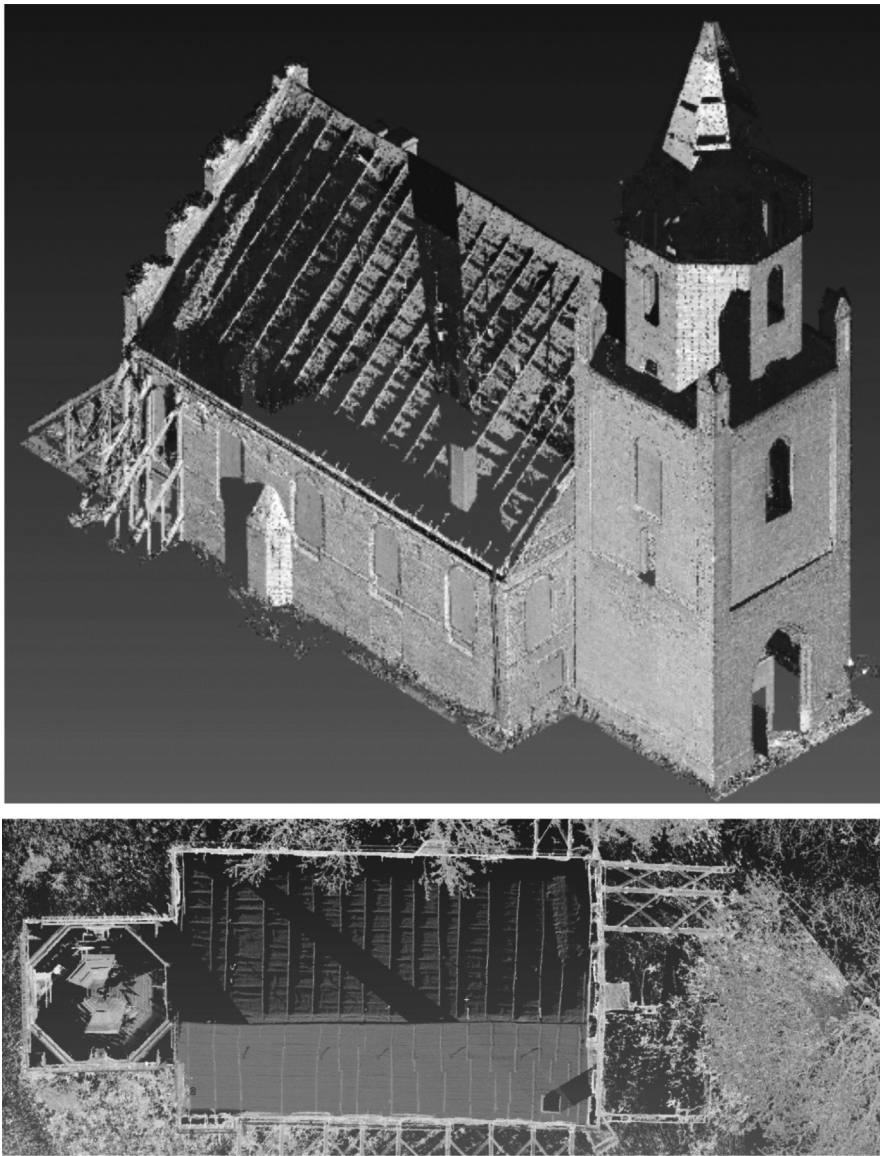
Fig. 8. View of the cloud of points.

The numerical models of the structures were created based on a standard architectural inventory with support from laser scanning (see Fig. 8). This technique and other similar techniques are not new and have been used for similar purposes, as presented in detail in [9,21]. A Leica ScanStation P20 3D laser scanner was used for the inventory. The data acquisition was based on the resolution

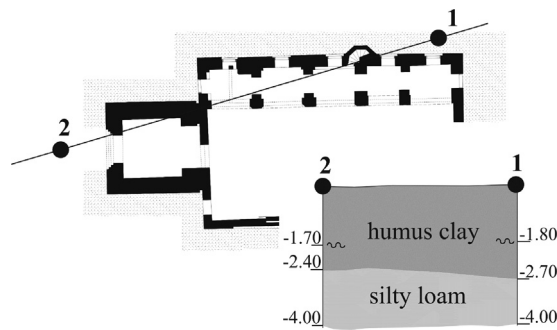
Fig. 9. Geotechnical research map.

The church is resting on the foundation approximately 1–1.5 meters below ground level (m bgl). As a part of field research, the locations of test points have been specified. The soil samples were retrieved from a depth of 4 m. Within the testing soil classification, water content, specific weight, cohesion, friction and soil consolidation properties were performed. On that basis, two main geotechnical layers were specified. The first layer of the soil under the church foundation is a humus clay that goes down to 2.7 m bgl and then up to 4 m bgl, where the second layer of dust clay is placed. Groundwater occurs below the foundation of the building (1.7–1.8 m bgl) in the form of filtration. The geotechnical investigation results indicate that the soil conditions are rather good for supporting the

structure [22] (see Fig. 9). In this paper, the support substrate on which the structure rests is treated in a simplified manner as a homogeneous and elastic material, without modelling the details of the support. The constrained modulus from oedometer testing is  $E_{ode} = 29700 \text{ kPa}$  [22]. Assuming that the Poisson's ratio of the tested soil substrate is  $\nu = 0.25$ , we can determine the Young's modulus of the soil according to the formula  $E = E_{ode} [(1 + \nu)(1 - 2\nu)] / (1 - \nu) = 24750 \text{ kPa}$  [23]. Furthermore, it is assumed that the average value of the soil mass is  $1775 \text{ kg/m}^3$ .

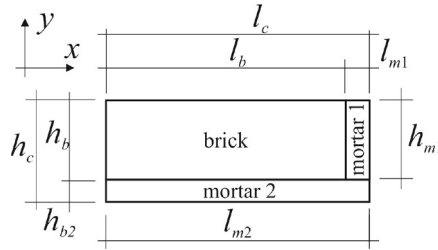
Fig. 10. Elementary cell in individual states.

The masonry church wall material modulus of elasticity was calculated using a homogenization algorithm described in papers [24,25]. In this method, an elementary cell is analyzed, where based on strain compatibility and stress balance equations of its components, the basic material properties of the entire element can be calculated. The cell is comprised of a brick and mortar attached along its two edges (see Fig. 10). The method assumes that the width and height of an elementary cell is greater than its thickness, which makes it possible to assume a plane stress state in the wall; the layout of bricks and joints in the wall is regular, and the stress gradient in the construction is small, with no concentrations.

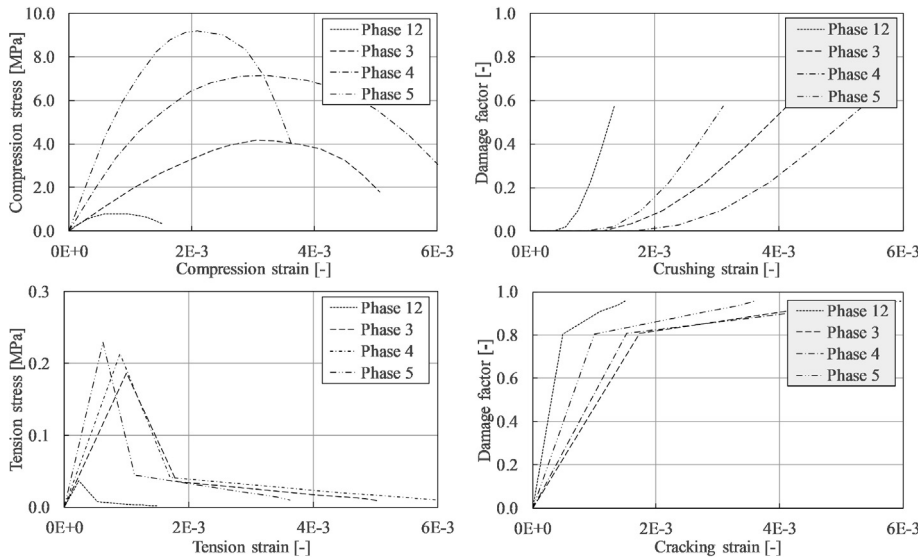
Fig. 11. Masonry properties: phase 1/2 (14th century), phase 3 (16th century), phase 4 (18th century), phase 5 (19th century).

1/2 and 3, 3% for material in phase 4 and 2.5% for material in phase 5). The values of the individual parameters are shown in Figs. 11 and 12.

Considering the material behaviour of the specific parts of the structure, the soil (basic and degraded), stone foundations and timber roof are modelled as linearly elastic (see Table 3), whereas the masonry walls (see Table 3 and Fig. 11) and concrete columns (see Fig. 12) are modelled as continuum plastic with damage and stiffness degradation in the sense of continuum damage mechanics. Plasticity-based damage constitutive modelling is widely used to describe the nonlinear properties of masonry structures and concrete. Such a model was first proposed for concrete analysis [37–39] and reinforced concrete (RC) structures [40] but also can be used to represent other brittle material behaviours such as for ceramic masonry structures [41,18,42]. The applied material model is described extensively in [36]. It assumes that the main two failure mechanisms are tensile cracking and compressive crushing of the masonry or concrete. The evolution of the yield (or failure) surface is controlled by two hardening variables  $\tilde{\varepsilon}_t^{pl}$ , which is a tensile equivalent plastic strain, and  $\tilde{\varepsilon}_c^{pl}$ , which is a compressive plastic strain. Both refer to failure mechanisms under tension and compression loading. It assumes that uniaxial tensile and compressive response of the brittle-like material is characterized by damage plasticity, as shown in Figs. 11 and 12.

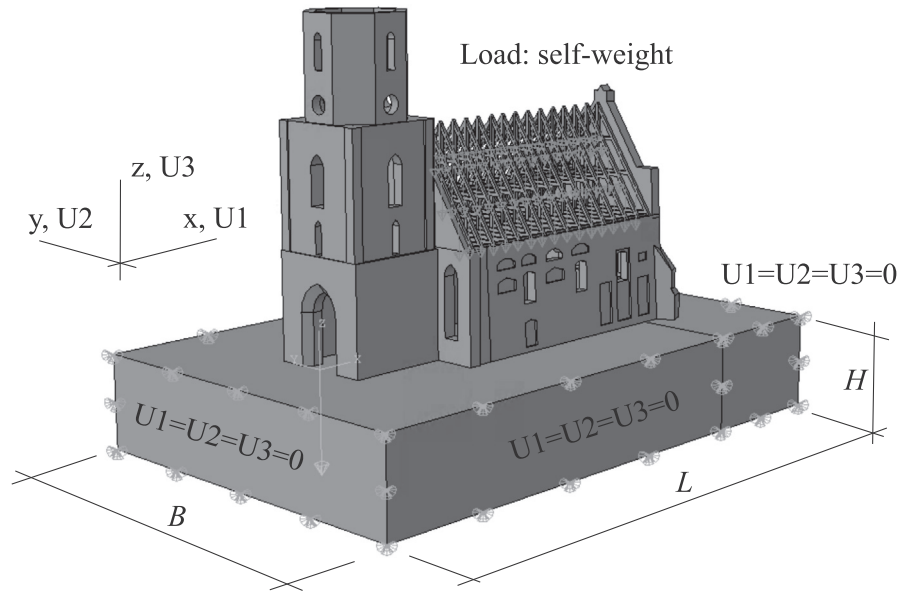
Fig. 13. FEM model: load and boundary conditions.

The whole numerical model (see Fig. 13) is built of 4-node linear tetrahedral volumetric finite elements with one integration point and three degrees of freedom in each node-type C3D4 [35]. The total number of finite elements in all the analysis cases equals approximately 3.5 million. The FE mesh density was determined in a parametric study based on convergence analysis of the cracked form. The numerical model is loaded only by its self-weight. The geometrically nonlinear analysis was performed using a dynamic explicit procedure [36], as it is computationally efficient for the analysis of large models with relatively short dynamic response times and for the analysis of extremely discontinuous events or processes. The dynamic explicit analysis can also be used to perform a quasi-static analysis. In the proposed numerical solution (quasi-static technique), the load is applied smoothly; consequently, slow deformation triggers a low strain rate. This type of analysis allows for using a consistent, large-deformation theory. In view of the above, the proposed method of analysis is highly effective for studying the damage and degradation of masonry structures. Due to this approach, one can track very carefully the propagation of gradually occurring damage (like cracking and crushing) under an increasing load value, regardless of the type of loads. The ABAQUS package apparently offers several other methods performing dynamic analysis of nonlinear problems, such as implicit dynamic analysis. However, implicit dynamic analysis is not as effective as the explicit approach. The authors' experience shows that while modelling large complex nonlinear problems, like damage of masonry structures, a solution convergence problem often emerges at the time of structural degradation start while applying implicit dynamic analysis.

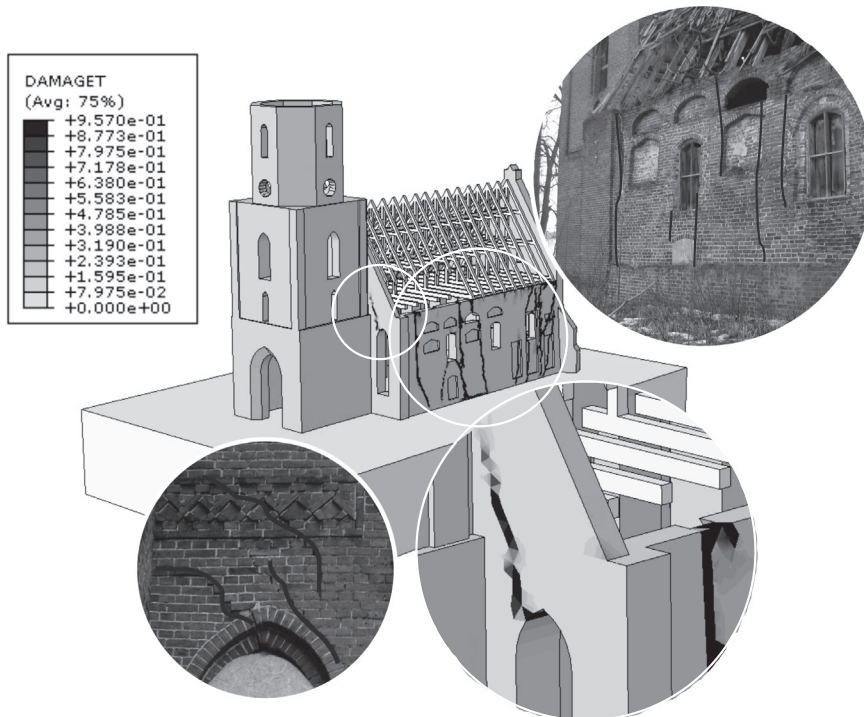
Fig. 14. Selected details of main cracks on the west-south walls compared with FEM solutions expressed by tension damage factor DAMAGET.

The main results of the numerical analysis are shown in Figs. 14–16. All the main cracks of the real structure of the church are reflected by the numerical results. Fig. 14 shows the main cracks of the west-south walls in the real structure and the resulting

- The first and main cause of the cracking damage is a result of improper techniques used in the successive reconstructions of the church. Due to frequent church rebuilding in many parts of the structure, ceramic materials (bricks) with different strength parameters are combined (see e.g. Fig. 16), which is unfortunately contrary to the known principle that “No man also seweth a piece of new cloth on an old garment: else the new piece that filled it up taketh away from the old, and the rent is made worse. And no man putteth new wine into old bottles: else the new wine doth burst the bottles, and the wine is spilled, and the bottles

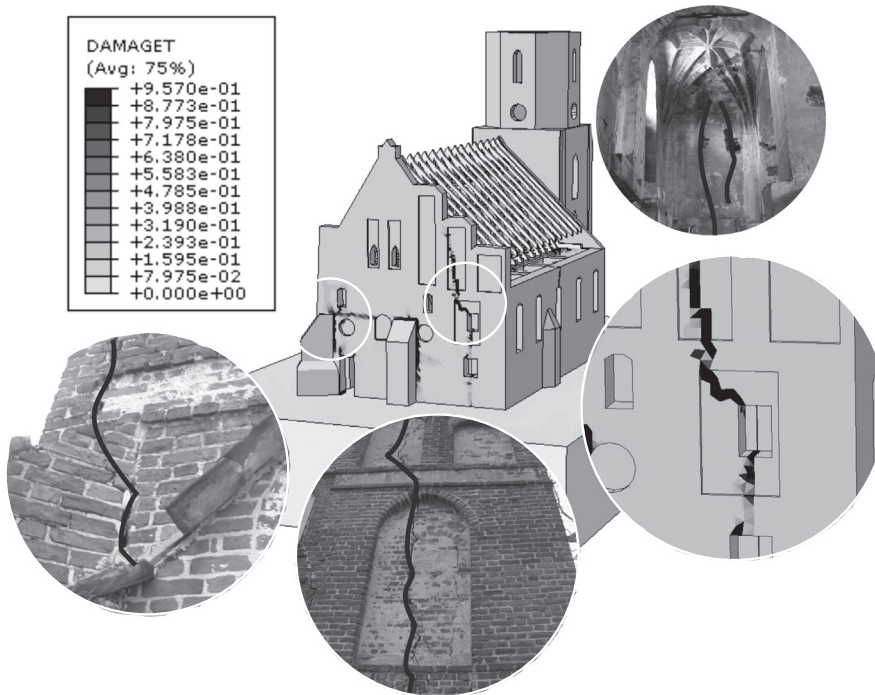
Fig. 15. Selected details of main cracks on the east wall compared with FEM solutions expressed by tension damage factor DAMAGET.

damage obtained from the numerical analysis. Similarly, the main damage to the east wall and the damage to the inner nave arch are presented together with the appropriate numerical results of the mechanical analysis in the Figs. 15 and 16.

- The second but also very important cause of the masonry cracking is varied settlement of soil under the church structure (see Fig. 4). The numerical study results clearly indicate that the soil conditions, although seemingly good enough for supporting the structure, unfortunately are the cause of cracks in masonry. The geotechnical investigation carried out did not show problems with the bearing capacity of the soil merely because of the inadequate number of geotechnical test drillings (see Fig. 9). An additional geotechnical drilling should be conducted at the south-east corner of the church, where the soil seems to be weaker. The soil weakness can be confirmed by the reconstruction of the church in the 18th century (see Figs. 4 and 15 - phase 4) because the buttresses probably built in at that time were supposed to prevent the structure from collapsing. Moreover, a sacristy built later at the same corner made the situation even worse because it caused the overloading of the soil and the east masonry wall cracking (see Fig. 15).

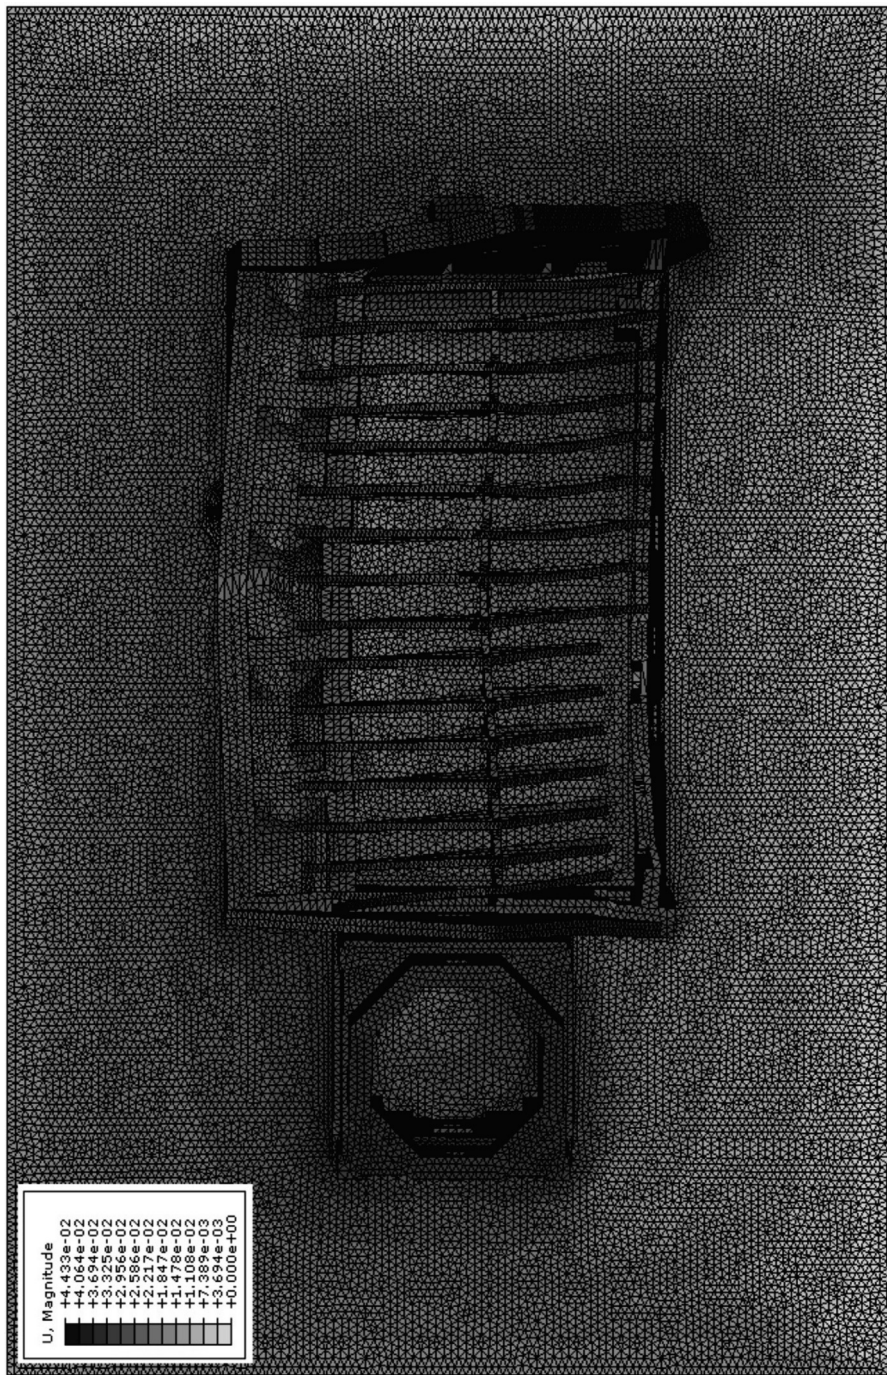
Fig. 17. Numerical solution - deformations [m] according to soil volume at  $H = 6$  m ( $L = 37$  m,  $B = 24$  m).

cracks remains constant and independent of soil volume. As the volume of soil increases, structural settlement stabilizes. Numerical analysis considers soil weakening under the south-eastern corner of the church.

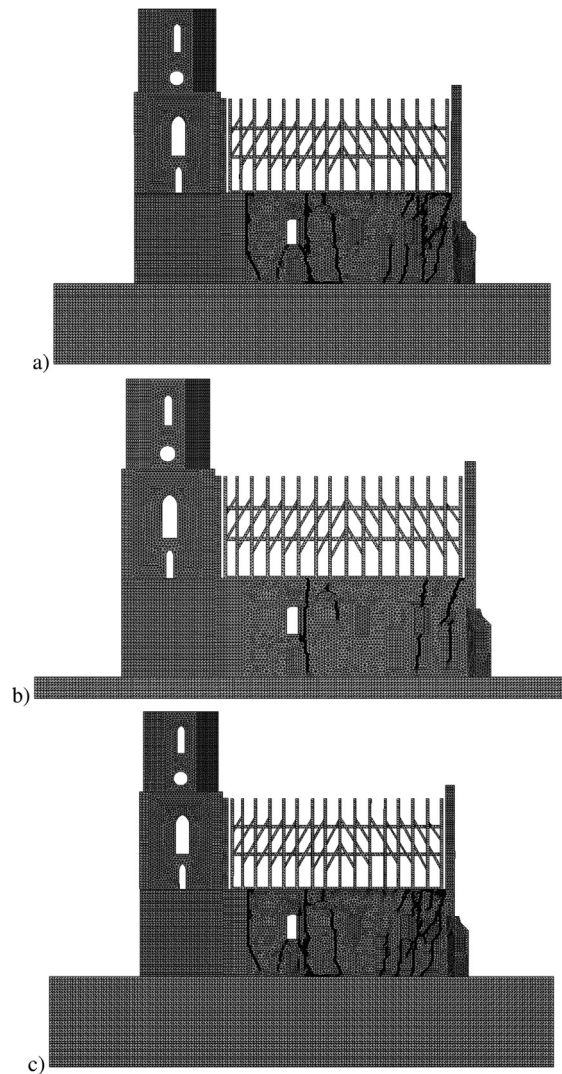
**Fig. 19.** Numerical solutions, view of the south wall – damage factor DAMAGET due to: (a) the soil volume at  $H = 6$  m ( $L = 37$  m,  $B = 24$  m), (b) the soil volume at  $H = 1.5$  m ( $L = 37$  m,  $B = 24$  m) and (c) the soil volume at  $H = 7$  m ( $L = 39$  m,  $B = 26$  m).

Tension damage  $d_t$  is expressed by means of a tension damage factor, i.e. when using ABAQUS and the DAMAGET function [36]. This parameter is a scalar variable that describes stiffness degradation and takes values from 0 (undamaged material) to 1 (material completely destroyed). Damage to the structure due to crushing (ABAQUS function DAMAGEC) is practically not observed. Thus the problem of structure crushing has not been described in the paper in detail.
