Improvement of the load capacity of the road overpass as a result of repairs after breakage caused by vehicle impacts

Abstract. Damages of spans of the overpass caused by impact of underpassing vehicles are relatively frequent. Objects that use prefabricated load-bearing elements that are not designed for such impacts are particularly exposed. After impact, such structural elements suffer extensive damage that must be repaired. Taking advantages of this recovery actions it is worth to perform strengthening that will protect object against possible future impacts. In this study the influence of the structural strengthening of the damaged overpass on its strength parameters is investigated. For this purpose the advanced computational model was created. The numerical model includes the response of the reinforcement and prestressing tendons. This model enables precise description of damage caused due to the vehicle's impact and further analysis of re-impact of the strengthened structure.

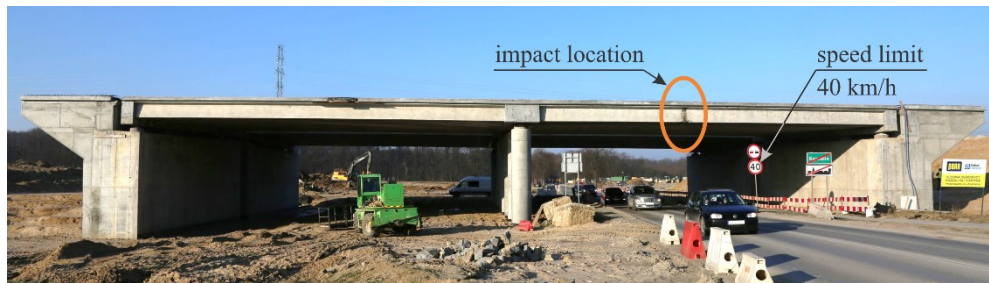
Fig. 1. Overall view of the bridge. The location of the impact is marked orange.

The considered WD-113 overpass (Fig. 1) is located along the S-6 expressway at km 2+842.39, near the Koszalin (Poland). Object consists of two independent structures, namely: WD-113L and WD-113P. They have been designed as a two-span concrete objects. The load-bearing elements are T-type prefabricated prestressed concrete beams (length 24.0 m, height 1.0 m) and a reinforced concrete slab over the T-beams (height 0.24 m). The crossgirders are located over the abutments and over the intermediate supports. The total length of the WD-113P object is equal to 48.90 m and the total width is 18.95 m.

During the inspection, the failure of the prestressing tendons was not confirmed. As a result of the second accident (01.12.2017) the bottoms of the girders were scratched which did not endanger the safety of the structure. Therefore, it was decided to only analyse the first collision event. The impact point is shown in Fig. 1 and the summary of the damage is given in Fig. 2.
