# Influence of a Lighting Column in the Working Width of a W-Beam Barrier on TB51 Crash Test

**Abstract:** Road equipment, such as, e.g., road safety barriers and lighting columns, are subject to certification according to the EN1317 standard to be allowed for use on European roads. In engineering practice, due to the terrain conditions, there are cases where other road equipment is installed within the working width of road safety barriers. Such situations are not considered during the certification process. Hence, the aim of this study is to analyze the effect of a lighting column installed within the working width of the barrier on the results of the TB51 crash test. The full-scale crash test and numerical simulation of this event were conducted. In the full-scale crash test, as well as in the simulation, the lighting column prevented the barrier's post from properly disconnecting from the guardrail, which resulted in the barrier failing to restrain and redirect the 13-t bus. The simulation was quantitatively compared to the experiment, where the correlation coefficient of ASI curves equaled 84%. The THIV curves differed significantly between the experiment and the simulation,

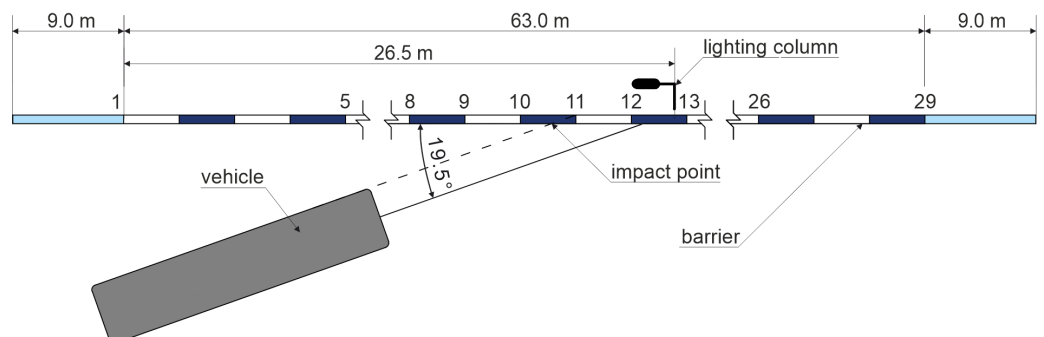
The full-scale crash test was conducted on 10 August 2017 at the testing grounds of the Research Institute for Protective Systems (IBOS) [33]. The experiment was carried out by the Research Institute for Roads and Bridges (IBDiM) [34]. This institute is certified by the Polish Center for Accreditation to, among others, perform crash tests according to the EN1317 standard [14]. The setup of the test is presented in Figure 2. The total length of the system was 81 m, where there was 63 m of straight section and 9 m at each end of the barrier.

**Figure 2.** Scheme of the test setup.

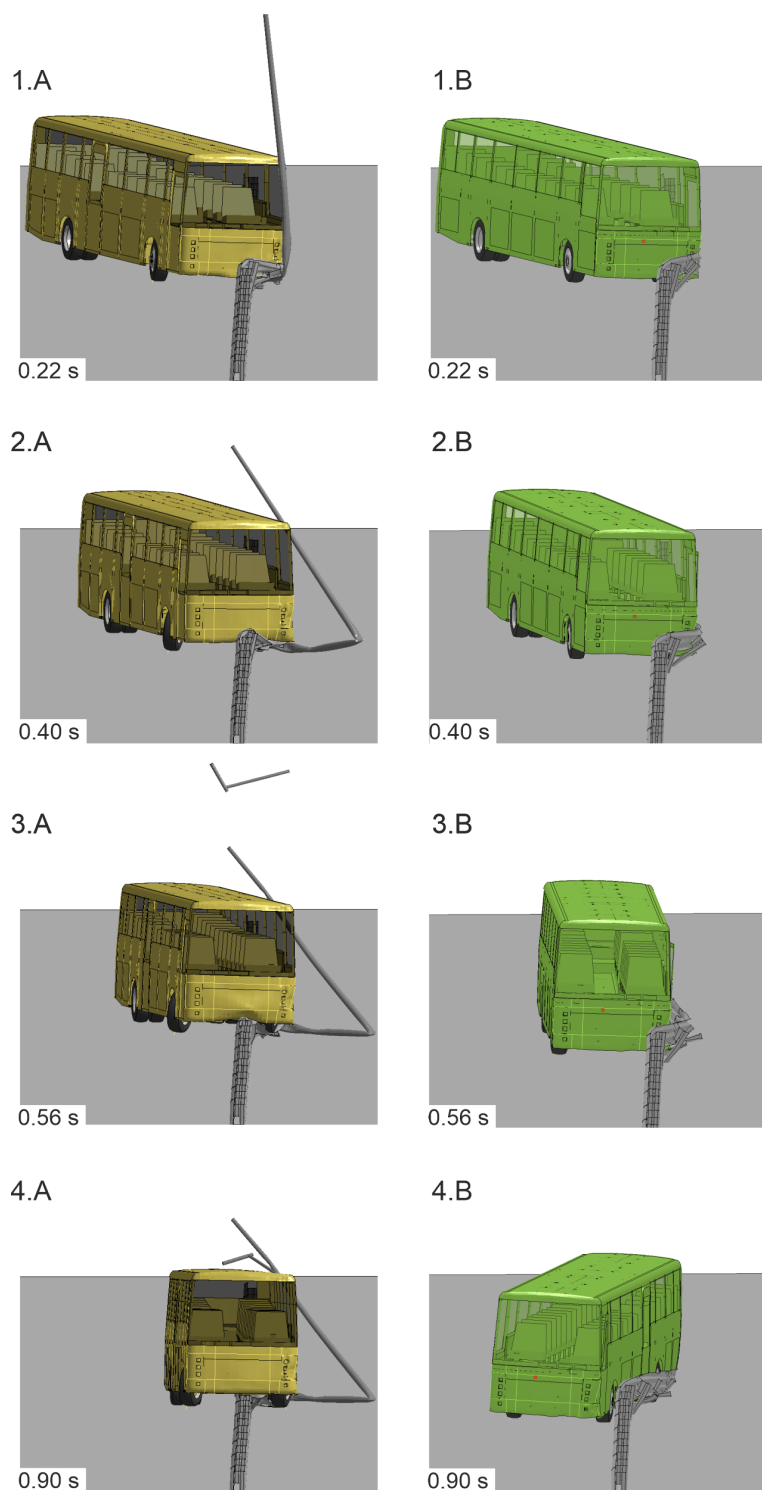
**Figure 16.** Vehicle trajectories of numerical simulations of (A) the barrier without an obstacle (Case No. 1) and (B) the barrier with a lighting column within its working width (Case No. 2).

The trajectory of the vehicle in Case No. 1 was described in Section 3. In simulation Case No. 2, 0.08 s after the impact, the barrier guardrail flattened on the left-front side of the vehicle body and the vehicle began to slide and redirect along the guardrail. At 0.14 s after the impact, Spacer No. 12 was detached from the guardrail, and then, two more spacers (Nos. 13 and 14) also detached from the guardrail consequently. At 0.54 s after the impact, the rear of the bus hit the guardrail at the height of Post No. 10 (see Figure 16(3.B)). The rear of the vehicle was also caught by the barrier, and the guardrail properly redirected the vehicle; at 1.30 s after the impact,

the vehicle eventually left the barrier. The calculated working width was 1.37 m, and the dynamic deflection was 1.03 m. The difference between the working width from the simulation and the value from its certificate was less than 10 cm. The maximum roll angle of the vehicle in the simulation Case No. 2 was 2.01°, and it was 3.95° less than in Case No. 1. A comparative analysis of the vehicle trajectories for both simulation cases is summarized in Table 3, where the time 0.0 s is the time of vehicle impact and the time 2.0 s indicates the end of the simulation.

Time Intervals, s	Comparison between Simulations	
	Case No 1	Case No 2
0.0 *–0.13	Similar Course	
0.14–0.25	The guardrail made contact with the lighting column, which prevented the connection between the post and the guardrail from breaking (see Figures 16(1.A) and 20A).	Post No. 12 was detached from the guardrail (see Figures 16(1.B) and 20B).

0.26–0.39	Post No. 13 did not detach from the guardrail, and the system was pressed to the ground by the vehicle chassis (see Figure 16(2.A)).	Another post (No. 13) was detached from the guardrail. The guardrail flattened against the vehicle body and began to redirect the vehicle (see Figure 16(2.B)).

0.40–0.63	After sliding underneath the vehicle chassis, the guardrail was shaped into a flat surface parallel to the ground, which acted as a ramp, which allowed the vehicle to run over the barrier (see Figure 16(3.A)).	Post No. 14 disconnected from the guardrail, and the guardrail continued to effectively redirect the vehicle (see Figure 16(3.B)).

0.63–0.85	The left-front wheel of the vehicle crossed to the other side of the barrier, and the vehicle chassis landed on the top of the guardrail. The system underneath the bus almost completely laid down on the ground (see Figures 16(4.A) and 19A).	The bus was moving parallel to the line of the barrier. Post No. 12, 13, and 14 were disconnected from the system (see Figures 16(4.B) and 19B).
