# Influence of Lubrication Water Contamination by Solid Particles of Mineral Origin on Marine Strut Propeller Shafts Bearings of Ships

Gdansk University of Technology, Faculty of Mechanical Engineering and Ship Technology, Poland

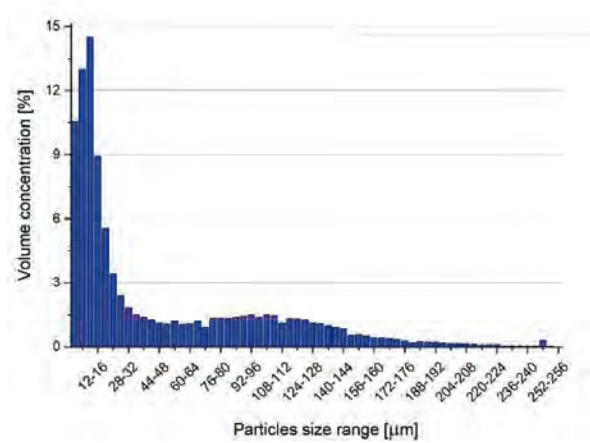
Fig. 6. Percentage size distribution of solid particles used during the tests.

A mixture of fresh water with particles of mineral origin typical of the Baltic Sea catchment area was used as a lubricant [29][30]. For this purpose, natural sedimentary material was collected from the river. It was cleaned from biological contaminant like leaves parts. The high quality, modern digital microscope was used for making pictures (Fig. 5) The dedicated software provided by manufacturer was used for analysis of the particles size. After conducting a statistical analysis after many measurements of different samples percentages of particles of various sizes figure with particles size distribution was plotted (Fig. 6).

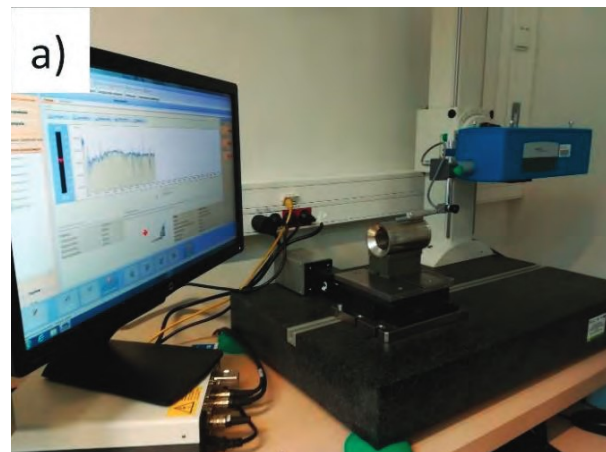
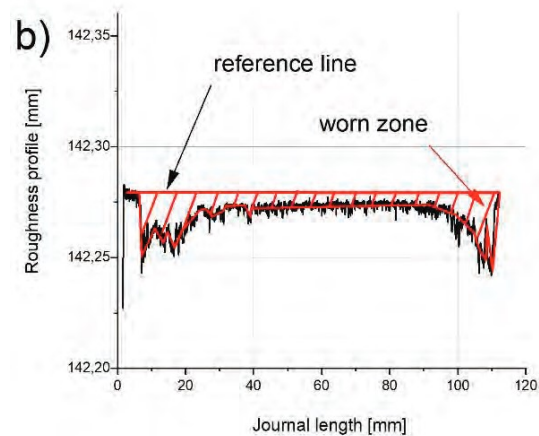
Fig. 7. (a) Profilometer measurements of the shaft journal surface profile; (b) method used to calculate the wear field based on the roughness profile.

In order to investigate the wear of the sliding pair, it was necessary to measure the wear of the shaft journal and bushings. The shaft journal wear was determined by analysing the measurement results with a profilographometer, which allowed us to calculate the consumption area and then the volume (Fig. 7).

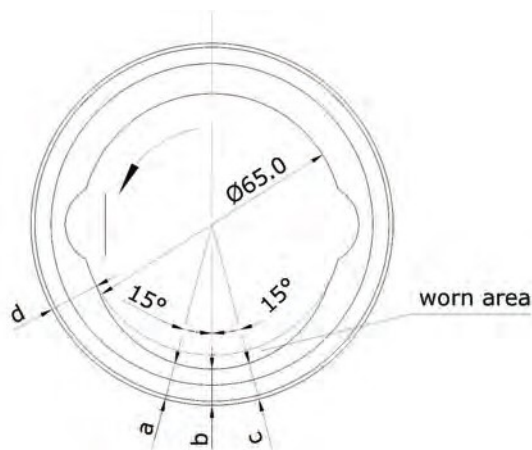
Fig. 8. Measurement of bush wear at three surfaces a, b, c, relative to the original bush thickness d.

The bush wear was determined based on the loss of bush

wall thickness measured at three surfaces (Fig. 8), and the amount of consumption was then calculated using the method proposed by Archard [31]. The specific wear rate coefficient ( $k_i$ ) was determined based on the wear volume ( $V_i$ ), sliding distance ( $s$ ) and applied force ( $F$ ) as

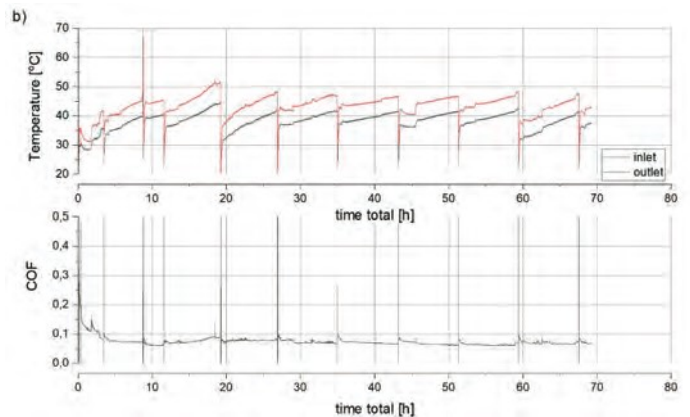
Fig. 10 Temperature of the water at the inlet and outlet sides of the bearing, and coefficient of friction (COF) for a classic bearing with a rubber bush with grooves around the entire circumference, under contaminated water lubrication (bearing 1a)

particle crushing process was not intensive. The wear process was accompanied by a visible increase in temperature over the entire system, which was due, among other things, to the small volume of the lubricant system, which had a volume of only 10 l. The temperature and COF charts presented below were acquired for a classic, popular solution, a rubber bearing with grooves made around the entire circumference (Figs. 9 and 10), and the low intensity of the wear process is visible. A comparison of the temperature measurement results clearly shows an increase in the temperature of the lubricant flowing through the bearing. In the case of clean water, this increase is about 4°C, whereas for contaminated water it is about 6°C. This is undoubtedly due to the greater resistance to movement in the case of lubrication with a liquid containing solid particles compared to pure water.

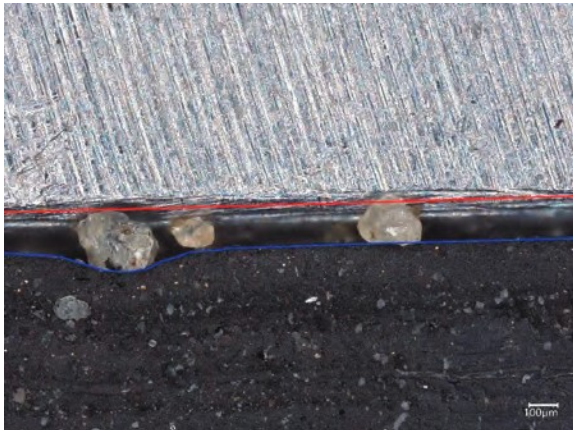
Fig. 12. Contact surface of the steel-NBR pair, with solid particles of mineral origin between them, showing the local deformation of the flexible NBR.

It was found that the forces exerted on the particle were not large enough to crush it, and that it rolled between the shaft journal and the bushing. The local deformation of the bush is shown in the microscopic photo below of a specially prepared model (Fig. 12). This concept helps to explain why on elastic bearing bushes only large scratches probably made by larger hard particle are easy to notice (fig. 13, 2b and 4b). For harder bushes process of crushing a particles results intensive wear especially when hydrodynamic properties are poor because of lubrication grooves located in lower half of the bearing bush (fig. 13, 6d and 7a).

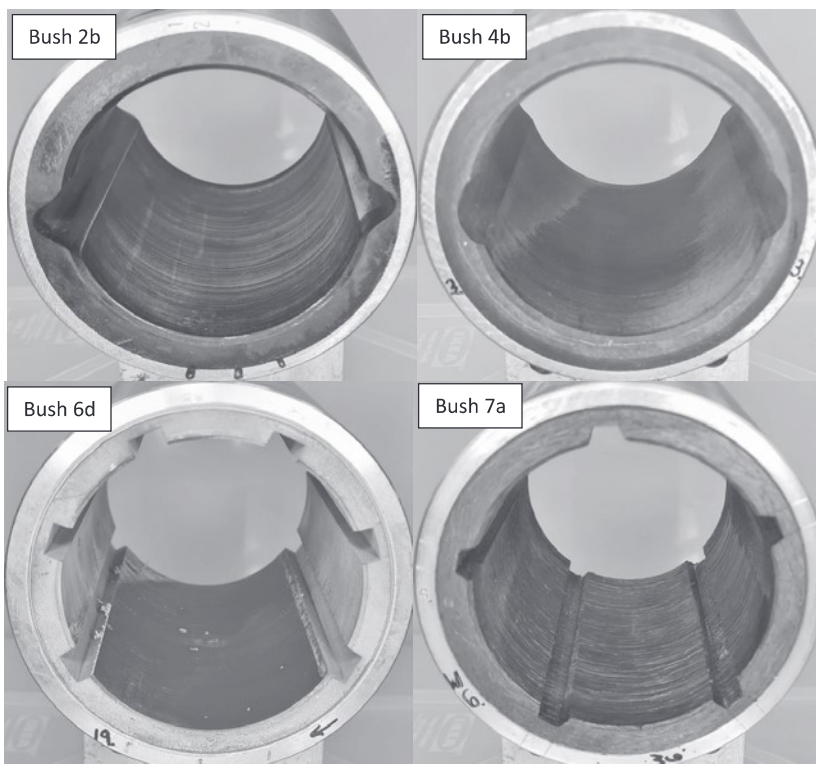
Fig. 13. Selected group of tested bearing bushes; 2b- NBR with scratches on surface, 4b- 3 layer bush with smoothed surface and visible contact zone, 6d - polymer bush with wear zone between grooves, 7a- composite with deep worn zone - visible contact zone (dark)
