# INFLUENCE OF PROCESS OF STRAIGHTENING SHIP HULL STRUCTURE MADE OF 316L STAINLESS STEEL ON CORROSION RESISTANCE AND MECHANICAL PROPERTIES

**Keywords:** 316L steel, flame straightening, corrosion resistance, mechanical properties

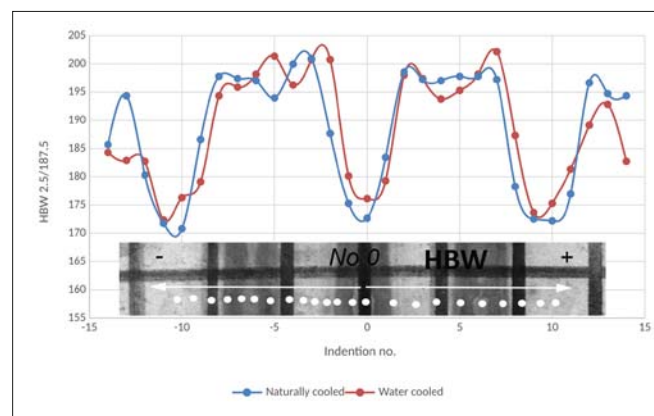
Fig. 5. Surface hardness measurement test result

As can be clearly seen in Fig. 5, the hardness distribution on the surface of the tested objects is heterogeneous and is similar in both cases. It is clearly seen that the lowest hardness values can be found at the points -10, 0, and 10. These are measuring points that coincide with the marks after the burner passes. The increase in hardness occurs between the tracks, that is, in places where there was no direct impact of the heat source. The hardness distribution in the tested panels therefore resembles the hardness distribution in the welded joint, where there is a clear increase in hardness in the heat affected zone (on the fusion line), that is, in a place where the heat source did not work directly.

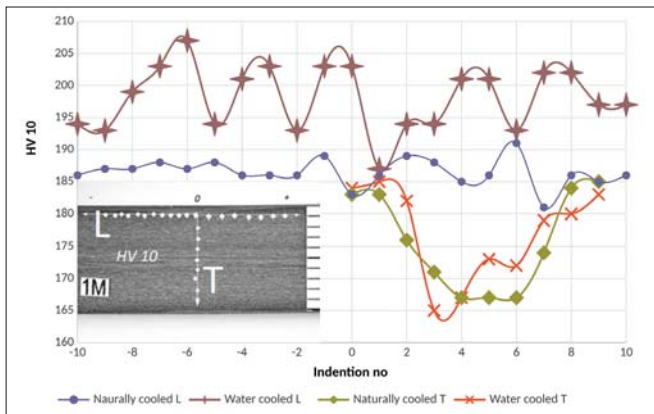
Fig. 6. Vickers hardness test results

To determine whether the observed changes in the hardness distribution are purely surface in nature, a cross-sectional study was performed. Two measuring lines were made for each case. For the line marked “L”, the measurement was made at a depth of about 1 mm from the heated surface of the test plates, and the measuring points were numbered and arranged as for a surface test. For the line marked “T”, the measurement was made according to the material thickness, with measuring points spaced approximately every 1 mm. The measurement lines and test results are depicted in Fig. 6.

As can be seen in Fig. 6, the hardness values measured 1 mm under the heated surface of the sheet show significantly lower fluctuations. The nature of the graph caused the results to be averaged, and the standard deviation was calculated. For the naturally cooled sheets, the average hardness was  $186.5 \pm 2.0$  HV10, while for the water-cooled sheets it was

$198.0 \pm 4.8$  HV10. Analysing the T lines, in both cases, one can notice a certain regularity – the hardness reaches higher values at the material surfaces. This is the result of metallurgical processes – rolling and the effect of the greater pressure on the surface of the sheet (compared to its interior). For sheets cooled after straightening in a natural way, the hardness distribution over the sheet thickness is practically symmetrical. In the case of test plates cooled in a water bath, the effect of the thermal process is clearly visible – the hardness distribution is asymmetrical and its minimum is clearly shifted towards the heated surface.

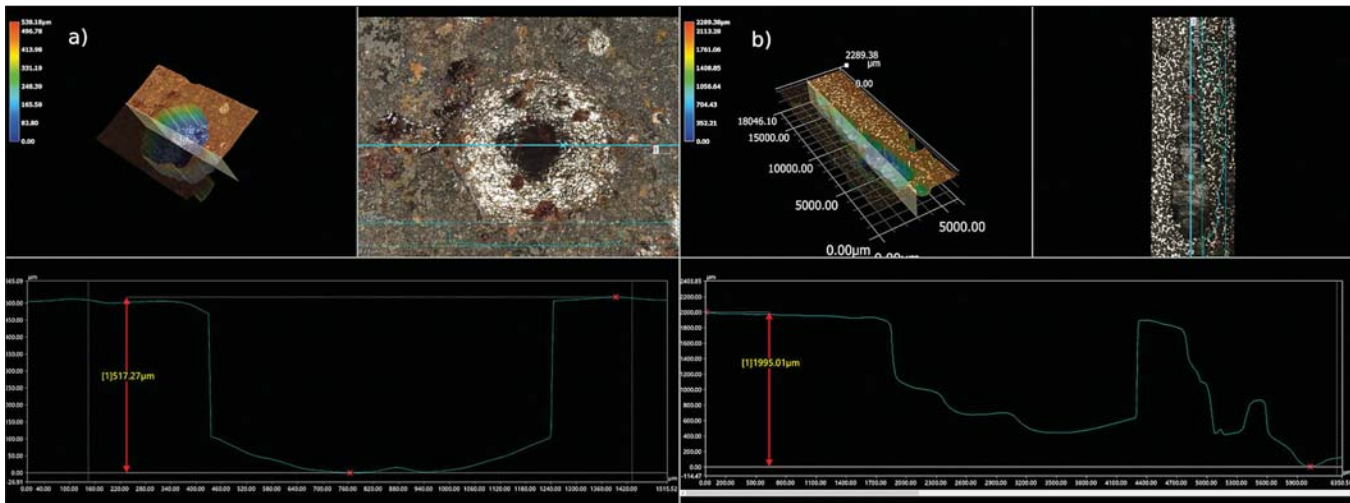
Fig. 10. a) Profile and depths of the smallest observed pits; b) The depths of the largest pits formed during the test; Keyence VHX 7000

It is also worth noting the large dispersion of the size of pits formed during the experiment. For example, for sample No. 3.7 (shown in Fig. 9), it ranges between 0.5 and 2 mm, which is already classified as severe pitting corrosion according to the standard [1]. As shown in Fig. 10a, the smallest pit is 517 μm deep and the largest about 1995 μm. There are also significant differences in the surface profile of the pits. The smallest ones are close to a spherical shape and their longest diameter is about 610 μm. The largest ones, as seen in Fig. 10b, are oblong and consist of several pits combined with each other, with a total length of about 16 850 μm.
