# INFLUENCE OF SOLID PARTICLE CONTAMINATION ON THE WEAR PROCESS IN WATER LUBRICATED MARINE STRUT BEARINGS WITH NBR AND PTFE BUSHES

Gdańsk University of Technology, Poland

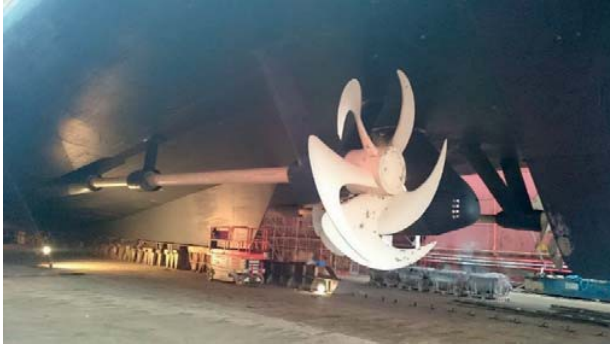
Fig.1. Propeller shaft strut bearings [1]

Special consideration should be given to the working conditions of the propeller shaft strut bearings (Fig.1). It is common to utilize bearings lubricated with seawater that surrounds the hull of vessels, where there is not control of the water flow and the water is not filtered. Therefore, when a vessel is operated in shallow or inland waters, various types of contaminants tend to enter the friction zone, resulting in accelerated wear processes.

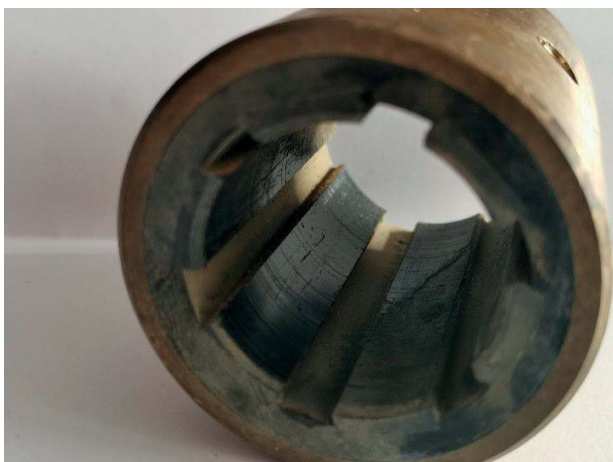
Fig. 5. The PTFE sliding bush (B)

Traces of wear caused by friction are visible on both internal surfaces of the bushings. The circumferential grooves were the result of sand particles getting between the shaft journal and the bush, but deeper grooves were seen in the NBR bush. As for the journals, the rubber bushings had the greatest wear in the middle of the bushing and at the edge of the load application. On the other hand, the wear of the PTFE bushings was evenly distributed over the entire surface of the joint. Inside, there were visible fragmented sand particles embedded in the longitudinal grooves, which could have

caused detachment the upper layer of the sleeve material, as shown in Figure 5.
