**Anna Orchowska-Smolińska\*, Anna Kriegseisen\*\*,  
Jakub Szczepański\*\*\***

*Interdisciplinary research as a form  
of monument protection and preparation for the investment process  
on the example of the former Gdańsk Shipyard complex*

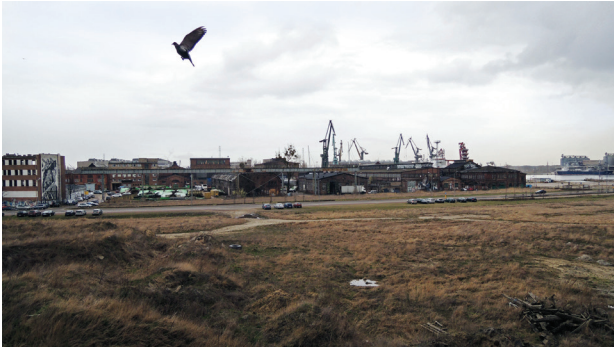
Fig. 1. View of a fragment of the area of the former Gdańsk Shipyard in 2019. Until the beginning of the 21<sup>st</sup> century, the area in the foreground of the photo was filled with shipyard halls constituting one of the main production lines of hull construction. Currently (2022), investment works related to the construction of multi-family buildings are underway there (photo by A. Orchowska-Smolińska)

The transformation process of the Gdańsk shipyard area initiated this way was associated with the emergence of plans to convert the oldest part of the shipyard into a new district of Gdańsk, i.e. connecting the post-shipyard area with urban tissue (Fig. 1). It is worth mentioning here the unique documentation of the Shipyard's heritage by Michał Szlaga, which began to be created in 1999. The artist undertook a several-year-long project of photographic recording of changes in the cultural resources of the shipyard areas undergoing the first transformations. The publication of the results of the documentation work took place in 2013 in the form of a richly illustrated album with numerous descriptions [19]. Two industrial heritage researchers, Dr. Waldemar Affeld from the Gdańsk University of Technology and Professor Jacek Dominiczak from the Academy of Fine Arts, played an important role in the project in the context of reading the meanings of shipyard remains.

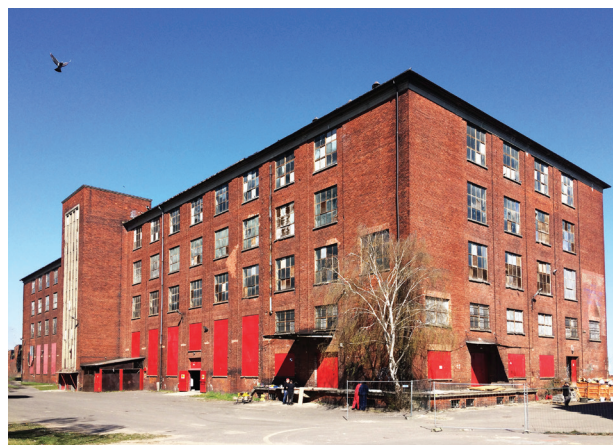
Fig. 5. The body of the Main Warehouse (89A), so-called the U-Boat Hall, in the view from the south-east, 2019 (before the start of conservation works) (photo by A. Orchowska-Smolińska)

An example of a detailed-scale study was the research prepared for the building of the former Main Warehouse (89A), the so-called U-Boat Hall<sup>10</sup>. Based on that research, *Wytyczne konserwatorskie rewaloryzacji budynku dawnego Magazynu Głównego 89A, tzw. Hali U-Bootów, na terenie dawnej Stoczni Gdańskiej* [The Conservation Guidelines for the revalorization of the building of the former Main Warehouse 89A, the so-called The U-Boat Hall, on the site of the former Gdańsk Shipyard] [22] were elaborated. The aim of architectural and conservation research was to determine the actions and solutions necessary to restore the historical building (Fig. 5). The research was undertaken at the stage preceding the design development of the building for adaptation to cultural, commercial and residential functions. It was meant to point out any works that could cause damage to the historic structure and indicate the way to carry out the conservatory works to maximize the value of historic architecture. The study included: (1) a historical study of the facility, (2) a detailed architectural and conservation description with photographic documentation, (3) a program of conservation

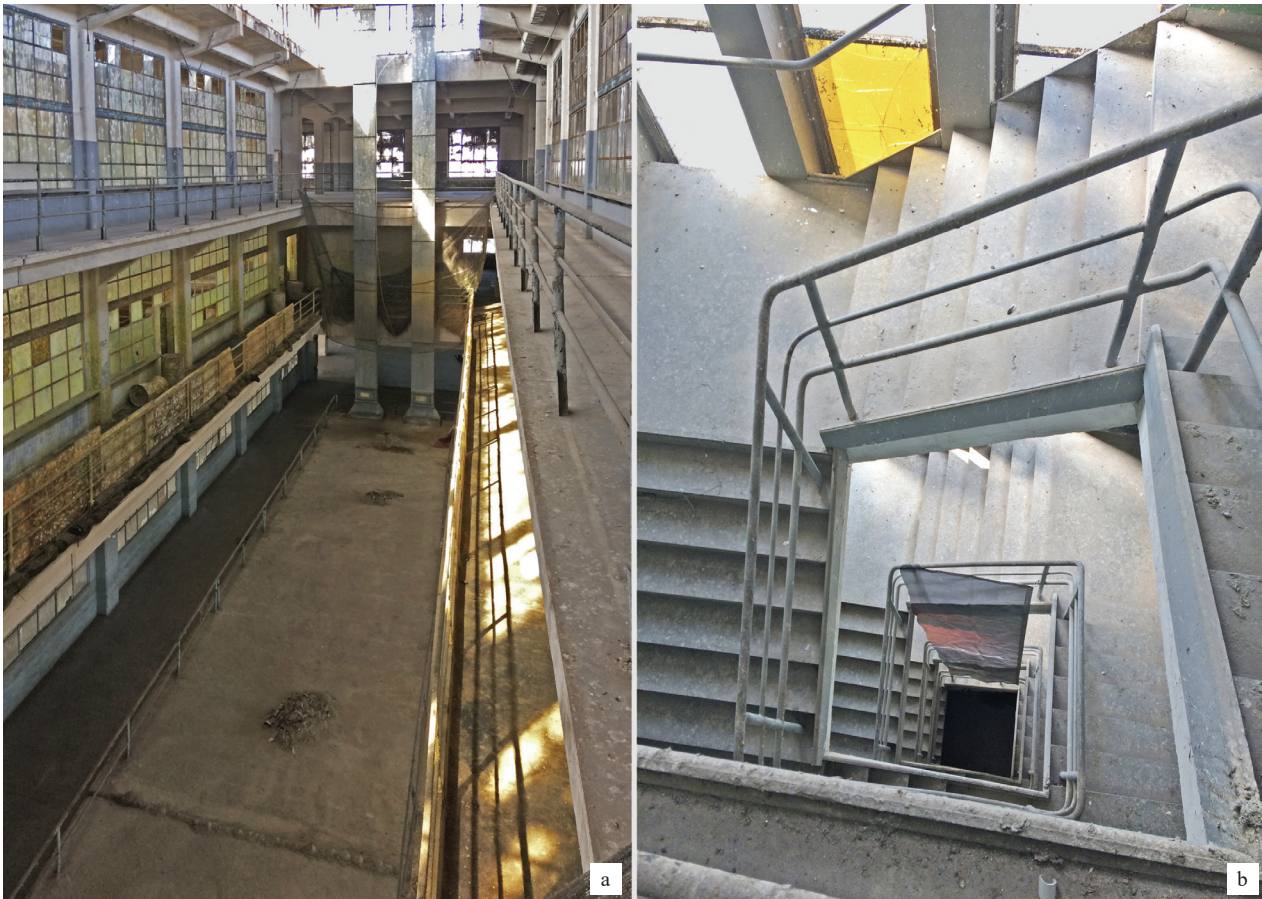
Fig. 6. Interiors of the Main Warehouse (89A), so-called the U-Boat Hall, 2019 (before the start of conservation works):  
 a) repetitive floor of the building (6<sup>th</sup> floor) – top view of one of the atriums,  
 b) the staircase – stairs in all three staircases – double L-shaped stairs, monolithic, reinforced concrete structure  
 (photo by A. Orchowska-Smolińska)

buildings, these analyzes are performed using methods that would apply to historically more complex buildings (Fig. 6). The reason is the assumption made for the entire complex that the primary phase is not overriding, and the adaptations, repairs, and maintenance are to be carried out with respect to all layers by 1989 or even 1996<sup>11</sup>. As a result of this assumption, not only a detailed analysis of bricks, joints, plasters, and artificial stone used for the façade decoration was carried out, but also such elements as metal gates, glazing of industrial window joinery, primary and subsequent colours of individual elements.
