Mechanical and Microstructural Characterization of TIG Welded Dissimilar Joints between 304L Austenitic Stainless Steel and Incoloy 800HT Nickel Alloy

Abstract: In this article, the mechanical properties and microstructure of 304L austenitic stainless steel/Incoloy 800HT nickel alloy dissimilar welded joints are investigated. The joints were made of 21.3 mm × 7.47 mm tubes using the TIG process with the use of S Ni 6082 nickel filler metal. No welding imperfections were found and high strength properties of joints were obtained, meeting the assumed acceptance criteria of the product's standards. The tensile strength of the welded joints was higher than for the joined materials (Incoloy 800HT). Macro- and microscopic metallographic tests revealed the correct morphology of the joints and the appropriate structures in their critical zones. However, differences were found in the morphologies of the zones between the weld and the base materials. In fusion boundary from the side of the Incoloy 800HT alloy, no clear outline of the fusion line was observed (type A fusion boundary), while increased grain size and an epitaxial structure were observed. In turn, in the zone: weld–304L steel,

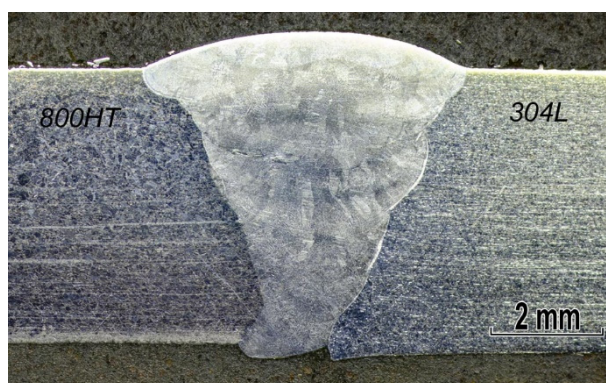
Figure 6. Cross-section of the Incoloy 800HT nickel alloy–304L austenitic stainless steel welded joint.

Figure 6 presents a macroscopic view of a cross-section of the obtained dissimilar welded joint. There were no welding imperfections in the specimen, i.e., no cracks or porosity. The joint was symmetrical and was characterized by complete penetration and a smooth transition of the face into the base material. On the fusion line in 304L steel, white bands can be seen, which were formed as a result of structural changes. Metallographic microscopic tests were performed for base materials, weld and in the transition areas: weld–Incoloy 800HT and weld–304L stainless steel. Figure 7 shows the structure of base materials: Incoloy 800HT and 304L austenitic stainless steel. Incoloy 800HT is a solid solution with a full austenitic structure, many twins (Figure 7a) and Ti(N,C) precipitates (Figure 7b, indicated by an arrow). No changes were found relative to the typical structure of the material; 304L stainless steel has an austenitic structure (Figure 7c) with characteristic twins, slip bands and δ ferrite precipitates (Figure 7d). The structure of the tested 304L steel is correct. No structural anomalies caused by the manufacturing process, e.g., inadequate solution annealing, were identified for either material. Figure 8 shows the structure of the middle part of the weld. The weld has an equiaxed, fully austenitic structure with coarse and fine dendrites. Eutectics and microcracks were not detected in the weld.
