**H. Smoleńska<sup>1</sup>, W. Kończewicz<sup>2</sup>**

## **MICROSTRUCTURE AND PROPERTIES OF THE COBALT BASE CLAD LAYERS AFTER LONG TIME SERVICE**

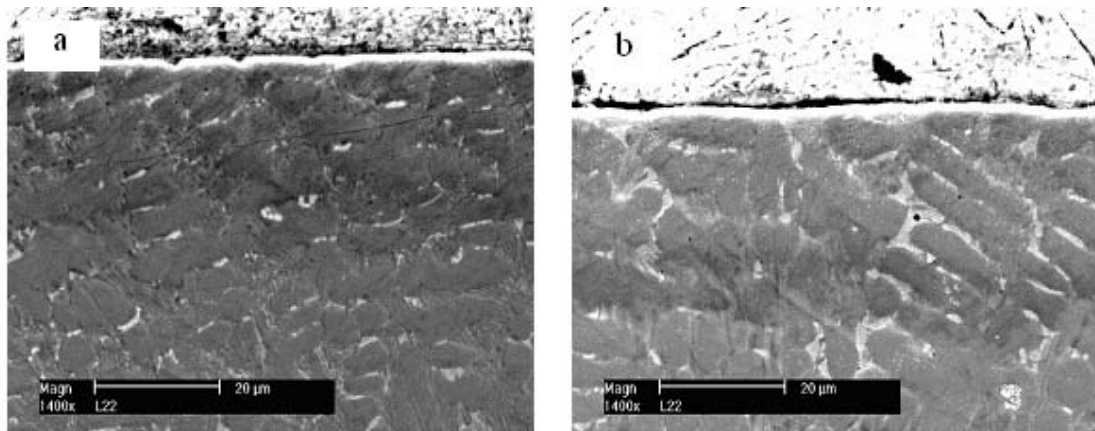
**Fig. 5.** SEM of the cross-section of the clad; valve head from L22 engine; a- region where the small pits were observed; b- typical structure for the most of the faces

On the cross section of the clad layers general visible changes in microstructure were not found (Fig. 5). On the surface some small pits were observed (Fig. 5a) but in the great deal the surface was smooth (Fig. 5b).

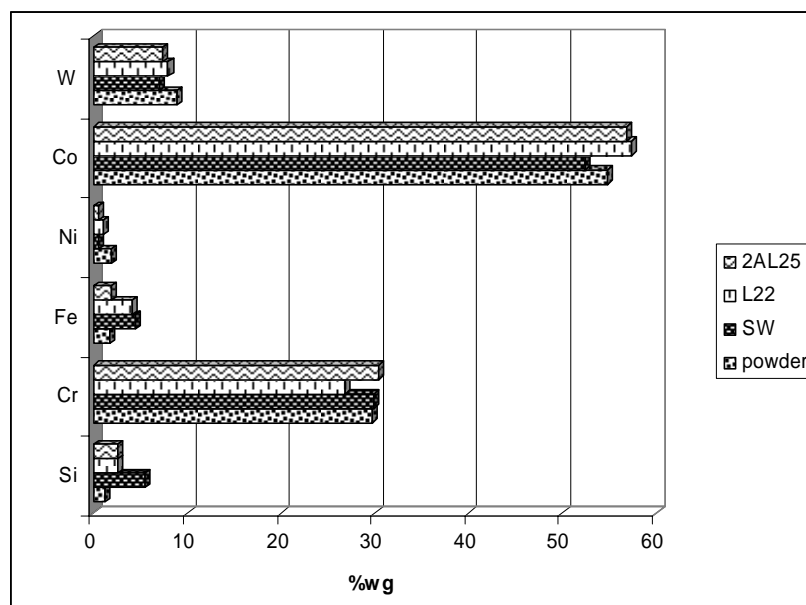
**Fig. 6.** Chemical composition of the powder and composition of the surface region for: SW – as clad state, L22 – surface region of the face from L22 engine, 2AL25 - surface region of the face from 2AL25 engine

The chemical analysis EDS in the micro region on different part of the clad layer allowed establish the trends of chemical changes. Fig. 6 presented result of chemical analysis on the cross section of the clad layers, close to the surface for faces from the both engines after service in comparison to clad state and powder composition

The small changes in the composition corroborated earlier metallographical results about not significant structural changes. Different service conditions resulted with differences in diffusion of some elements. Lower amount of chromium for L22 engine indicated more intensive oxidation and building a chromia scale. For less demand condition the “use” of chromium was less intensive.
