1
2 **1 Modernized cathodic protection system for legs of the production rig –**
3
4 **2**
5 **3 evaluation during ten years of service.**

33
34
35 15 The modernization of cathodic protection system of the Baltic Beta platform legs is described.
36
37 16 It was that the sacrificial anodes cone-shaped groups were to be placed on the seabed at a
38
39 17 depth of 80 meters. The measurements results of cathodic protection effectiveness during its
40
41 18 ten-years operation are presented. The effectiveness was assessed based on the potential value
42
43 19 along the entire length of the legs from the sea surface to the seabed. The gained experience
44
45 20 indicates that use of sacrificial anode systems mounted on the seabed can be an effective form
46
47 21 of cathodic protection of offshore platforms legs. It is basically the only means of
48
49 22 anticorrosion protection in case of a platform not able to leave its location for renovation
50
51 23 works in a shipyard.
52
53
54
55
56
57 24

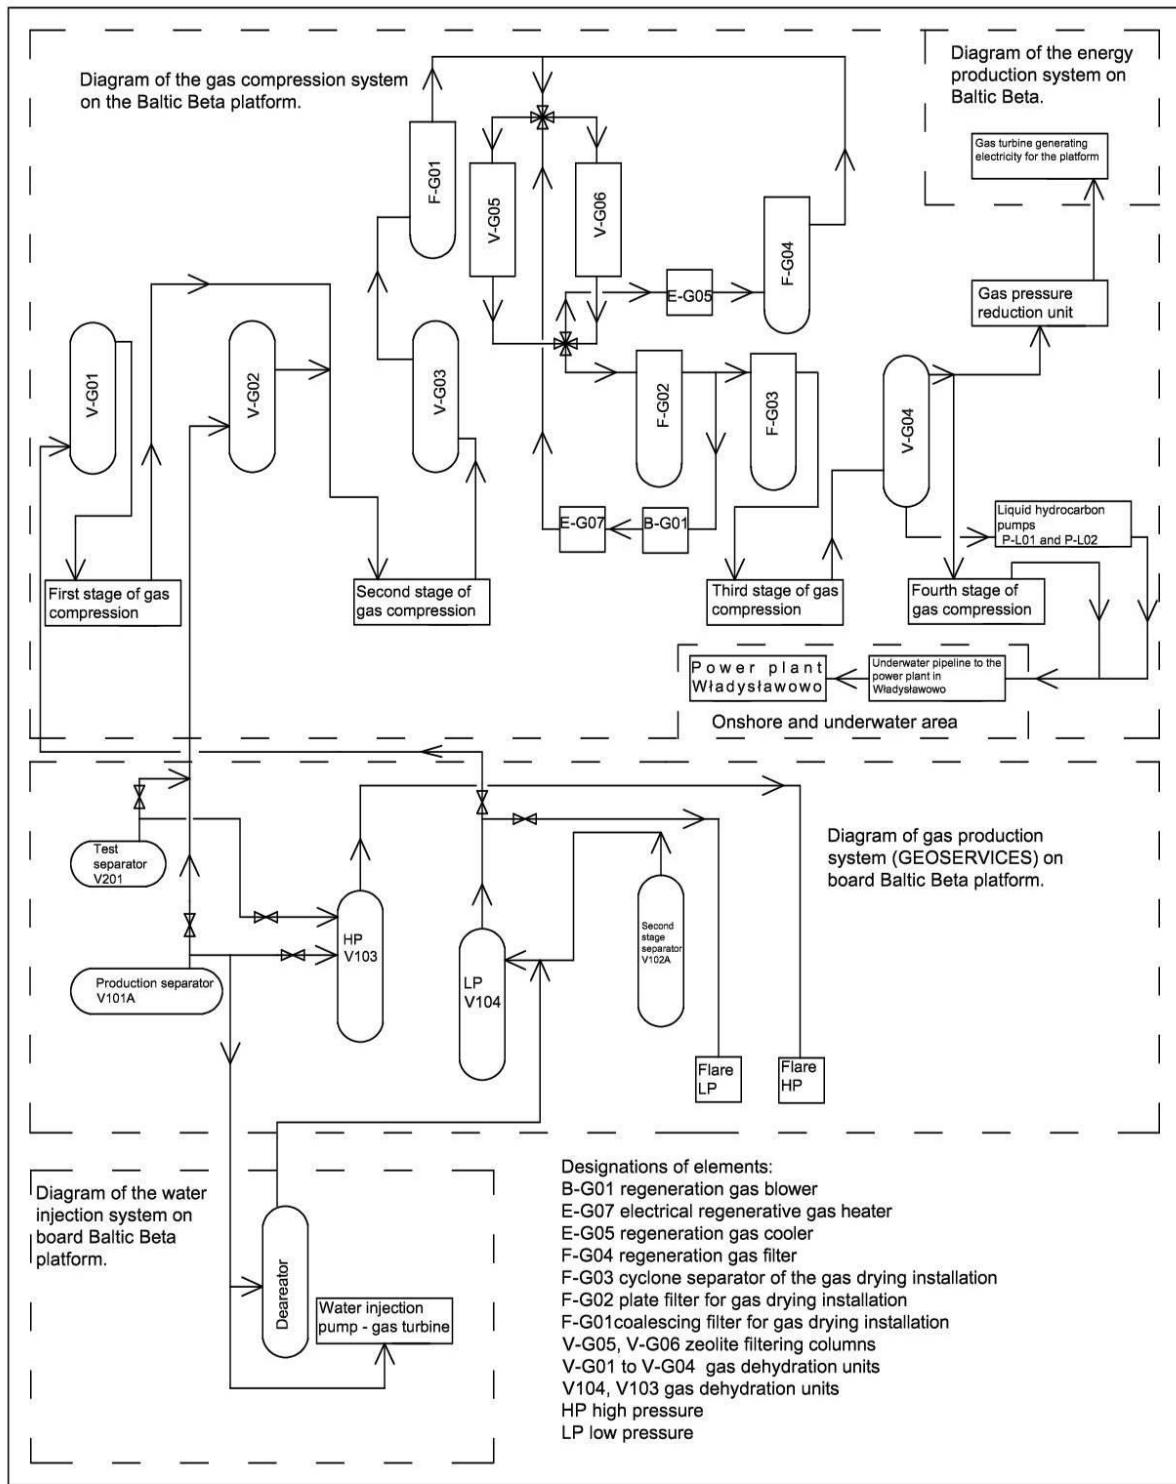
92 The block diagram of the gas processing systems on board Baltic Beta is shown in Fig.
93 1. The natural gas separated from the crude oil is used on board Baltic Beta in three basic
94 processes. The first and most important is the electrical energy production process which
95 powers the rig itself. This is achieved by a gas turbine driving an electrical generator which
96 covers all of the rig power demand. This system is shown in Fig. 2 with field number five-
97 B2G8. The second process is related with the injection of sea water. In this process a second
98 gas turbine is used to drive a centrifugal pump, which injects specially prepared sea water to
99 the oil reservoir in order to sustain the oil pressure at a constant level, this system is called
100 BHPS. The third process uses all of the gas which was not used in the first two processes

Fig. 1. Block diagram of the gas processing systems on board Baltic Beta.

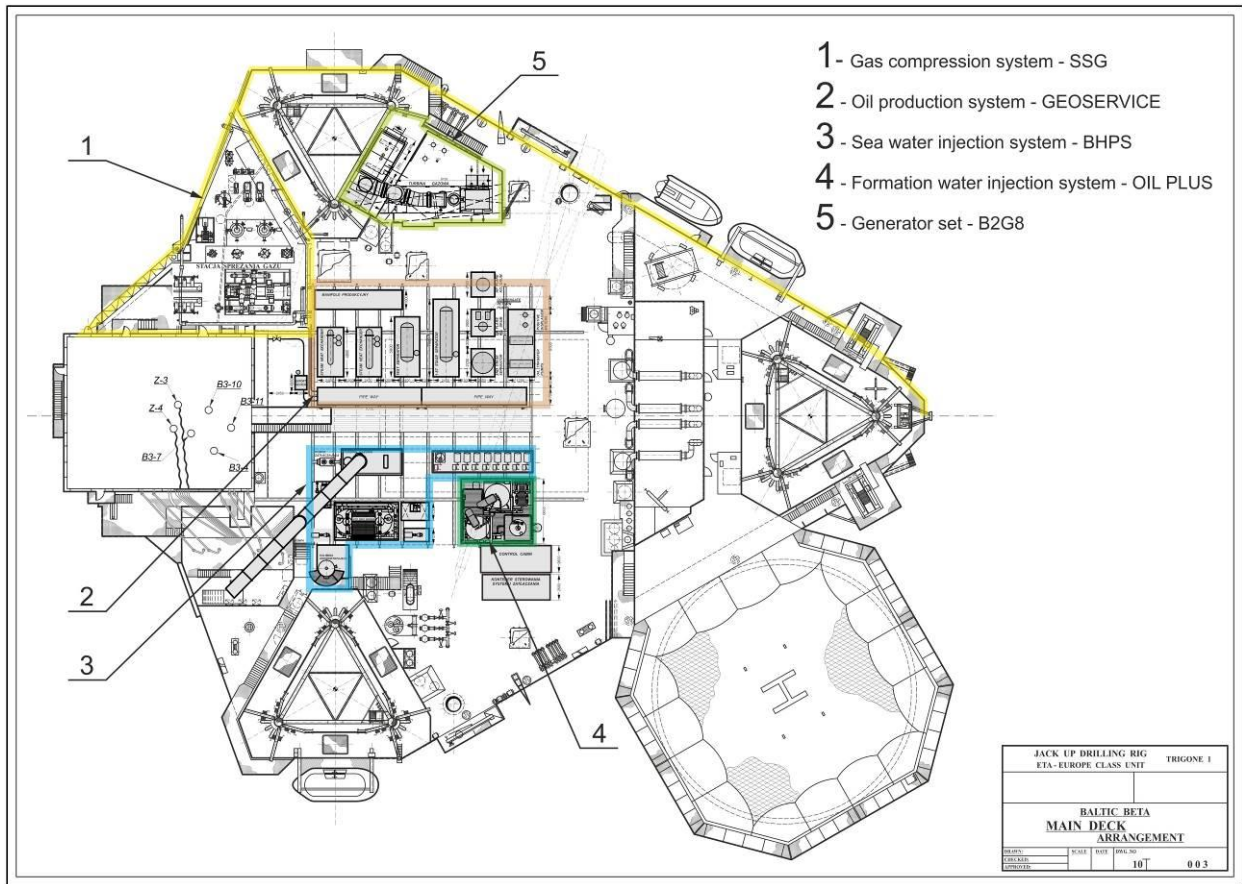
101 mentioned above. This remaining gas is dried, filtered and compressed in a four stage
 102 electrically driven piston gas compressor. All component of this system are located on the
 103 stern of Baltic Beta and are shown in Fig. 2 with field number one- SSG.

Fig. 2. Main deck arrangement of Baltic Beta with the indication of all five main systems.

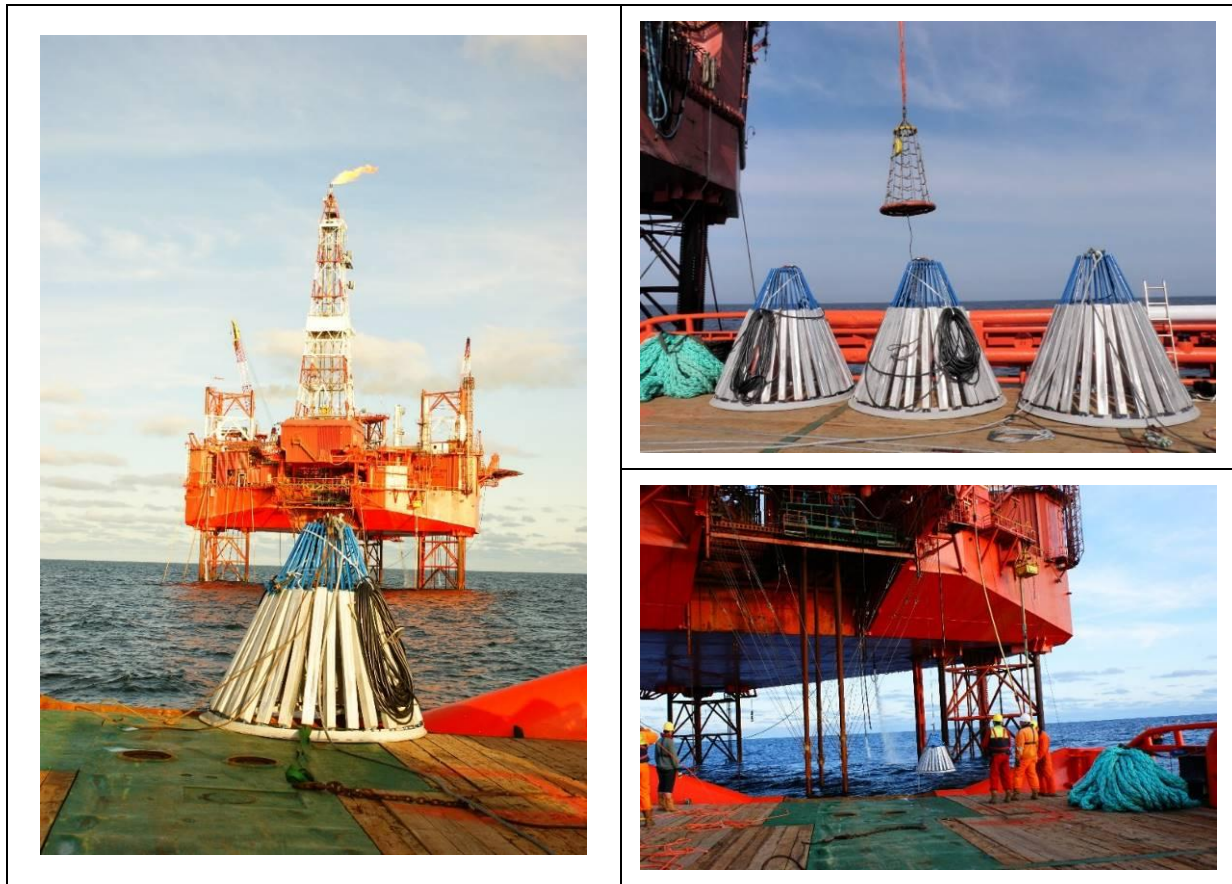
31 162 Works related to mounting and connecting the anode groups were implemented in
32
33 163 September 2009. The task of placing the anode groups on the seabed required a cooperation
34
35 164 of tugboats, rig cranes and divers. The total time for assembly of the anode groups as well as
36
37 165 start-up of the installation was about one week. Photographs taken during the works in 2009
38
39 166 are included herein as Photos 1–3.
40
41
42
43
44
45
46
47
48
49
50
51

Photos 1–3. *The anode groups system installed during the modernization of cathodic protection system of the Baltic Beta sea platform.*

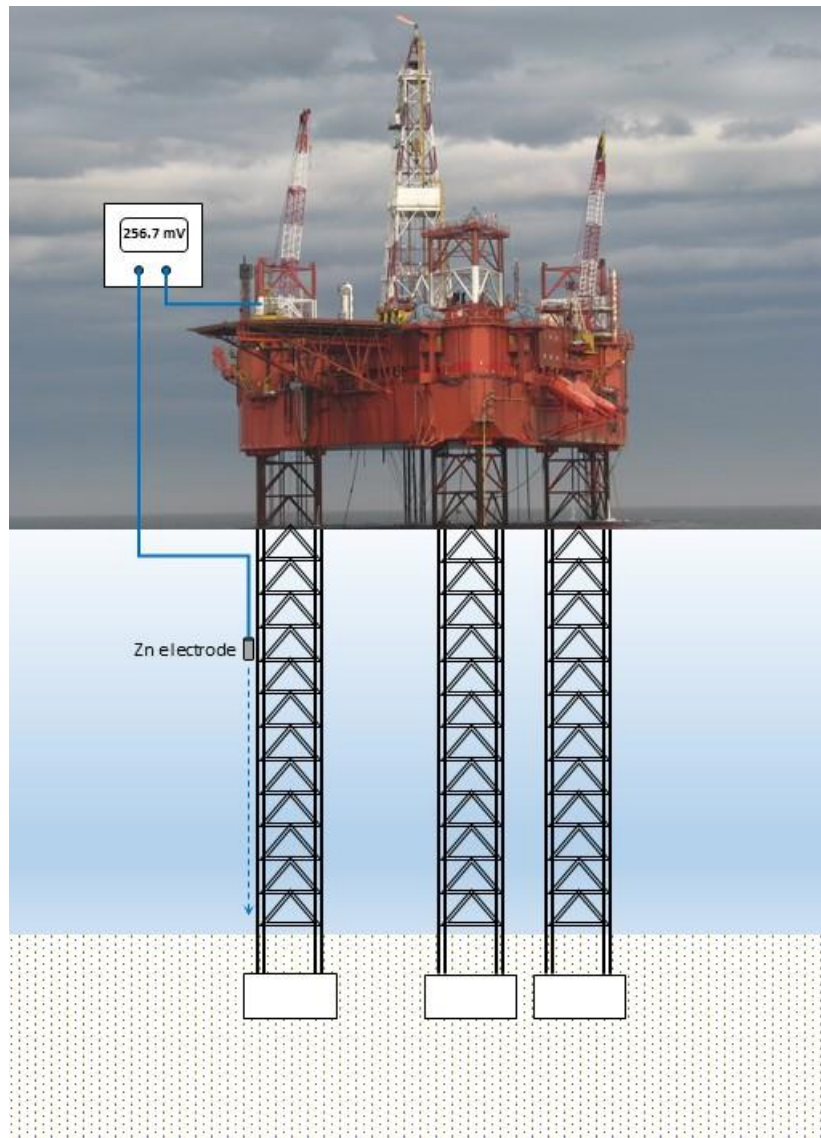
Following modernization of the cathodic protection system, its effectiveness was assessed periodically based on measurements of the platform legs potential (Zakowski, 2011). The measurements were conducted in a way allowing to obtain the potential profiles of each leg over its entire height. The potentials were measured versus the zinc/seawater reference electrode, which was lowered on a measuring line along the entire length of the leg from the

181 sea surface to the seabed, as schematically shown in Figure 3. The results were recorded with
1
2
3
4
5
6
7
8
9
10
11
12
13
14
15
16
17
18
19
20
21
22
23
24
25
26
27
28
29
30
31
32
33
34
35
36
37
38
39
40
41
42
43
44
45
46
47
48
49
50
51
52
53
54
55
56
57
58
59
60
61
62
63
64
65
66
67
68
69
70
71
72
73
74
75
76
77
78
79
80
81
82
83
84
85
86
87
88
89
90
91
92
93
94
95
96
97
98
99
100
101
102
103
104
105
106
107
108
109
110
111
112
113
114
115
116
117
118
119
120
121
122
123
124
125
126
127
128
129
130
131
132
133
134
135
136
137
138
139
140
141
142
143
144
145
146
147
148
149
150
151
152
153
154
155
156
157
158
159
160
161
162
163
164
165
166
167
168
169
170
171
172
173
174
175
176
177
178
179
180
181
182
183
184
185
186
187
188
189
190
191
192
193
194
195
196
197
198
199
200
201
202
203
204
205
206
207
208
209
210
211
212
213
214
215
216
217
218
219
220
221
222
223
224
225
226
227
228
229
230
231
232
233
234
235
236
237
238
239
240
241
242
243
244
245
246
247
248
249
250
251
252
253
254
255
256
257
258
259
260
261
262
263
264
265
266
267
268
269
270
271
272
273
274
275
276
277
278
279
280
281
282
283
284
285
286
287
288
289
290
291
292
293
294
295
296
297
298
299
300
301
302
303
304

Fig. 3. A way to measure the potential profile of the platform leg.

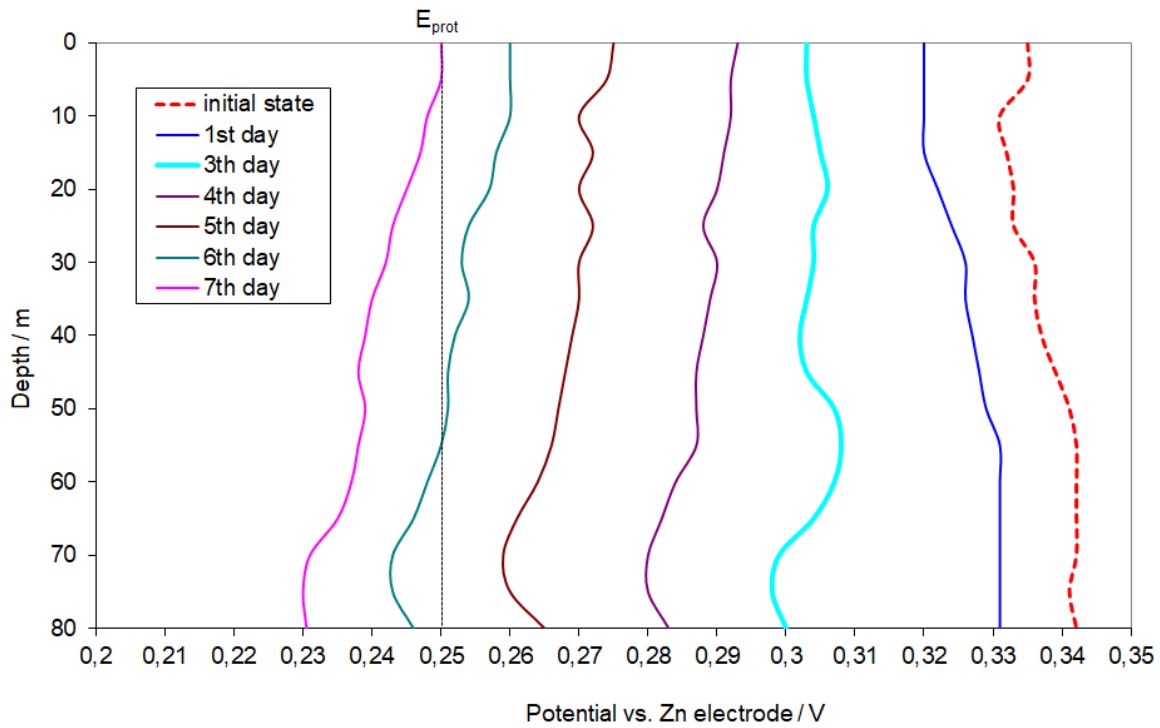
The potential profiles of the leg on the bow of the rig, measured during the assembly of subsequent anode systems in 2009 are shown in Fig. 4. Before assembling the anode groups, the average value of the potential along the entire length of the leg was approximately 0.34 V versus Zn reference electrode (initial state – red dashed line in Fig. 4). A gradual increase in the size of cathodic polarization (i.e. gradual decreasing the value of the potential) on the subsequent days can be observed, which is associated with assembly of each new anode group. The potential change in relation to the potential from before assembly of the systems (the initial state) was about 100 mV in the lower leg, and about 80 mV in the upper part – see pink line in Fig. 4 (7th day). The potential of the lower part of the leg was 0.23 V and potential of the upper part of the leg was 0.25 V. The lower cathodic polarity of the upper part results from the greater distance from the anode group. It is visible in Fig. 4 that polarization to the protective potential, i.e. below 0.25 V, occurred along the entire length of the leg. So, the effect of effective corrosion protection was obtained.

227
228 **Fig. 4.** An example of the potential profile of the platform leg during assembly and start-up of
229 the installation.

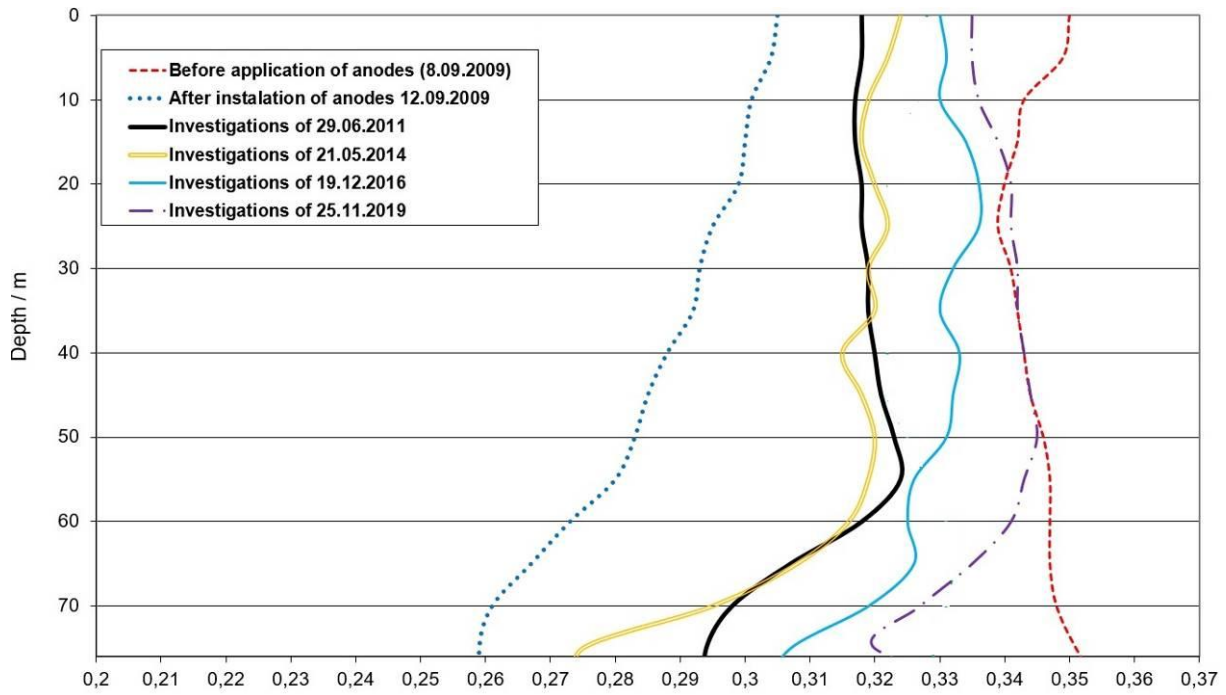
236
237 **Fig. 5.** Potential profiles of the leg located on the left side of the stern, obtained during ten-
238 year operation of the cathodic protection system.

243 In both figures the red dotted line shows the potential distribution over the entire
1
2 244 length of the legs in 2009 before applying new anodes. You can see that old, worn anodes
3
4 245 welded to the legs (in accordance with the original protection scheme developed for the
5
6
7 246 structure) did not provide enough current to polarize the legs to the potential of full cathodic
8
9
10 247 protection. The value of the potential over the entire length of the leg located on the left side
11
12 248 of the stern was in the range 0.34 - 0.35 V (see Fig. 5), and potential of the leg located on the
13
14 249 right side of the stern was 0.32 - 0.33 V versus Zn electrode (see Fig. 6).

16
17 250 After installation of a new anode systems in 2009, the potential of the left leg
18
19 251 decreased to 0.26 V at the bottom, and up to 0.3 V at the sea surface (blue dotted line in Fig.
20
21
22 252 5). The potential of the right leg was 0.24 V and 0.26 V, respectively (see Fig. 6).

23
24 253 In next years, there was a gradual deterioration in the cathodic polarization of the legs,
25
26 254 which progressed with dissolution of the anode material and degradation of the protective
27
28
29 255 coating over the years. At present, in November 2019, the system causes polarity of the left
30
31 256 stern leg to the potential approx. 0.32 V at the seabed, 0.34 V at a depth of 40 m, and 0.33 V
32
33
34 257 at the sea surface (see Fig. 5). For the right stern leg: 0.26 V by the seabed, 0.31 V at a depth
35
36 258 of 40 m, and 0.34 V at the sea surface (see Fig. 6). Thus, an effect of partial cathodic
37
38
39 259 protection of the legs is now obtained.

40
41 260 At the seabed, the potential of the leg located on the left side of the stern is more
42
43 261 negative (0.32 V – Fig. 5 investigation in November 2019) than the leg on the right side of the
44
45
46 262 stern (0.26 V – Fig. 6). This is due to the presence of bare, non-insulated steel casing pipes for
47
48
49 263 the oil and gas extraction system (risers). These pipes capture the cathodic protection current
50
51 264 flowing from the sacrificial anodes, which results in less current flowing to the platform legs.
265 The result is less cathodic polarization, so the potential is more positive.

305 Dissolution of sacrificial anodes means that a periodic assembly of new anodes is
306 necessary. The more degraded the protective coating gets over time, the higher the demand
307 for cathodic protection current, which further accelerates wear of the anode material. The
308 sacrificial anode groups installed on the seabed, anticipated for 10 years of operation, have
309 worn out. Therefore, currently work is underway on the next same renewal of the cathodic
310 protection system of the Baltic Beta platform legs. On the basis of experience presented in
311 this publication, it is planned also to use additional anodes welded to the legs at a depth of 0-
312 10 meters. They will provide a better cathodic polarization effect of the upper part of the legs
313 to ensure polarization to the full cathodic protection potential.

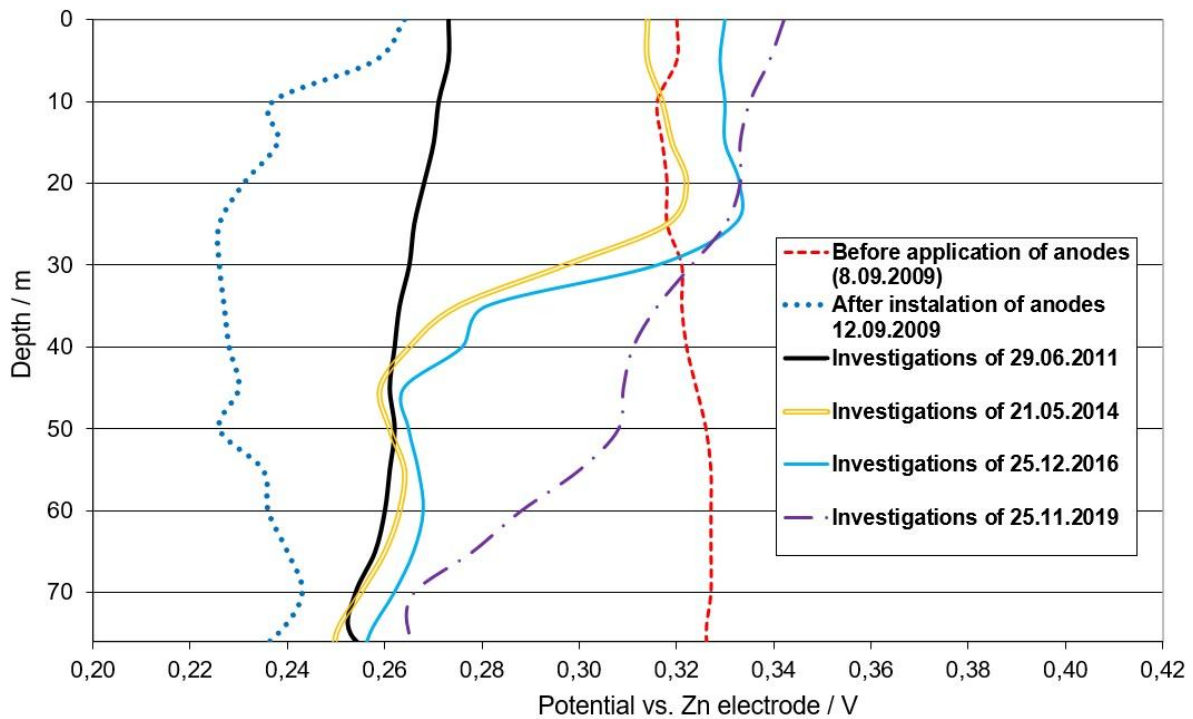
240
241 **Fig. 6.** Potential profiles of the leg located on the right side of the stern, obtained during ten-
242 year operation of the cathodic protection system.

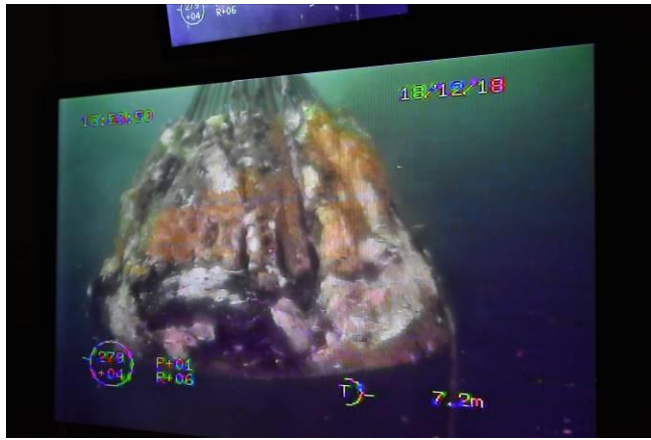
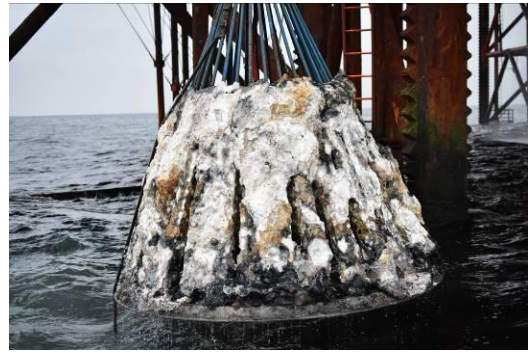
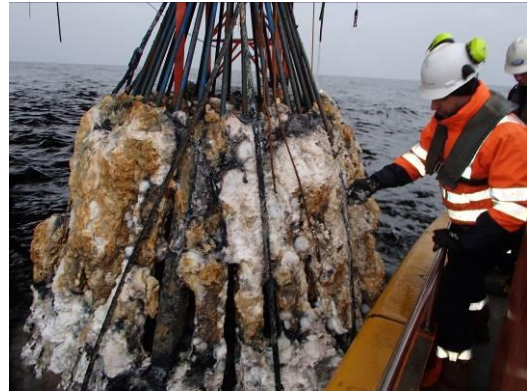
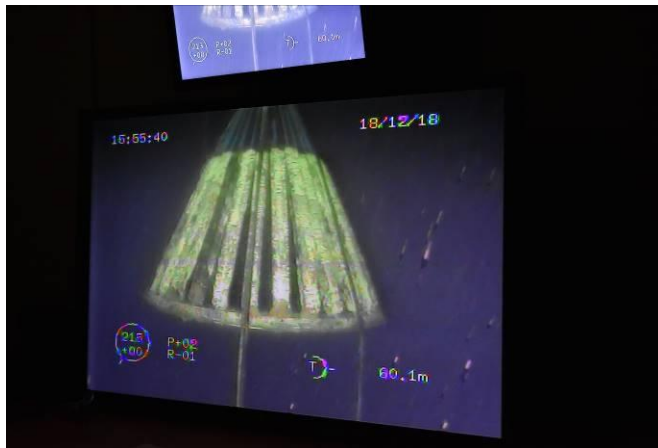
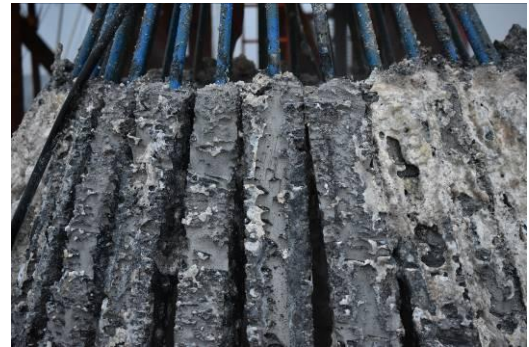
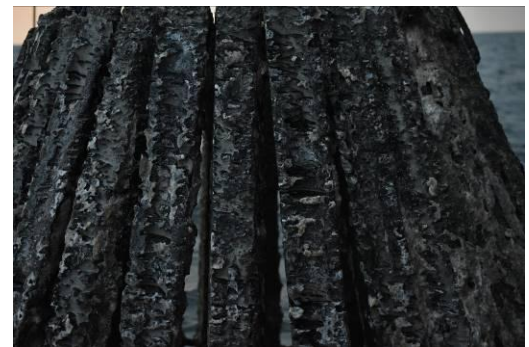
266
267 **Photos 4–9.** One of the cone-shaped anodes basket during a cleaning procedure carried out
268 at sea. The upper three photos show the cone before hydro-cleaning, and the lower three
269 photos show the cone after is cleaned.

270 Every time during potential measurements a close visual inspection of the anode
271 groups (cones) is carried out. These inspections indicated that all cones are working properly,
272 this is due to the fact that some products of aluminium alloy dissolution are overgrowing the
273 surface of the anodes. Such deposits can reduce the flow of protection current from the
274 anodes, this phenomenon is unwanted when it comes to corrosion protection. In order to
275 obtain the original operating parameters of the anodes, it is necessary to clean them of the
276 anode dissolution products. Due to their design, anode cones can be lifted and moved from the
277 seabed, this property has been useful several times before during their lifetime. This ability is
278 very useful and practical for any this type of objects when it comes to operating a platform at
279 sea. In 2018, a decision was made to recover the anodes cones for a cleaning operation.

280 Photos 4-9 show one of the cone during the cleaning process. Removing the overgrown
281 dissolution products was carried out by hydro-cleaning, all of the loose material was rinsed
282 off so that only the hard, unreacted protective alloy remained on the anodes. Information
283 gathered during each previous visual inspection, gave concerns about the amount of alloy left
284 on the anodes. After the cleaning process was finished it was clear that the amount of
285 protective alloy remaining on the anodes is about 50% of the original volume. After the
286 cleaning operation was completed, all of the cones were returned to their previous location on
287 the seabed.
