MONITORING SYSTEM OF THE ROAD EMBANKMENT

Abstract. The paper presents the analysis of the monitoring system of the embankment supported on concrete columns and overlaid by a load transfer platform with the embedded steel grid. This field investigation was to study the complex interaction between the columns, the load transfer platform layer, and steel grid via in situ measurements during erection and live loading of the embankment. The study was focused on the behaviour of steel grid and the behaviour of the outer rows of columns since there are limited reference data available for this problem. The system was designed to inform the engineers about the condition of the embankment at every stage of construction and during standard operation of the road. The measurements brought the information on strain variations of steel grid, concrete columns, and structural settlement and provided necessary evidence for the embankment numerical model validation.

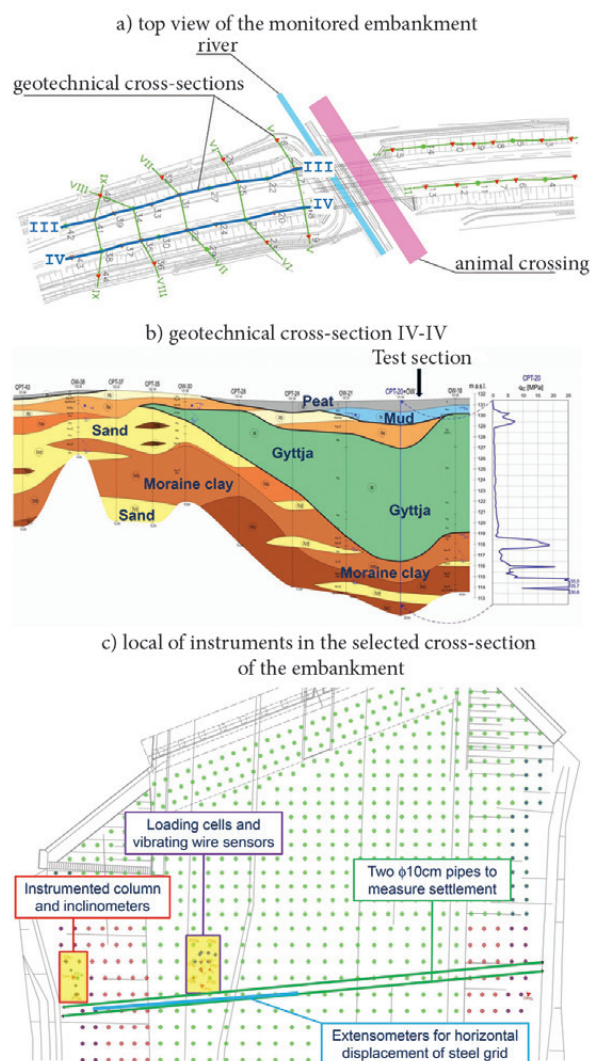
Fig. 1. Location of the monitored embankment

The monitored embankment is located next to the bridge (Fig. 1a). It is supported on CSC columns constructed by Keller Polska Sp. z o.o. moreover, overlaid by an LTP layer with an embedded steel grid (Fig. 2). The subsoil condition near the bridge is unfavourable: over 15 meters of mud, peat and gytja over moraine clay and fine sand. The structure of the embankment is the foundation on CSC columns diameter 360 mm with spacing changing from 1.4×1.9 m to 1.6×2.2 m. At the place of the most unfavourable soil conditions, the thickness of organic soil is about 13 m (according to Cone Penetration Test (CPT) 20, Fig. 1b). At that location, the spacing of columns changes from 1.9×1.9 m in the centre to 1.9×1.5 m near the fill slopes. The columns are built of concrete C16/20. Two rows of outer columns are reinforced of UBs 160 (S355/JR steel), the LTP layer is 0.5 m thick, the steel grid is made of S355 steel with the rigidity of 157 MN in the across road direction and 121 MN in the long road direction. The design was based on ASIRI National Project (Simon 2013).

The monitoring program includes the following measurement components (Fig. 1b, Figs 2–3):

The location of various components of the monitoring system is shown in Fig. 1c.

Numerical analysis was conducted with the use of Finite Element Method. The FEM model of the cross-section with organic soil thickness of 13 m (according to CPT 20) (Fig. 1b) was created. The soil was modelled by elasto-plastic material (CM); the linearly elastic material was adopted for reinforced columns. The equivalent live load equal 25kPa was assumed for the problem. Selected simulation results are shown in Fig. 9. The maximum total settlement achieved 9.9 cm, its part; equal to 3.9 cm came from deadweight, the rest 6.0 cm was produced by the live load.

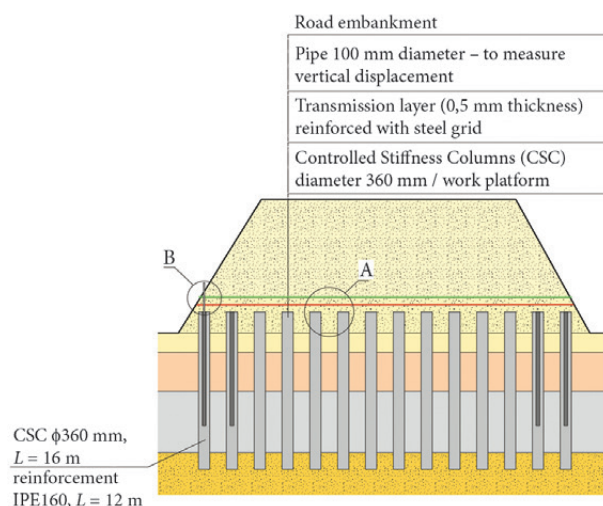
Fig. 2. Measurement scheme on cross-section of the embankment (detail A – Fig. 3a, detail B – Fig. 3b)

- forces in outer CSC column – 12 strain gages welded to steel beam IPE160 (4 sensors at three levels);
- distribution of vertical stresses on the columns and subsoil – load cell sensors mounted on the columns heads (2 sensors) and the subsoil (4 sensors);

- forces in the steel grid and horizontal displacements of steel grid – 14 strain gauges and four long base extensometers mounted to the steel grid;
- settlement of the embankment – measurements in one cross-section of the embankment, in two PVC pipes using “hydrostatic leveller”;

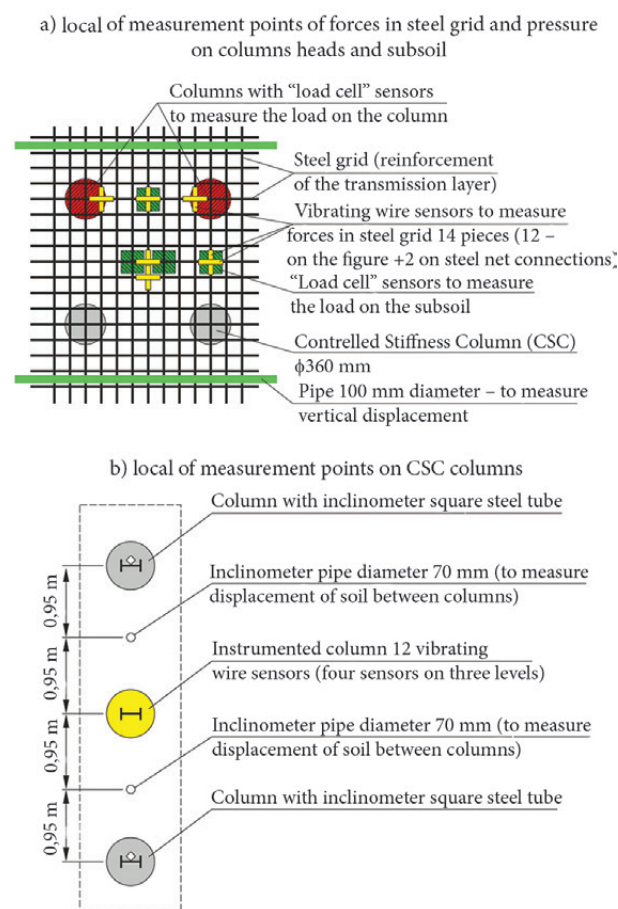
Fig. 3. Measurement details

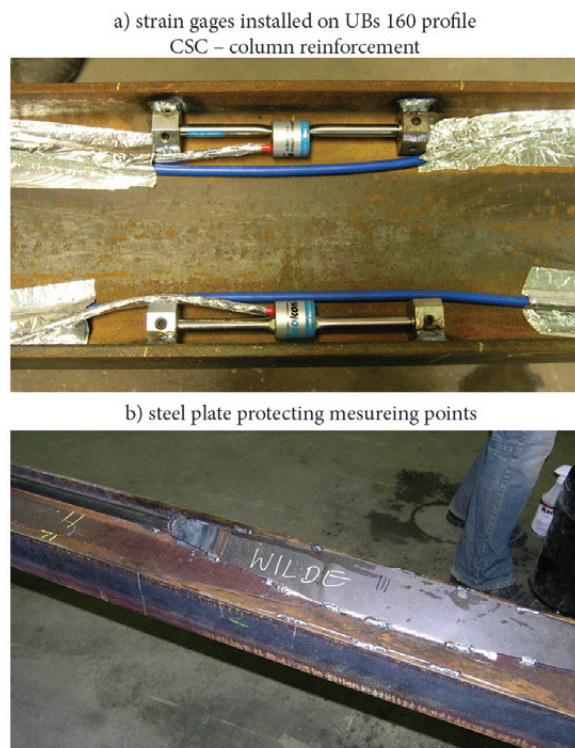
Fig. 4. Measurement points located on columns reinforcement

Force identification in CSC columns was possible based on strain measurements. The vibrating wire sensors with the base 150 mm were applied (Fig. 4a). The sensor range is $3000\mu\epsilon$, resolution $1\mu\epsilon$, accuracy $\pm 0.5\%$ F.S. and nonlinearity $< 0.5\%$ F.S. These sensors work in the temperature range from -20°C to $+80^\circ\text{C}$. The sensors consist of a steel wire tensioned between two mounting blocks arc welded to the steel surface. The sensors detected excellent stability over an extended period. The essential task was to protect the vibrating wire sensors and cables against possible damage during installation in the CSC column. That was why preliminary tests and calibration procedures were done in the workshop a few weeks before installation on a construction site. After the installation, steel plates (Fig. 4b) protected the sensors.

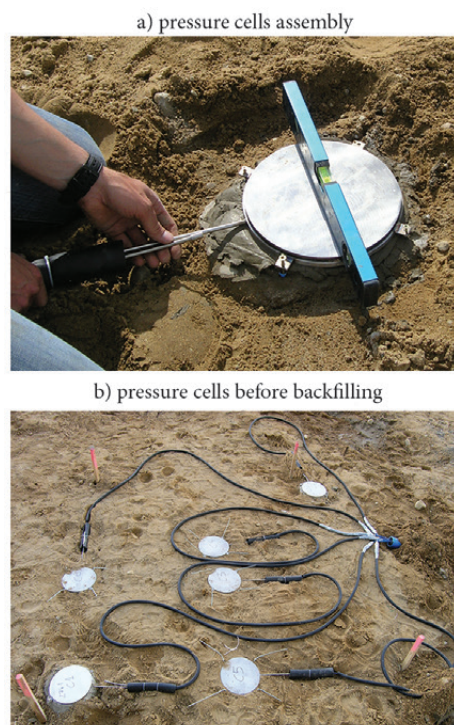
Fig. 5. Vibrating wire load cells measurement points

Vertical stresses acting on the column heads and the subsoil were measured using vibrating wire earth pressure cells with diameter 230 mm (Fig. 5b). These cells with ranges 5MPa (on columns heads) and 70 kPa (on subsoil)

showed resolution of 0.025% F.S., and accuracy $\pm 0.1\%$ F.S. They work in the temperature range from $-20\text{ }^{\circ}\text{C}$ to $+80\text{ }^{\circ}\text{C}$. The applied cells (Fig. 5a) were made of two circular stainless steel plates welded together around their periphery and spaced apart by a narrow cavity filled with de-aired oil. The change of earth pressure squeezed the two plates together causing a corresponding increase in fluid pressure inside the cell. A vibrating wire pressure transducer converted this pressure into an electrical signal, next transmitted to the readout location. The site of the applied cells is presented in Fig. 5b. The stresses acting on the ground were measured at the centre between four adjacent CSC columns and among “side” CSC columns. The cells placed on the columns were levelled and screwed (Fig. 5a). Pressure cells on the ground were placed directly on a compacted soil among the columns, fixed in positions with pins and backfilled.

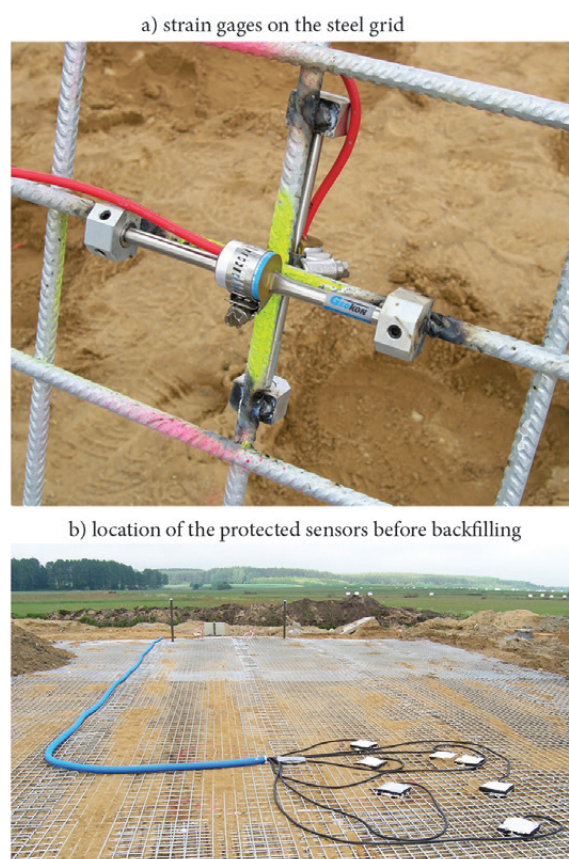
Fig. 6. Measured points on steel grid

Short base vibrating wire sensors were welded to the steel grid (Fig. 6a). The works were conducted after backfilling the first part of the LTP layer (Fig. 6b). The instrumented steel grid was laid down on the compacted fill. Afterward, the vibrating wire sensors were covered with waterproof boxes to protect them from external influences. The sensor shields were constructed using plastic boxes, sealed with micro-rubber and silicone seal. While all the sensors were installed, the control measurements showed each of them operationally; the readings were within the desired range.

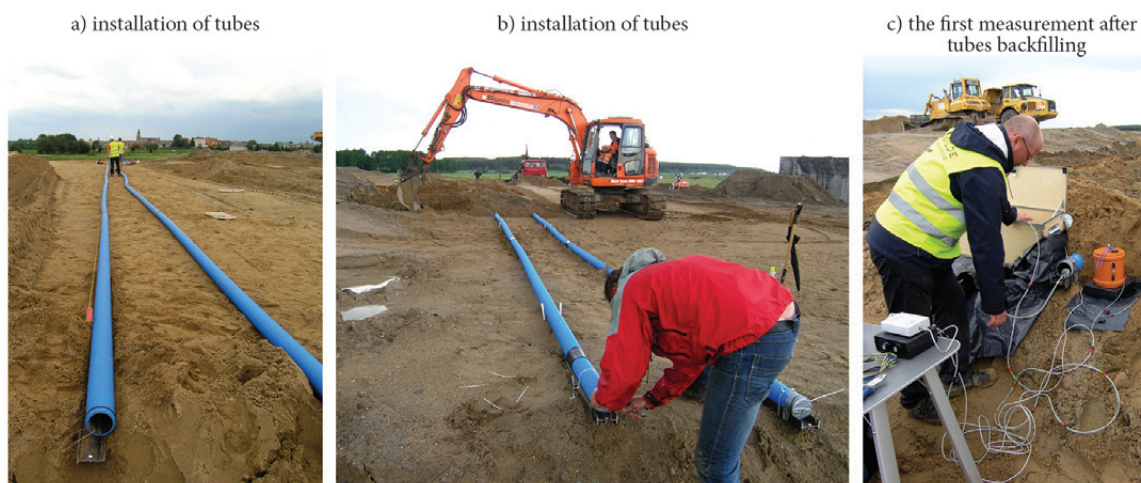
Fig. 8. Embankment settlement measurement by hydrostatic levelling

Two horizontal tubes were initially installed (Fig. 8a–b). First, it was planned to install one tube beneath the transmission layer and the second one above this layer. However, because the monitoring system was a prototype, it was decided to double the measurements conducted at the top of the transmission layer. Both tubes of 10 cm diameter were made of PVC, corrugated outside and smooth

inside. At both ends of each tube, steel H-beams of 1 m length were attached (Fig. 8a). The steel beams allowed to stabilize the tubes and were used for installation of the reference pins required to make geodetic measurements.

The settlement at the LPT level was measured using a high-precision differential pressure transducer (Fig. 8c). The device consists of a probe, inserted into the tube and pulling the tube using a rope. Inside the probe, there is a sensor with a membrane recording small pressure changes

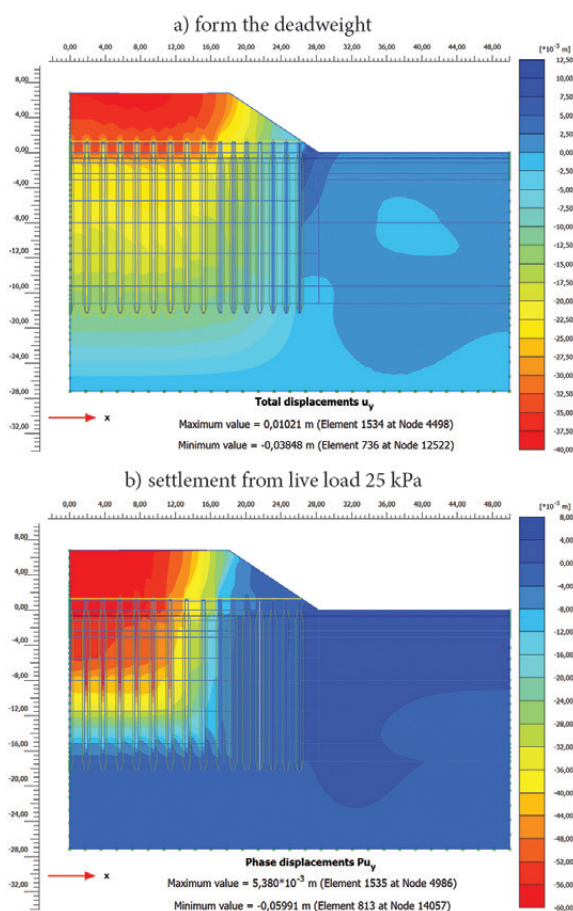
Fig. 9. Simulations of embankment settlement

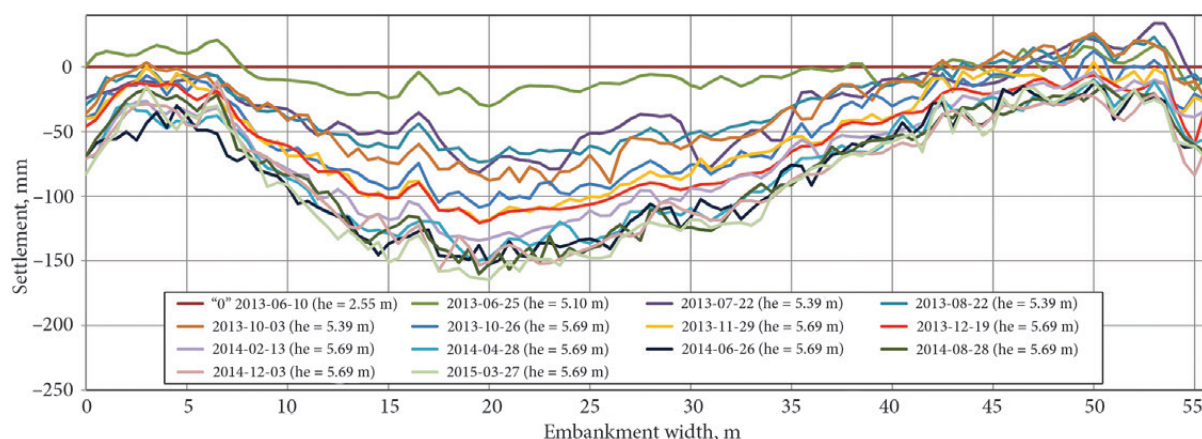
Fig. 10. Embankment settlement during construction (he – height of embankment)

Structural displacements obtained by the observational method are shown in Fig. 10. The measurements corresponding to the above numerical results are plotted by the red line, corresponding to the day of launching the road S-61 to public transport (December 19, 2013). At that time, the maximum displacement reached 12 cm, more than the displacement obtained by numerical analysis. The measured displacement profile (Fig. 10) is unsymmetrical along the road cross-section indicating that the soil parameters are irregular. The settlement process finally stabilized around one year after completion of the embankment construction. The maximum value of settlement during the observation period is about 150 mm.

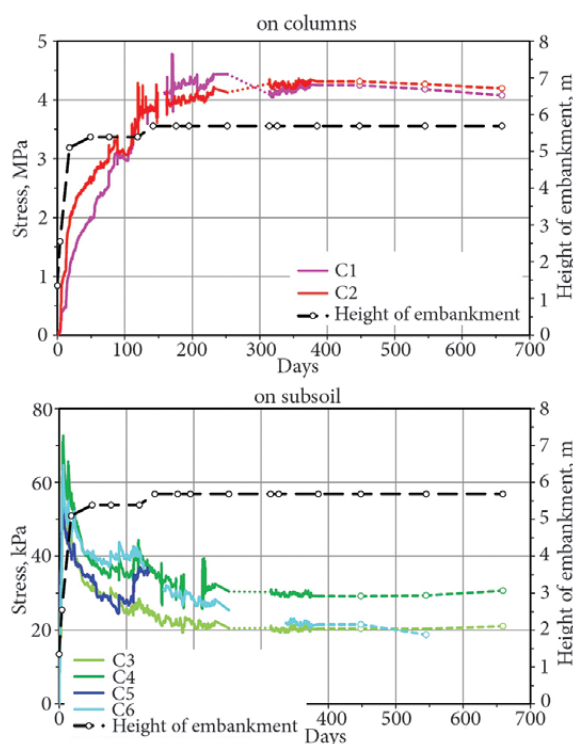
Fig. 11. Measured stresses

Figure 11 presents the measurement results of compressive stress on column and subsoil. Within about 2 years of observation, the average pressure values per one column reached 4.2 MPa, the average pressure values on subsoil were 26 kPa. The column pressure detected numerically was 4.8 MPa. The numerical results approximate the experimental ones well. It can be stated that the real behaviour of the embankment met the designer expectations (Sondermann, Topolnicki 2014). However, the interpretation of other measurement data is relatively complex. It requires extensive numerical simulations updated on data gained from the monitoring system. In the design procedures and embankment condition evaluation during operation only primary numerical parametric study was conducted, a further study aiming at the solution for the inverse problem is planned too.
