MONITORING SYSTEM OF THE ROAD EMBANKMENT

Abstract. The paper presents the analysis of the monitoring system of the embankment supported on concrete columns and overlaid by a load transfer platform with the embedded steel grid. This field investigation was to study the complex interaction between the columns, the load transfer platform layer, and steel grid via in situ measurements during erection and live loading of the embankment. The study was focused on the behaviour of steel grid and the behaviour of the outer rows of columns since there are limited reference data available for this problem. The system was designed to inform the engineers about the condition of the embankment at every stage of construction and during standard operation of the road. The measurements brought the information on strain variations of steel grid, concrete columns, and structural settlement and provided necessary evidence for the embankment numerical model validation.

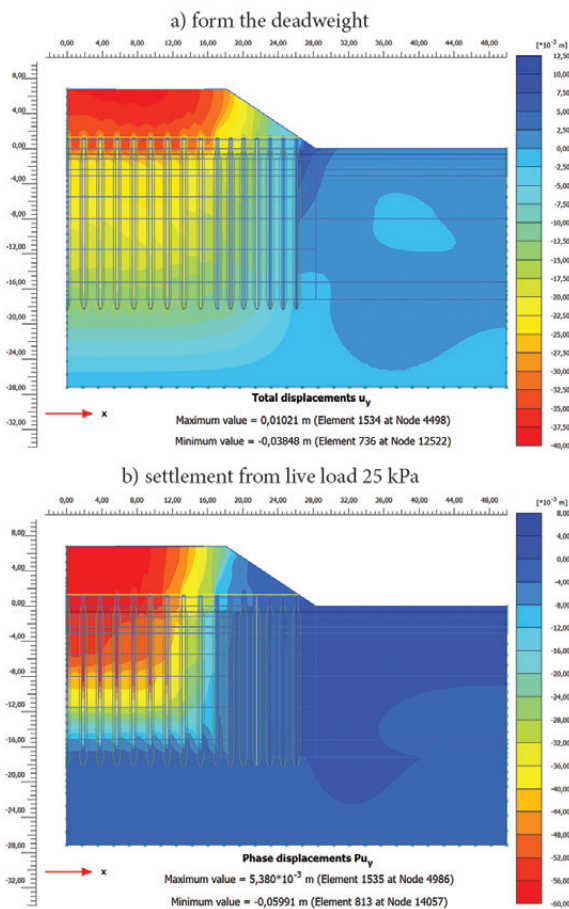
Fig. 9. Simulations of embankment settlement

Numerical analysis was conducted with the use of Finite Element Method. The FEM model of the cross-section with organic soil thickness of 13 m (according to CPT 20) (Fig. 1b) was created. The soil was modelled by elasto-plastic material (CM); the linearly elastic material was adopted for reinforced columns. The equivalent live load equal 25kPa was assumed for the problem. Selected simulation results are shown in Fig. 9. The maximum total settlement achieved 9.9 cm, its part; equal to 3.9 cm came from deadweight, the rest 6.0 cm was produced by the live load.
