Article

Non-Destructive Testing of the Longest Span Soil-Steel Bridge in Europe—Field Measurements and FEM Calculations

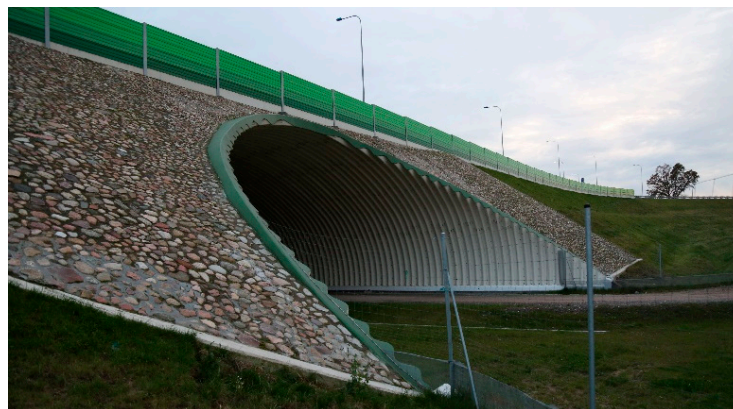
Figure 2. Close up of one of the bridge sides taken in October 2019.

The considered soil-steel bridge is a new one, built in 2017. It is a single-span arch structure, as shown in Figures 1 and 2. The steel shell is made from UltraCor, 9.5 mm thick, corrugated sheets, produced by ViaCon Polska Ltd. company ([36]) (Rydzyzna near Leszno, Poland), which are shown in Figure 3. The corrugated sheets are connected to each other with bolts. S315MC steel was used to produce the shell. The bridge foundations are built of Franki piles. The UltraCor structure is covered by soil compacted in a way that its relative density is not less than 98% of the maximum density determined in the laboratory. In the close vicinity of steel sheets, the compaction is not less than 95%. The steel arc span length is 25.74 m, whereas the total length of the bridge equals 95.70 m. The arc sagitta equals 9.0 m. These basic dimension, characterizing the structure, are depicted in Figure 1.

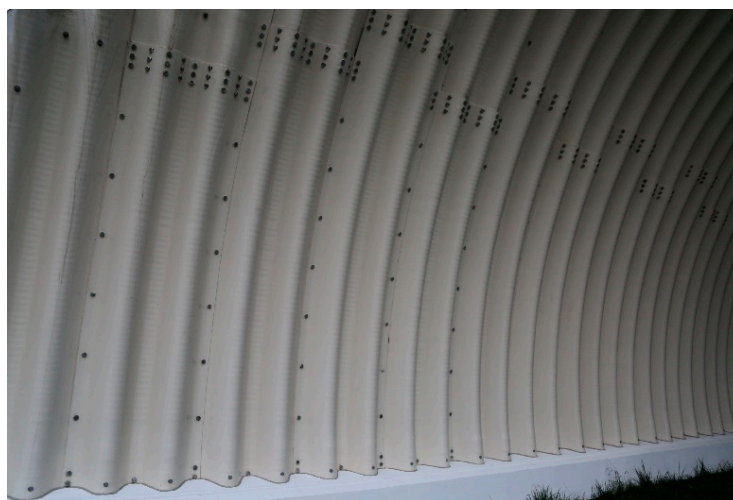
Figure 3. The corrugated steel sheets and their bolt connections.

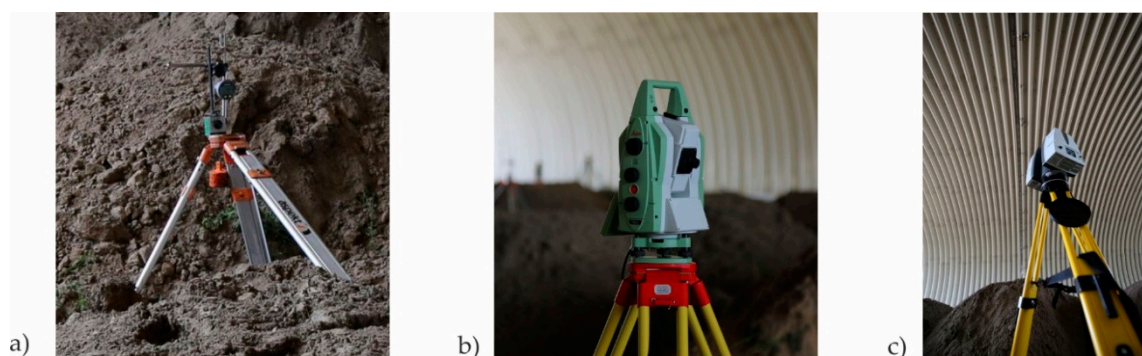
Figure 4. Devices and sensors used to measure basic bridge properties: (a) vertical translation inductive sensor, (b) total station, (c) laser scanner.

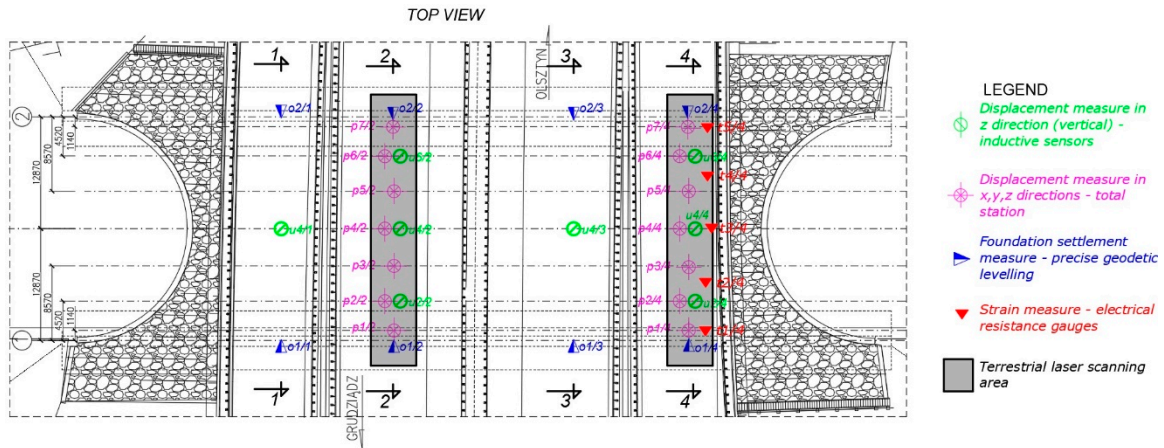
Figure 5. Location of the network of sensor used to collect the data during the static tests. Top view of the bridge.

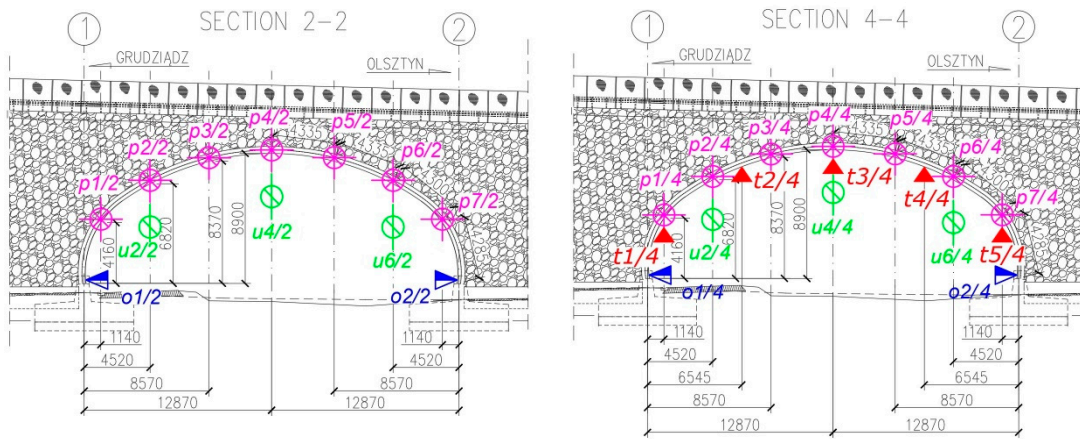
Figure 6. Location of the network of sensor used to collect the data during the static tests. Sections 2-2 and 4-4 (dimensions in (mm)).

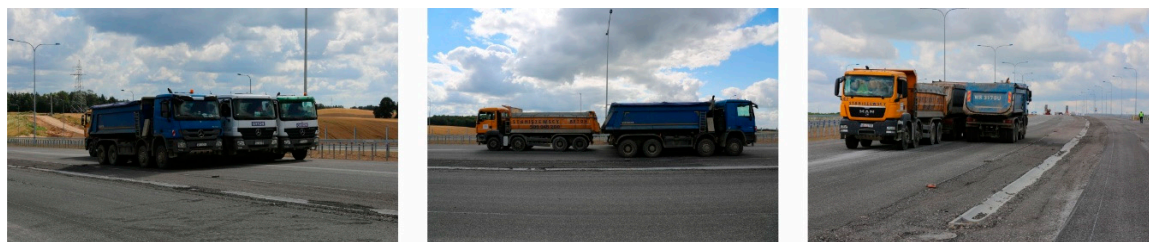
Figure 8. The trucks, positioned during the S1 test configuration. Views from three different perspectives.

To load the bridge and study its response during the tests 4-axle trucks were used. The total mass of each of the truck was 32 tons. The trucks were positioned in a way to maximize the loading effects in the measurement points. Two configurations of trucks positions were studied during the classical static tests. These were denoted as S1 and S2. The trucks were put on the bridge one by one, steadily in columns. Schematic drawing of trucks locations during the S1 test configuration is presented in Figure 7. Views from three different perspectives that document trucks positions during the S1 test configuration are shown in Figure 8.

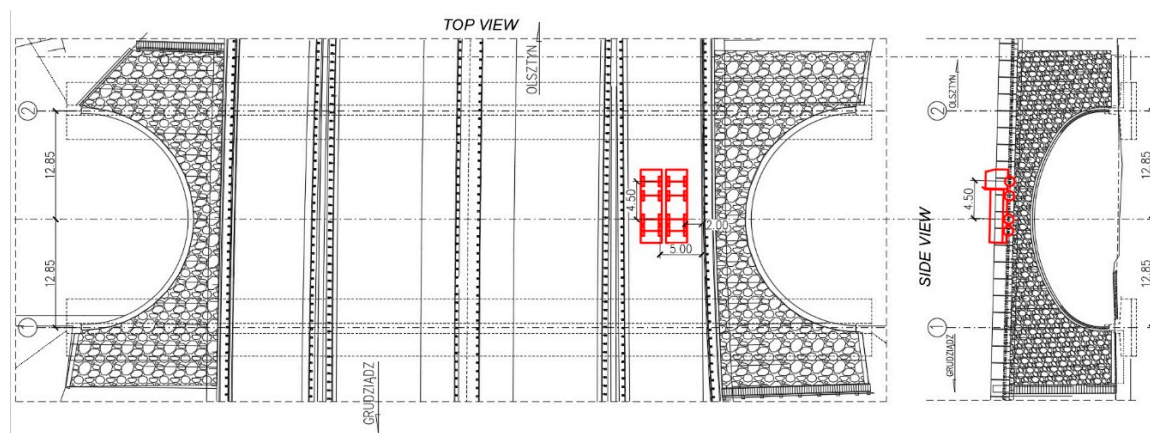
Figure 11. Schematic drawing of trucks locations at M24 stop (dimensions in (m)).

The bridge response was also checked under moving ballast of two trucks positioned side by side. These test configurations were denoted as M11 to M16 for the trucks standing on the road lane above 2-2 section and M21 to M26 for the trucks located above the 4-4 section. The trucks stopped in 6 equally spaced locations over the bridge. In Figure 11 schematic drawing of trucks locations at M24 stop is shown, whereas trucks moving between M23 and M24 testing positions are depicted in Figure 12.

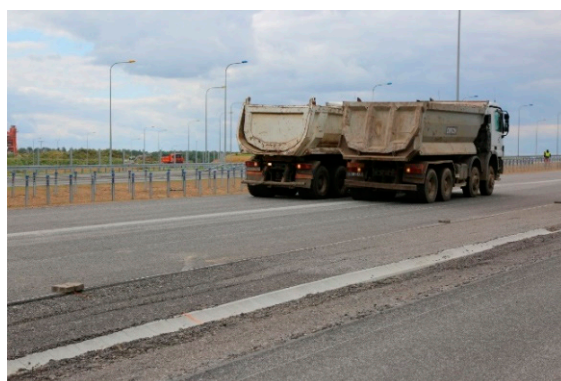
Figure 12. The trucks moving between M23 and M24 testing positions.

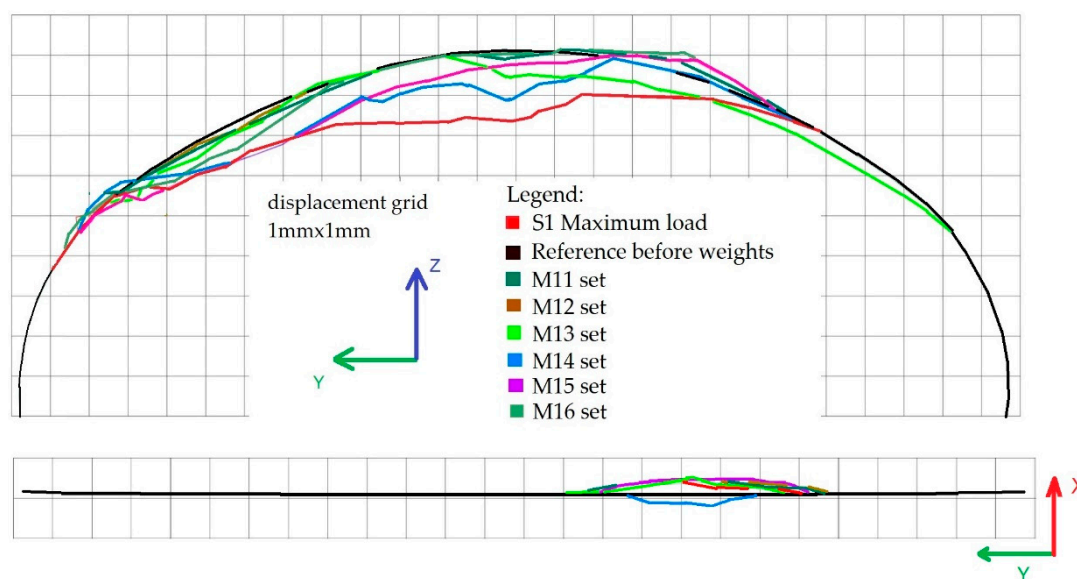
Figure 13. Deformations of the bridge cross Section 2-2 in the Y-Z (top) and X-Y (bottom) planes under loading schemes S1 and M11–M16.

At that point, data were collected, containing images of reference and deformed states of the structure. Therefore the displacements of the steel shell were easily calculated for all the cross sections under consideration. The resulting deformations of the bridge cross Section 2-2 in the Y-Z and X-Y planes under loading schemes S1 and M11–M16 are shown in Figure 13. Similarly in Figure 14, shell deformations are shown for the 4-4 cross section for the following loading conditions S2 and M21–M26.

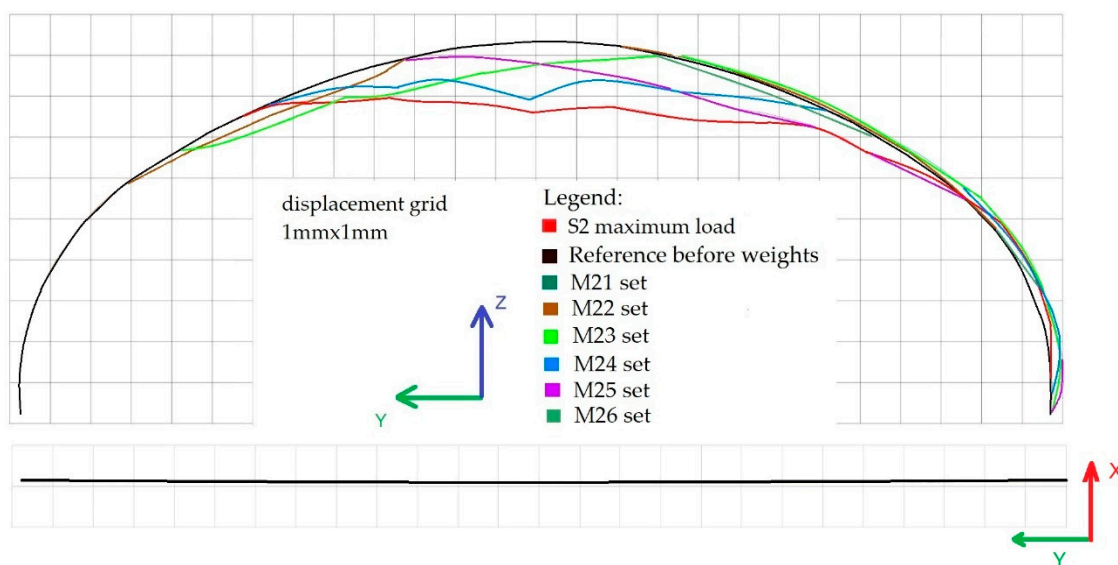
Figure 14. Deformations of the bridge cross Section 4-4 in the Y-Z (top) and X-Y (bottom) planes under loading schemes S2 and M21–M26.

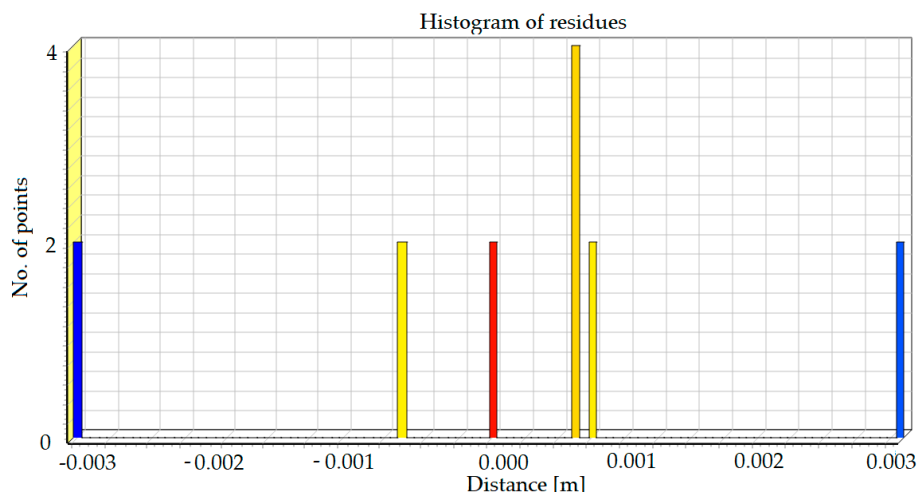
Figure 15. Histogram of residues which shows the precision of scan alignment.

As new scanning required new alignment of the device, the TLS accuracy could have been additionally checked. The Iterative Closest Points (ICP) algorithm was used to align scan positions correctly, besides of reference points that were stabilized outside of the structure. The positions of elements, which were used for the algorithm processing, were not changed during this time period and they have not been influenced by any external factors. The results of this alignment are presented in the form of histogram in Figure 15.

The standard deviation resulting from the alignment was $\sigma = 1.6$ mm. Therefore, in order to reliably estimate the accuracy of the measurement, in accordance with the principles of normal distribution, we assumed that it is $3 \times \sigma = \sim 5$ mm. In consequence, the accuracy of computed deformation differences (registered in the period between 2017–2018) should have not exceeded this value.

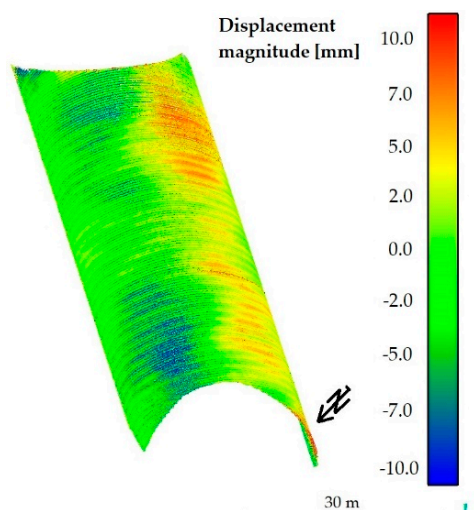
Figure 16. Periodic diagnostics of bridge deformations (displacement magnitude) measured one year after the final acceptance and inspection.

After the noise reduction had been done, it was possible to calculate the periodic diagnostics displacements of the steel shell that occurred between the years 2017 and 2018. The method described in paper [56] (available in CloudCompare software) was used for this purpose. This particular approach was chosen because most of the available comparative methods are based on the determination of the closest distance from a point or require 3D modelling of the compared surface. Thereby, they eliminate the problem of roughness, which cannot be eliminated here, as the corrugation of the steel sheets is an important feature of the whole structure and cannot be omitted. To find the distances between two point clouds, two main steps were done. First, normal surface and its orientation in 3D was estimated on a scale consistent with local surface roughness. Then, the mean surface change was measured along the surface normal direction and the local confidence interval was determined. This, in our opinion, allowed to obtain reliable information about the structure, which has varying roughness, as evidenced by the observed noise in the cloud of points and terrain diversity. The roughness is also reflected by the average change along the surface normal direction, as it was done in the second major calculation step of this procedure. In effect the distances between two point clouds were obtained and the deformations contours (magnitudes of displacements) are shown in Figure 16.

The results of the calculations presented in Figure 16 reveal that the upper part of the bridge has moved to the south up to 7 mm, while the shell in the vicinity of foundation remained undeformed. To check the accuracy of the obtained deformations a series of statistical tests, based on the Gaussian normal distribution, were run. Figure 17 presents the statistics of the Gauss function corresponding to the calculated distance uncertainties. On this basis it can be stated that the results were correctly determined in relation to the reference shown in Figure 15.

Owing to the above, the uncertainty of the measured deformations (Figure 16) equals approximately 2 mm (within the computed σ from alignment). This means that the laser scanning enabled to register all of the points characterizing the largest geometric changes. Nevertheless, this uncertainty suggests that some discrepancies of the measurements occurred during the scanning. These resulted possibly from the standard issues connected with stabilization of points, their indication, and establishment. However, because of the fact that the measurements were repeated one year after the final acceptance tests and during this period of time the construction works were still ongoing, such an accuracy of measurements is to a large extent satisfactory. For example in paper [51] laser scans of an external system were done using other techniques and the resulting precision and accuracy was not as good as here.

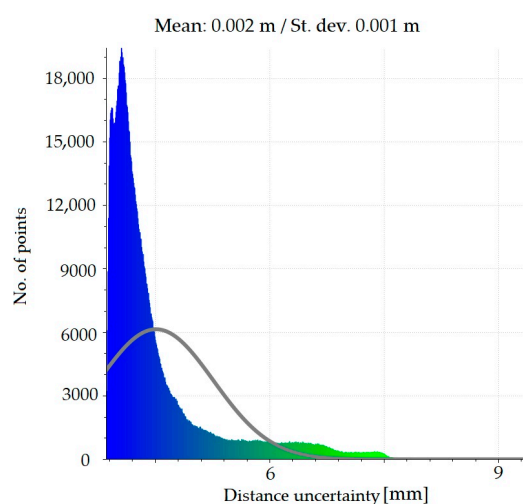
Figure 17. Distance uncertainty statistic.

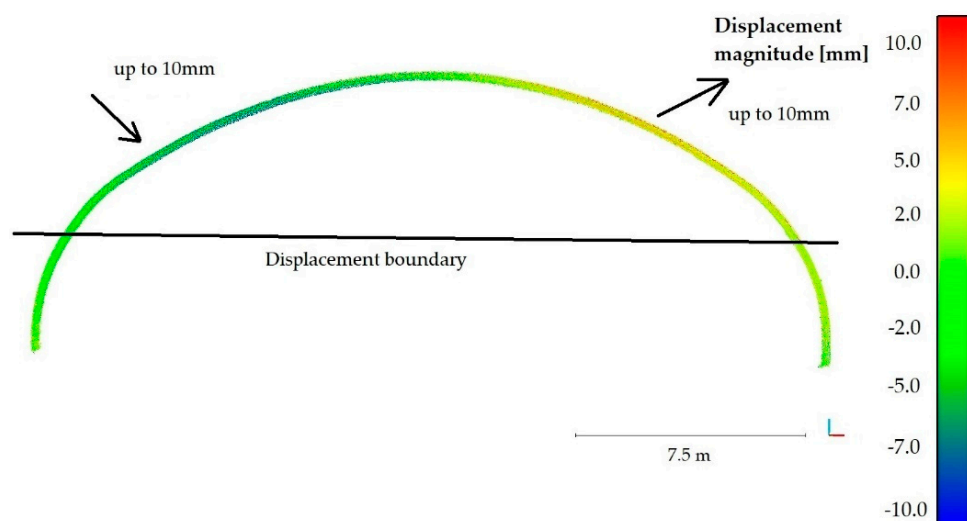
Figure 18. Displacements of the unloaded steel shell 2-2 section one year after the final acceptance and inspection tests.

Periodic diagnostic deformation images were created also in Sections 2-2 and 4-4, that were previously tested during static tests in 2017. This enabled to additionally cross-check calculations of deformations of the whole bridge, presented in Figure 16. To create them it was required to perform a number of computational operations, enabling interpretation of deformation changes of the bridge. The results obtained from scanning during short-term tests, were quite helpful in achieving this goal. Displacements of the unloaded steel shell one year after the final acceptance and inspection tests is shown in Figure 18 for the 2-2 section and in Figure 19 for the 4-4 section. The directions of the extreme values of displacements are also shown in Figures 18 and 19.

The aforesaid results reveal, that during one-year period of time, the bridge did not exhibit deformations below the black border line, marked in the figures and named as “displacement boundary”. In view of that, we noticed a certain negative feature of the computed periodic diagnostics deformations (see Figures 16, 18 and 19). Despite attaining satisfactory result of calculations, the displacements were not obtained in the lower parts of the steel shell. However, because of the measurement accuracy, their exact values are not so certain and may rather indicate the displacement tendency. Similarly, this could have resulted from the properties of the algorithm used. On the other hand, what also is interesting, the “displacement boundary” intersects the shell approximately at the same height at which bolt connections were done (refer to Figure 3). As one year passed since the date of final acceptance tests, slippage of this connections could have occurred and some rotations of the shell have become possible in this areas. This may explain why displacements of the upper part of the shell are only observed. Hence, a research gap has been identified here. These aspects will be analyzed and addressed in further studies.

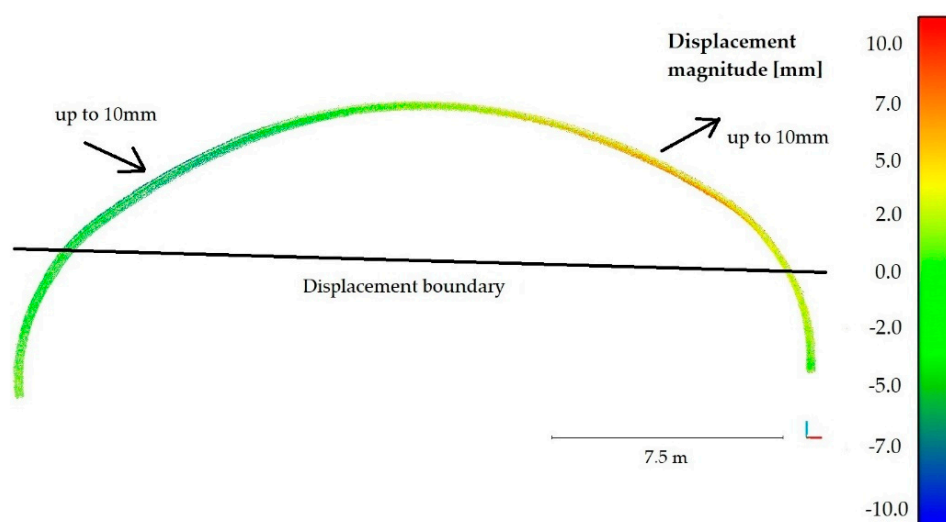
Figure 19. Displacements of the unloaded steel shell 4-4 section one year after the final acceptance and inspection tests.

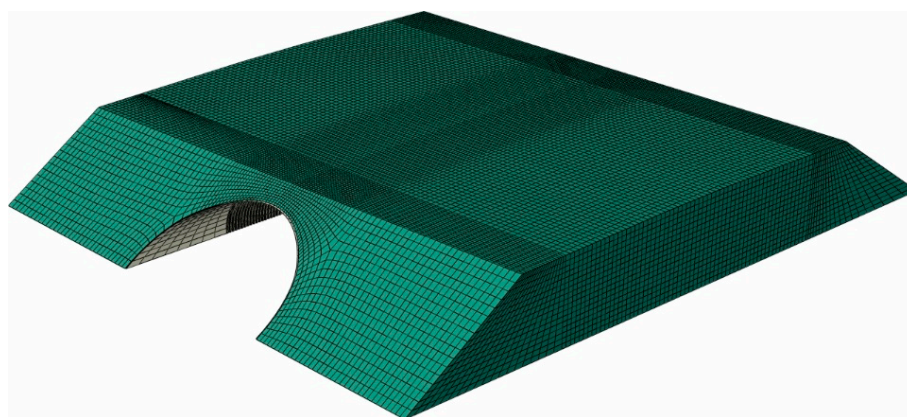
Figure 20. Finite element method (FEM) computational domain of the bridge.

Its size (distance from the bridge to the outer boundaries of the domain) was selected in such a way that it did not affect the results in the area of the steel shell. A structured mesh of finite elements was created. First-order solid C3D8I elements (refer to [58]) were used to model the soil continuum. These elements are enhanced by incompatible modes. This formulation enables very strong reduction of the locking effect, as stiffening in bending, being a consequence of the parasitic shear stresses or Poisson's effect, is almost eliminated. The steel parts were represented by shell S4 elements (see for example papers [34,59–61] for other applications of shell elements) with linear shape functions and full 2×2 in-plane Gauss-Legendre integration scheme and some additional procedures preventing the locking effect. In the central part of the structure, namely in the region where the in situ measurements were taken, the corrugated sheets were modelled in detail having regard to the real geometry. A simplification was made close to the structure ends, where the steel sheets were treated as a shell endowed with equivalent orthotropic properties and thickness. It is worth mentioning that, often, the whole steel shell is treated as the one having some equivalent properties and uniform thickness (see for example papers [42,62]). Nevertheless, such a simplification cannot be done here, because we are interested in accurate estimation of stresses in the shell-corrugated sheets. The whole computational domain of the soil-steel composite structure is shown in Figure 20 and the detail depicting modelling approach of steel shell in Figure 21.

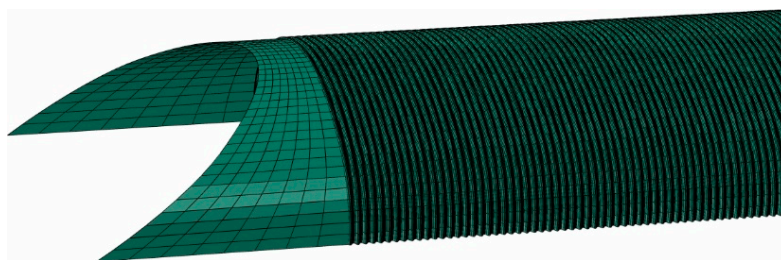
Figure 21. Steel shell in the numerical model: corrugated sheets in the center, equivalent shell close to the bridge ends.

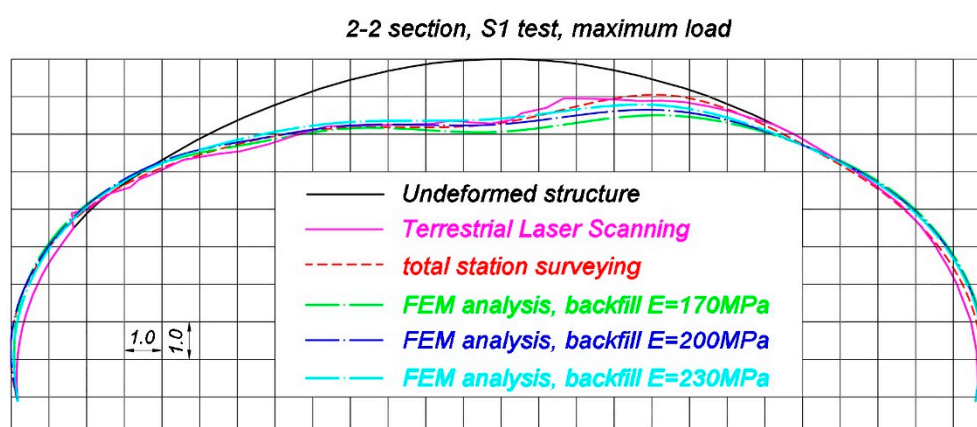
Figure 22. Comparison of the deformed shapes of the bridge in 2-2 section during the S1 test, when maximum load was applied, measured using terrestrial laser scanning, total station, and estimated by means of FEM (deformations in (mm) are 1000 times scaled).

It is seen in Figures 22–24 that the FEM estimations, even for different variants of the backfill elastic modulus, are generally in accordance with the measurements with regard to their quality and quantity. The backfill elastic modulus is an important parameter that affect the bridge response. It is a bit underestimated, when $E = 170 \text{ MPa}$. Better quality results are obtained for $E = 200 \text{ MPa}$ and $E = 230 \text{ MPa}$. In order to investigate displacements of the steel shell in detail, now, the extreme vertical displacements, that were obtained in the p4/2 point for the test S1, p4/4 for the test S2 and the corresponding FEM values (for different backfill material properties) are analyzed in Table 3. In Table 3 both total ($U_{\text{in-situ,tot}}$) and elastic ($U_{\text{in-situ,el}}$) in situ measured displacements are presented to highlight the issue of the shell shape change when the bridge was unloaded.

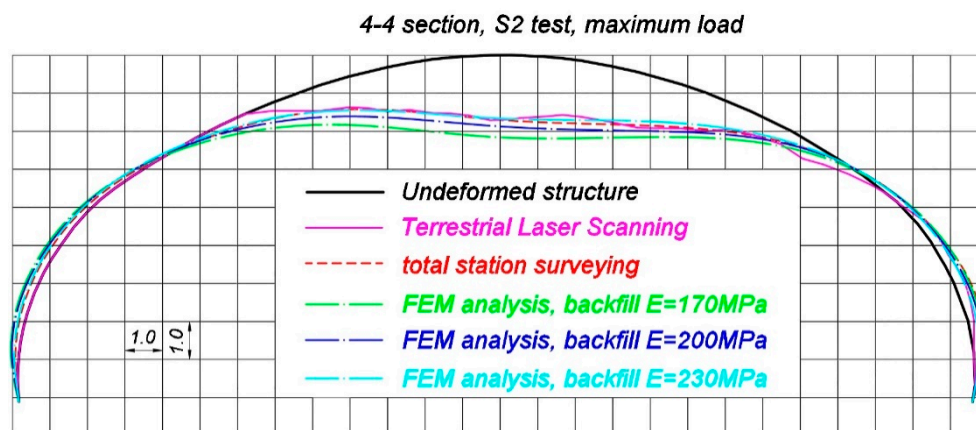
Figure 23. Comparison of the deformed shapes of the bridge in 4-4 section during the S2 test, when maximum load was applied, measured using terrestrial laser scanning, total station, and estimated by means of FEM (deformations in (mm) are 1000 times scaled).

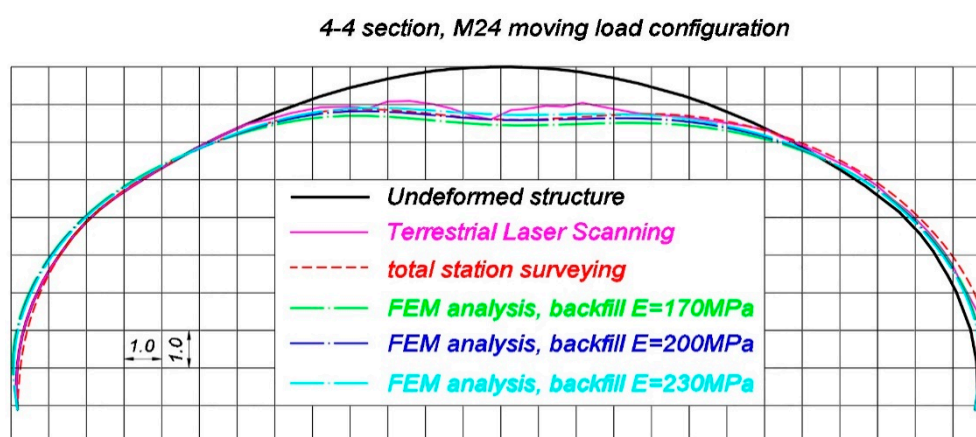
Figure 24. Comparison of the deformed shapes of the bridge in 4-4 section during the moving load M24 configuration, measured using terrestrial laser scanning, total station, and estimated by means of FEM (deformations in (mm) are 1000 times scaled).
