Article

Nondestructive Testing of the Miter Gates Using Various Measurement Methods

Faculty of Civil and Environmental Engineering, Gdansk University of Technology, 80-233 Gdańsk, Poland; mikbincz@pg.edu.pl (M.B.); przkalit@pg.edu.pl (P.K.); szulwic@pg.edu.pl (J.S.)

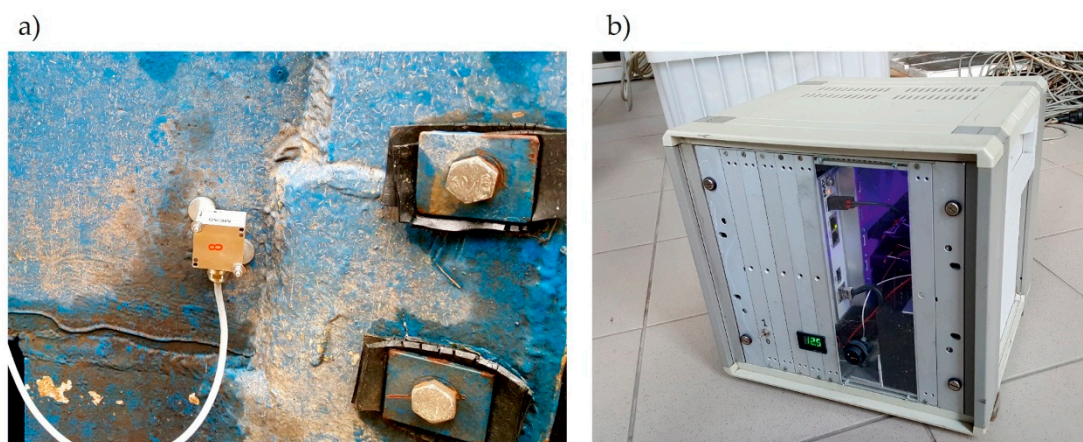
In addition, acceleration measurements were performed on the gates' steel structure. As mentioned, the dynamic measurements had two main purposes, i.e., validation of the numerical FEM model and detecting of the unexpected movements of bearings. The measuring system consisted of the HBM PMX Amplifier (Hottinger Baldwin Messtechnik GmbH, Darmstadt, Germany) system, 4 MEMS (Micro Electro Mechanical System) Direct Current (DC) response accelerometers, and wires. The amplifier was connected by an Ethernet wire to a PC computer. HBM CatmanEasy (Hottinger Baldwin Messtechnik GmbH, Darmstadt, Germany) software installed on the PC was used in the configuration of the system and data acquisition. The used amplifier was designed for, and typically utilized in, industry control systems. However, after some modifications, its parameters allowed researchers to use it in laboratory and field tests. Improvements were carried out by the crew of the Field Test Laboratory of the Technical University of Gdansk. The amplifier was covered with a stiff box to protect it from mechanical damage and adverse weather conditions. Additionally, a battery was inserted into the box. Therefore, after connection with the PC computer (notebook type), it created a stand-alone, portable, 16-channels measuring system, which could be used for up to 8 hours without access to electricity. Another advantage was the elimination of redundant, additional vibrations coming from the electric generator's work. It was especially significant to use low-noise sensors when low-magnitude vibrations are measured. Thus, the created acquisition system is very universal and convenient for field tests on bridges and other infrastructure constructions. In the system, following MEMS DC response, 4 to 20 mA signal output sensors were used as follows: 2 tri-axial accelerometers TE 4332M3-002 (TE Connectivity Ltd., Schaffhausen, Switzerland) and 2 one-axial accelerometers TE 4312M3-002. The following characteristic parameters of these accelerometers were: range ± 2 g, sensitivity 4.0 mA/g, frequency response 0 to 200 Hz, and natural frequency 700 Hz. The noise measured on the gates' leaf, if no intentional load was applied, was in the range of ± 0.005 m/s². The acquisition sampling rate was established to be 300 Hz. If predicted, interesting natural frequencies of the gates were below 30 Hz, it was evaluated as high enough to ensure the obtainment of all information about vibrations. Figure 9 shows the instrumentation for the acceleration measurements.

Figure 9. (a) Used tri-axis accelerometer TE 4332M3-002; (b) The individually improved HBM PMX Amplifier.

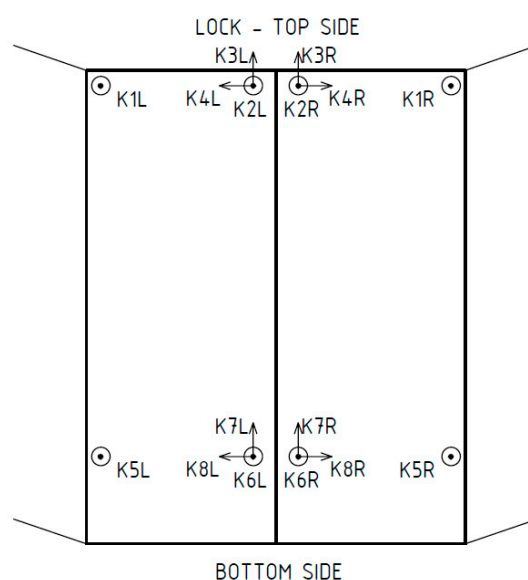
In each of the 6 positions, the gates' leaf was excited three times to natural vibrations, and then was left until vibrations damped. The measurements were carried out separately for the left leaf and separately for the right, as shown in Figure 4. Figure 10 specifies the location of the accelerometers placed on the gates' steel structure. The same sensors were used for both leaves. Therefore, the letter "L" (left leaf) or "R" (right leaf) was added, as shown in Figure 10, for channel markings. The gates were excited to vibrations by shaking the bridge railing, by one of the researchers standing on the top of the gates' leaf. The direction of the shakes was perpendicular to the gates' surface. The starting frequency of shaking was approximately 4 Hz, and during excitation, it was adopted to the natural frequency. After obtaining acceleration amplitudes close to 1 m/s^2 , the shaking stopped. For analysis, when the shaking stopped and vibrations were damped to about 0.5 m/s^2 was used as a signal.

Figure 10. Location of the control points on the gates and the direction of the acceleration measurements.

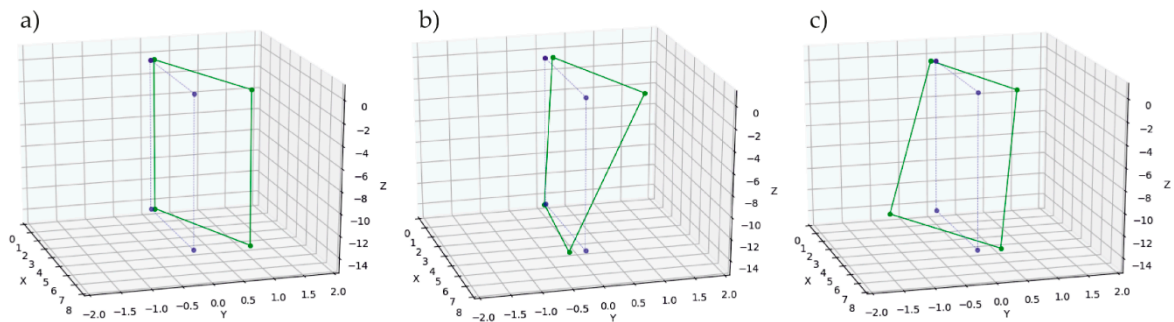
Figure 14. Identified in the eigensystem realization algorithm (ERA) eigenforms. (a) 1st; (b) 2nd; (c) 3rd. Blue points indicate the original positions of sensors. Green marked points displaced according to identified eigenform shape.

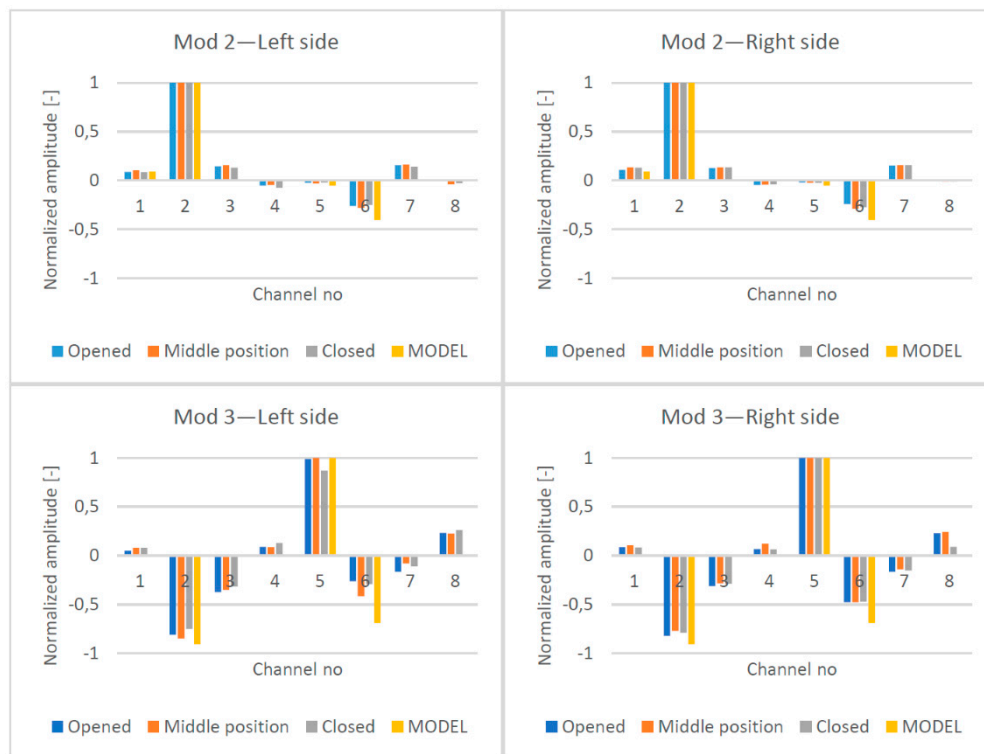
Figure 15. Comparison of the normalized eigenforms identified in three different positions of the gate's leaves for the two identified mods. Yellow bars represent corresponding results from the numerical model.

Dynamic measurements in different positions of the gates' leaves do not indicate any relevant displacements of the support bearings. A small difference between the identified, normalized modal displacements can be a consequence of adherence of the gasket to concrete elements. Differences occur, especially in the case of point K6, which is located near the bottom part of the gates, where the gasket is mounted. In addition to this, eigenfrequencies and eigenforms confirm matching between real structure and the numerical model.

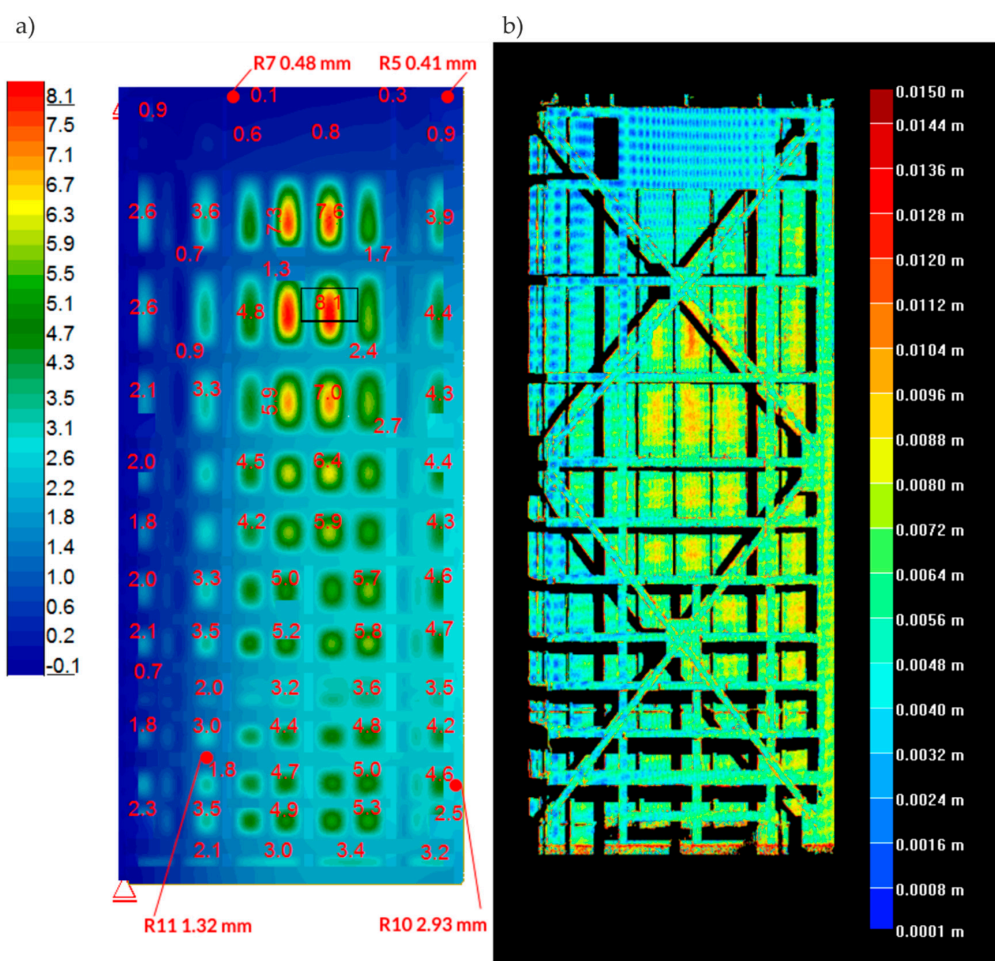
Note, at minimal water level, the minimal opening of the lock gates followed as a result of wind. During the initial filling phase, the displacement was also affected by the deformation of the gaskets. This fact explained the difference between dY displacements during filling and emptying. In addition, because of this, the diagram regarding top water increases from the 1/3 to the 3/3 level was used, as the most representative for the comparative analysis of displacements. The comparative analysis was performed regarding displacements at Y direction (horizontally at longitudinal direction) obtained during surveying measurements and laser scanning against numerical calculations. Figure 18 includes graphics of the results. On the map of displacements calculated with the numerical model (Figure 18a), four points are marked. The exact values of the calculated displacements are given. At these points, the measurement was performed with the use of a tachymeter. Table 4 shows a comparison of the calculated and measured displacements. Attention should be paid to two points (R4 and R5), for which the differences are in the order of several hundred percent. For the remaining points, the differences are much smaller. In Figure 18b, laser scanning results are presented. They were calculated by subtracting the coordinates of the two point clouds from two different measurements.

Figure 18. Comparative analysis regarding displacements at Y direction from. (a) Numerical model (mm); and (b) Laser scanning (m), top water increases from the 1/3 to the 3/3 level.

The comparative analysis was performed regarding measurements and calculations of structure displacement resulted from water level change from 1/3 to 3/3. Horizontal displacements, at a direction parallel to the gates' surface obtained based on the numerical model and the measurements with the tachymeter, were similar. Insignificant variance resulting from gates additional displacements resulted from pressure and gasket deformation at the initial phase during lock filling, which is a natural effect. Thanks to the miter gasket's deformation the sealing of gates was provided. The numerical model did not include this phenomenon; only points close to the miter axis indicate an anomaly. Displacements measured with tachymeter in points R5 and R4 (miter top corner) are significantly different than those obtained with the numerical model. However, the remaining results indicate that structure operation was consistent with the numerical model (design input). Therefore, we could exclude any significant damage to the main structural elements.

The displacements indicated by laser scanning were bigger than the results obtained using two other methods. The work provided an example regarding measurement accuracy difference during the elaboration of differential maps [58]. Additionally, water level changed slightly in the lock during laser scanning that featured a measurement period significantly longer (about seven min) than the one with the tachymeter.
