Article

# Optimization of Stabilizing Systems in Protection of Cultural Heritage: The Case of the Historical Retaining Wall in the Wisłoujście Fortress

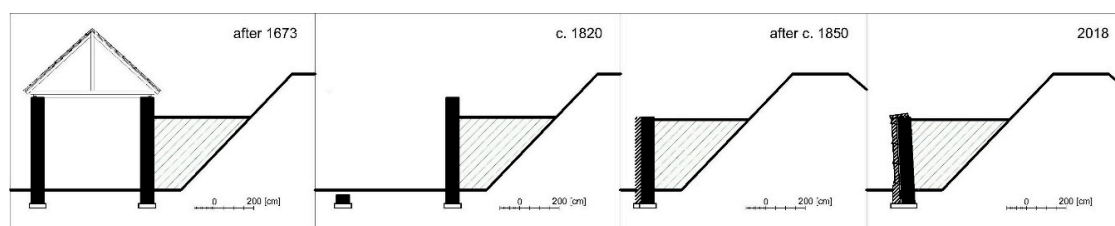
**Figure 2.** Sections through the auxiliary building and the retaining wall in the Wisłoujście Fortress. The schemes of transformations.

The alterations to the wall described above contributed to its current state of deformation. It is evident that no basic stability requirements for such wall—neither overturning about its toe nor sliding along its base—are met (Figure 3C). However, after demolition of the auxiliary building at the beginning of the 19th century, the retaining wall did not collapse. The actual stability is a result of the combination of the following: (1) the spatial rigidity of the wall's structure due to its irregular shape (Figure 1), (2) adding of the buttress which supported the wall and (3) the real active pressure decreased due to the wall deformation that had already occurred in the past.

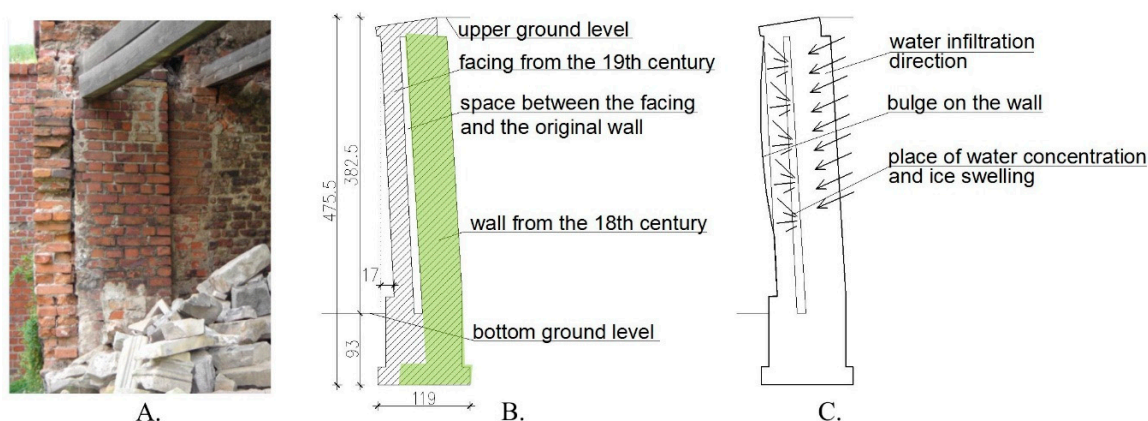
**Figure 3.** The retaining wall after its repairs from the second half of the 19th century: (A). The interface between the original wall and the 19th century siding layer, (B). Current geometry of the wall, (C). Scheme of water circulation in the wall.

Because the wall did, in fact, resist earth pressure for about 130 years, numerous vertical cracks have appeared on the surface of the wall, approximately within 0.5–2.3 m from each other (Figure 4). There is also surface freeze–thaw cycle damage visible on the wall, which could, to an untrained eye, look like cracks. Since the second half of the 19th century, two significant series of repairs have been carried out. The first was the addition of a 25 cm-thick brick siding layer and the second one was a buttress. The new facing (Figure 3A,B and Figure 5) was added without re-walling, which, paradoxically, led to deterioration of masonry over time: a crevice that developed between the new and old walls collected water (Figure 4). At low temperatures, the water froze, bursting the wall and

causing bulges in its upper part (150 cm from the top of the wall), which increased its deviation from the vertical (see Figure 3). In 2016, the deviation from plumb amounted to approximately 15 cm.

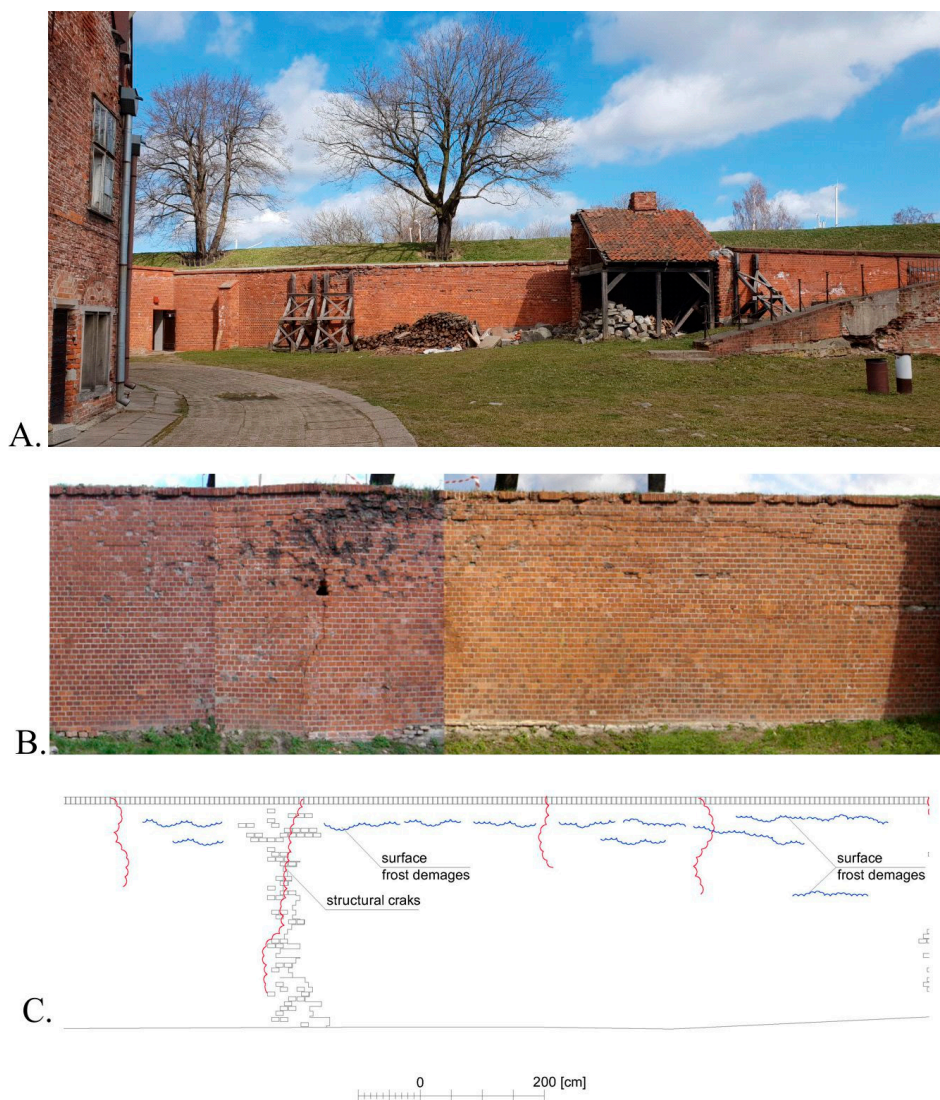
**Figure 4.** The retaining wall in the Wisłoujście Fortress: (A). Overall view; (B). Analyzed part of the retaining wall (photo taken in 2016); (C). Schematic pattern of cracks and damages.

In conclusion, the primary reason for structural failure of the wall is associated with its structural characteristics (Figure 4). However, some cracks observed nowadays may have developed accidentally, due to pressure increase during the removal of greenery. Finally, the retaining wall had lost its stability in the past and had to be strengthened by the temporary wooden buttress (Figure 4A). Therefore, it is impossible to confirm whether the inclination has stopped or it is still increasing.

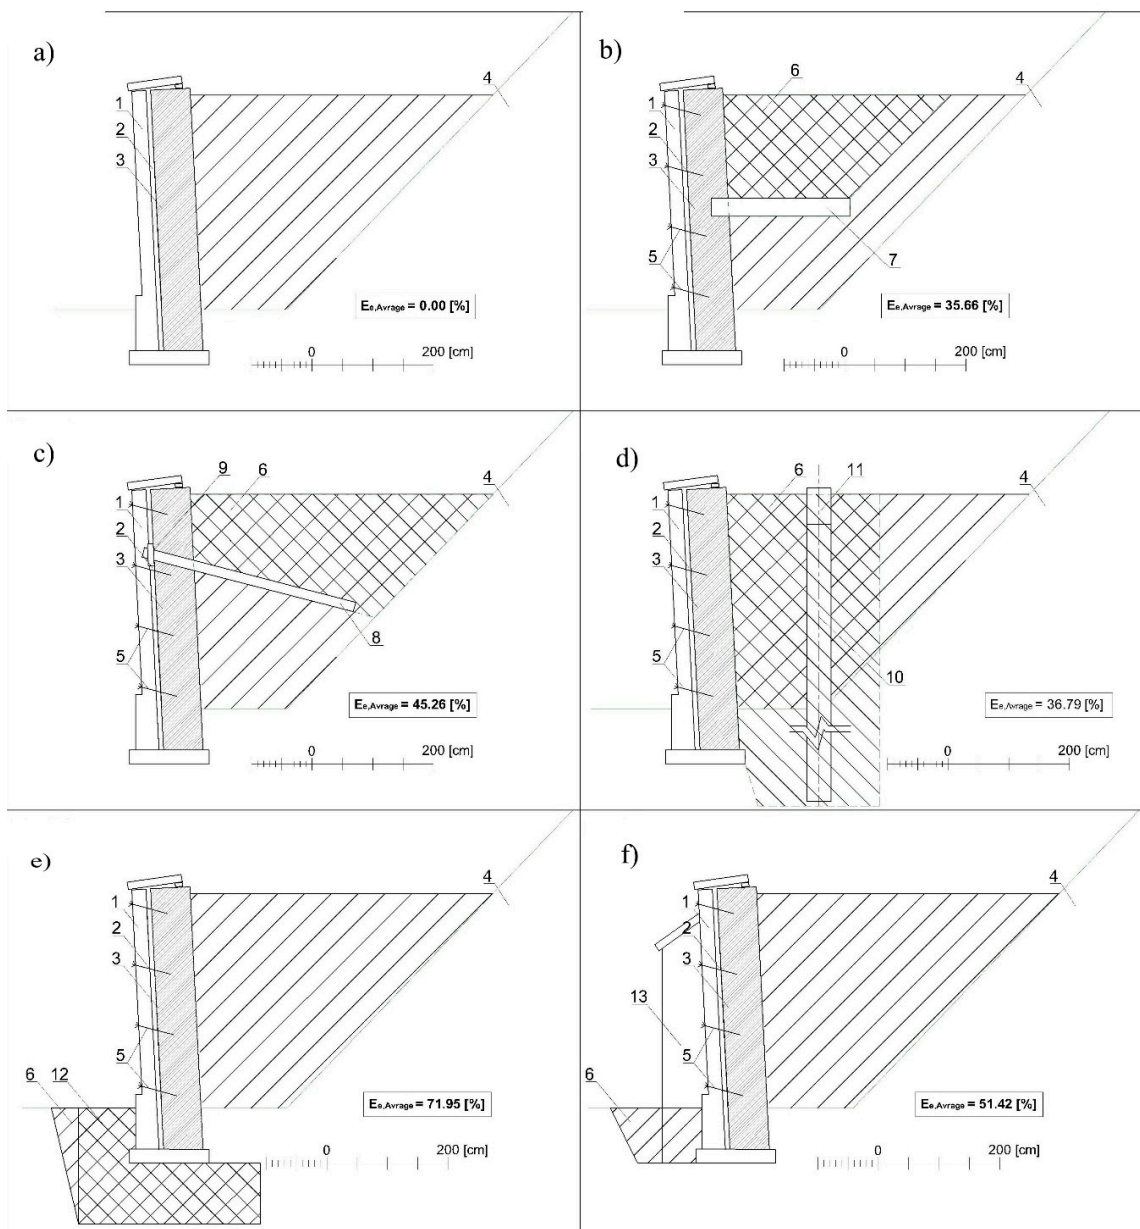
**Figure 5.** The repairing methods of the retaining wall. (a) Natural state; (b) relieving shelf; (c) passive anchors (nails); (d) CFA 3 CFA (continuous flight augering) piles; (e) jet grouting; (f) buttress.

No intervention (Figure 5a); the condition and appearance of the wall will not change. A measured and calculated deflection of 15.0 cm means that there is a high probability of a construction disaster.

The relieving shelf is a slab 1.8 m long and 0.3 m thick, inserted 2.0 m below the ground surface. The shelf is anchored to the wall (Figure 5b) and reduces soil pressure. The reinforcement is laid in a previously prepared excavation, nested in the wall and then poured over with concrete. Finally, the excavation is filled up with soil. Making a groove in the wall destroys the structure of the

Installation of passive anchors requires drilling through the wall (Figure 5c). Each borehole is then filled with a cement paste. The anchor itself, in the form of a steel bar with a diameter of 6 cm and a length of 3.6 m, is cemented inside the hole. The hole has a diameter of 10 cm. The spacing between the anchors is 3.0 m. Drilling disturbs the original structure of the wall, leaves the head in its outer face and changes the structure of unexamined (not yet excavated) soil, which might have archeological value. The effect of anchoring on the appearance of the wall will be minimized by masking the anchors under a siding layer or by using eight masking plates. Adding an inappropriate, disproportionate or aesthetically unpleasant feature may affect the visual assessment. Due to the control of the anchor installation, this method is very safe and effective.

This method involves making a palisade of reinforced concrete piles approximately 1.5 m behind the wall (Figure 5d). The palisade decreases the soil pressure on the structure. Piles with a diameter of 0.40 m and a length of 7.0 m are spaced every 0.50 m. The piles themselves do not alter the structure of the wall but the insertion procedure disturbs the soil by drilling, stirring and pulling it to the surface when the drill bit is removed. Furthermore, if the drill bit encounters an object larger than its diameter, the object will be drilled through or pushed aside. This technology can cause an additional bulging of the wall resulting from the operation of the drill and the weight of the drilling machine. For these reasons, a temporary support of the wall should be put in place for the duration of the drilling. The piles will not be visible. There is a risk of damaging the wall during the installation of the piles.

This method is about reinforcing soil under the existing foundation of the wall by injection of cement paste at a very high pressure. The dimensions of the reinforced foundation are  $0.80 \times 2.30$  m (Figure 5e). This technology does not damage the original surface of the wall as it affects only the soil under the wall foundation. In order to conduct archaeological excavations safely, it would be necessary to dig up the soil along successive sections of the wall, on its both sides. This is, however, hardly practicable as it involves extensive intervention in the ramparts, which remain under archaeological protection. The entire procedure is, therefore, costly. For these reasons, it was assumed that the excavations would be carried out in front of and under the wall (see Figure 5e). The changes will be invisible.

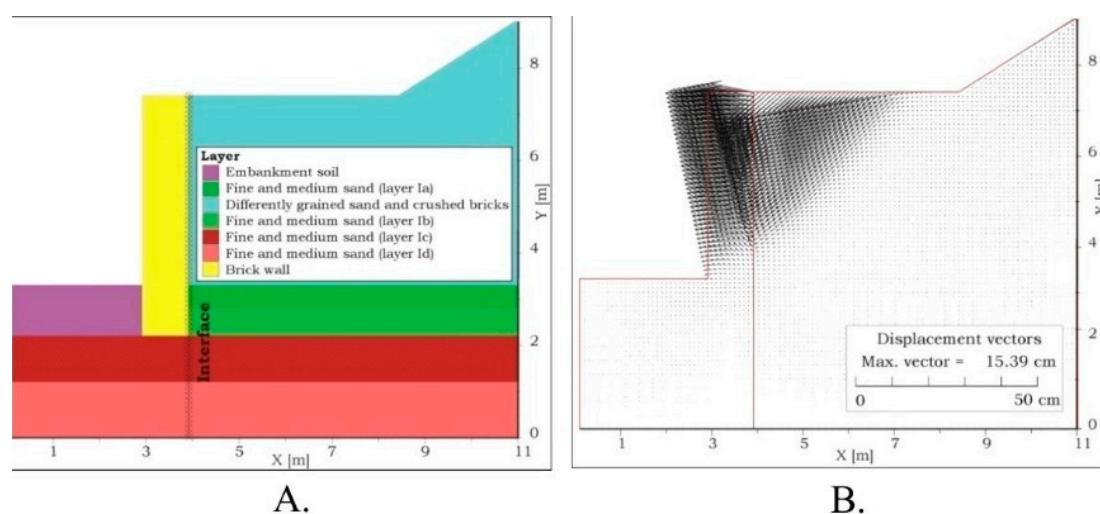
**Figure 6.** The numerical model of the retaining wall: (A) division of the model into geotechnical layers; (B) displacement vectors.

The purpose of the numerical analysis was to determine the effectiveness of the selected methods in strengthening and stabilizing the wall. The analysis was performed by the two-dimensional explicit Finite Difference Method (FD), using the FLAC2D software [45]. This method is an accurate and versatile approach to the analysis of both stability and displacement of retaining walls. It allows for calculating the field of displacement both in the soil mass and in the engineering structures, which are considered as appropriate for the stabilization and strengthening of the wall. Its stability was assessed based on the safety factor  $F$ , which is calculated using strength reduction technique fundamentals. The additional advantage of the proposed method is that it makes no assumptions about the failure mechanism—especially for simple geometry. In contrast to the traditional “limit equilibrium” analysis, this method provides a full solution to the coupled stress/displacement, equilibrium and constitutive equations. The calculations were based on the so-called “strength reduction technique” [52]. Geotechnical studies [53] have shown that the groundwater level is currently 2.0 meters below the base of the wall foundation. The substratum is composed mainly of fine and medium sand (Figure 6A), and the earthwork that loads the retaining wall consists of fine sand and brick debris. The soil density index in the rampart body (ID) is 0.2. Table 1 presents the parameters of soil layers in the calculation model. The diversity of soils in the Ia-Id layers results from their different degrees of compaction, ranging from 0.30 for the layer Ia to 0.70 for the layer Id. On the basis of laboratory tests, the average compressive strength of old bricks was determined to be equal to 15.8 MPa, mortar equal to 0.75 MPa and new ones (from external wall)—equal to 34.1 MPa and 19.3 MPa [52].

First, the current original state of the wall was examined by the “back analysis” method, i.e., the variant without wall stabilizing measures. The aim was to determine the values of strength parameters (cohesion and angle of internal friction of the soil constituting the earthwork that puts pressure against the wall), for which the measured and calculated displacements of the wall crown would be the same. It means that, by contrast to other parameters determined in the tests, these two strength parameters (i.e., cohesion and angle of friction) are found at the base of calculations using a “trial and error” approach and FLAC2D code. A numerical model and displacement vectors are shown in Figure 6. Calculated maximum displacement ( $u$ ) of the wall’s crown was equal to 15.21 cm.

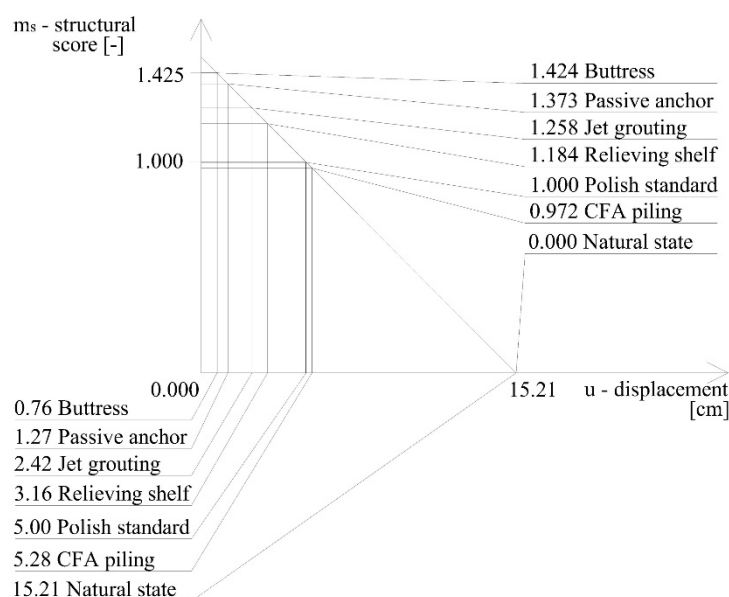
Figure 7. The displacement of the wall crown.

The relationship between the calculated displacement of the wall's crown and the structural score calculated by (Formula (2)) is presented graphically in Figure 7.

It is seen in Figure 7 that the calculated displacement of the wall's crown in the case of the relieving shelf is 3.16 cm and corresponds to 18.4% above the required level of safety, whereas the displacement of the wall's crown for buttress is 0.76 cm and corresponds to 42.2% above the required level of security and so on.
