## OVERFLOWING TESTS AT THE POLISH DREDGDIKES RESEARCH DIKE – STABILITY OF THE DIKE SURFACE AGAINST EROSION

**Abstract.** In the project DredgDikes the different research dike embankments were tested with respect to overflowing water induced erosion. Therefore, flumes were installed on the land side embankments in which the effect of overflowing water on the vegetated surface was investigated. On the Polish DredgDikes research dike near Gdansk, Poland, two parallel flumes were installed and the surface of the dike made of different mixtures of ash, silt and sand as well as clay was tested both in vegetated and unvegetated state. The results showed that the grass sods placed on the dike embankment had a comparably low erosion stability, particularly if placed directly on the hardened ash/silt dike cover with better results if placed on a clay cover, while the ash/silt mixture showed a high erosion resistance without vegetation. This results in the recommendation to use a thicker vegetation layer on top of the ash composite dike if the vegetation shall account for the erosion resistance or else, that even if the grass cover is washed away, a very solid cover made of the ash composit

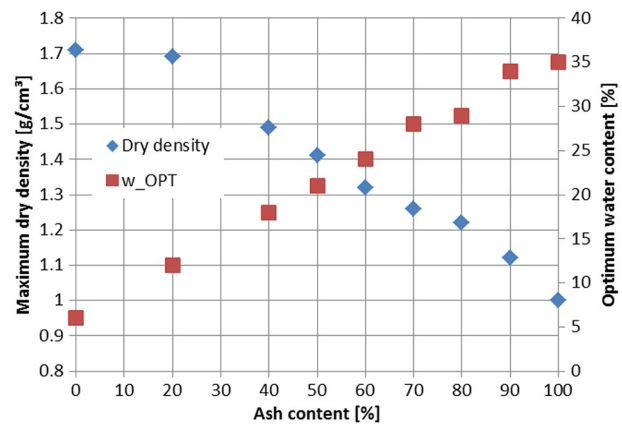
Fig. 1. Maximum dry density and optimum water content of the different sand ash mixtures

The proportion of components in the test dike was chosen based on initial tests on the dredged sand: it was examined, how the properties of the mixture are influenced by the variation of the percentage of ash. For the mixtures, the portion of ash was varied from 0% to 100% in steps of 10%. Figure 1 shows the maximum dry density and optimal water content for

the different mixtures. The optimum water content increases while the density decreases with increasing ash content.

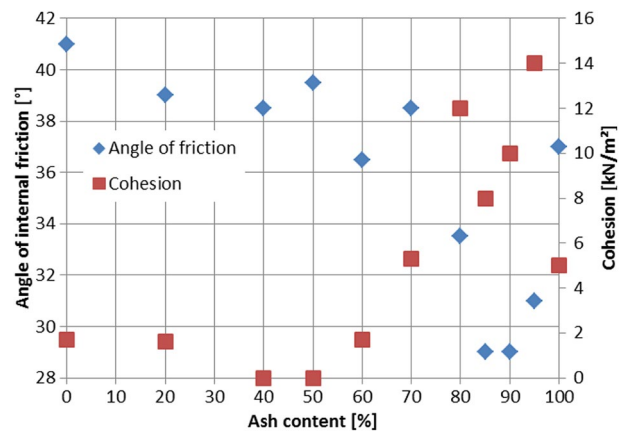
Fig. 2. Angle of internal friction and cohesion of the different sand ash mixtures

The void ratio  $e$  was determined in the oedometric tests. It increases with increasing ash content. The angle of internal friction and cohesion were derived from direct shear tests. The cohesion increases with an ash content of more than 60% while the angle of friction then decreases, as shown in Figure 2.

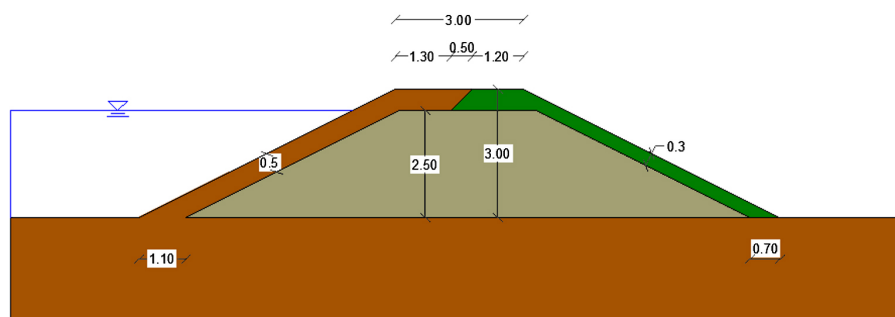
Fig. 4. Cross-section of the Gdansk research dike in the test section with the planned division of cover materials: clay (brown) on the upstream side and silt/ash composite (green) on the downstream side

Figure 4 shows a cross-section with the different materials as planned. During the tests it was found, however, that the clay cover was reaching over the crest into the upper third of the downstream face.

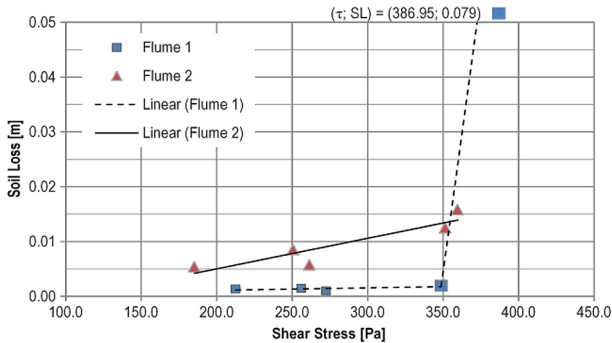
Fig. 8. Erosion rates flumes 1 & 2 (vegetated); soil loss and shear stress, steep trend line = high erosion rate, September 2014

Figures 8, 10, 11 and 12 show the results of the vegetated slope while Figures 9, 13, 14 and 15 present the results for the unvegetated conditions, both for the whole flume length and separated into upper and lower section. The shear stress results were chosen to be presented here, since they provide good information regarding the erosion resistance. In addition, Figure 15 shows an example of the image documentation of the slope surface development in flume 1. Due to the scattered measurement results, the definition of a “best fit” trend line through the data points was not reasonable. Instead, a linear trend line was chosen for all charts to define the flume specific soil loss functions. A higher inclination of the trend line stands for a higher erosion rate.

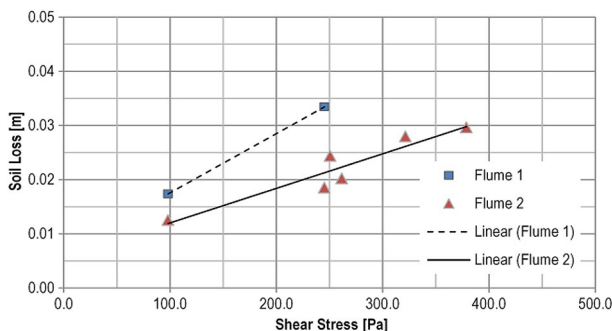
Fig. 9. Erosion rates flumes 1 & 2 (unvegetated); soil loss and shear stress, steep trend line = high erosion rate, September 2014

only moderate. This is illustrated by the modest slope of the regression lines in Figures 9 and 14.
