Article

Plasticity of Bead-on-Plate Welds Made with the Use of Stored Flux-Cored Wires for Offshore Applications

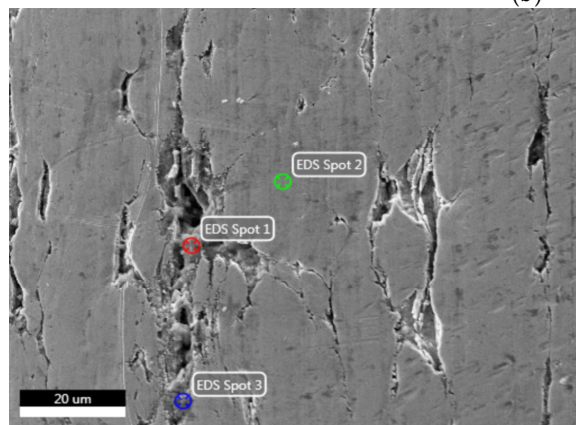
Zone	Fe	Cu	O	S
EDS Spot 1	5.01	91.44	3.55	-
EDS Spot 2	4.64	86.83	7.46	1.07
EDS Spot 3	4.19	90.68	4.48	0.65

Zone	Fe	Cu	O	S
EDS Spot 1	5.57	92.18	1.49	0.76
EDS Spot 2	43.53	53.44	2.45	0.58
EDS Spot 3	76.09	13.70	7.74	2.48

Zone	Fe	Cu	O	S
EDS Spot 1	22.38	65.55	9.43	2.68
EDS Spot 2	47.97	52.03	-	-
EDS Spot 3	22.37	58.85	19.48	4.30

Zone	Fe	Cu	O	S
EDS Spot 1	60.51	5.43	33.58	0.48
EDS Spot 2	66.30	33.70	-	-
EDS Spot 3	71.56	6.04	21.74	0.66
EDS Spot 4	60.68	6.26	32.61	0.45

Figure 6. SEM image and spot EDS analysis of flux-cored wires: (a) A wire stored in GWS; (b) A wire stored in MAB; (c) B wire stored in GWS; (d) B wire stored in MAB.

2. The wires stored in the welding site had a less degraded surface and after storage the copper compounds appeared in grooves. After being stored in an agricultural building, the surface of the wires was covered with iron compounds—for the B wire the amount of corrosion products is greater.

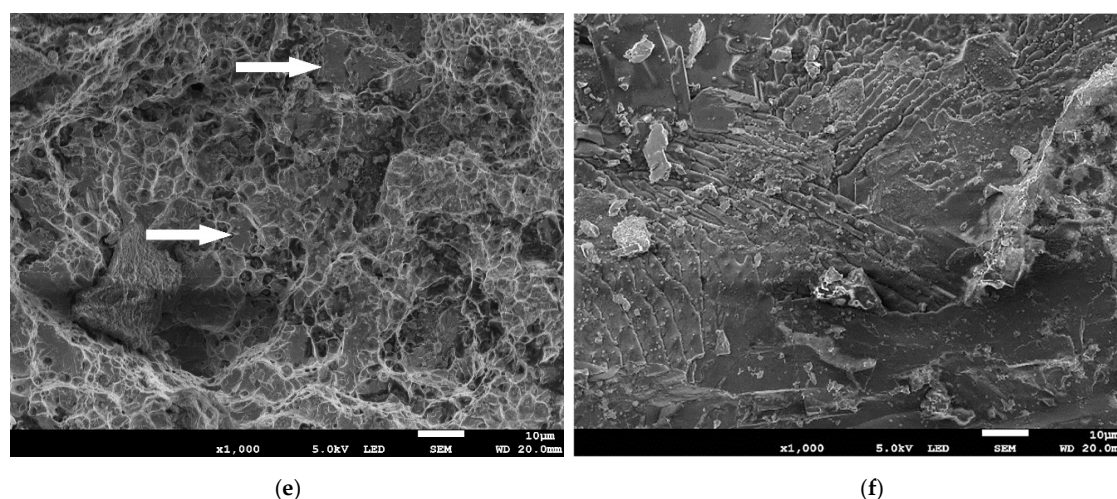
Figure 10. Fracture surfaces of specimens after tensile tests: (a) specimen made using A wire in delivery condition; (b) specimen made using B wire in delivery condition; (c) specimen made using A wire stored in GWS; (d) specimen made using B wire stored in GWS; (e) specimen made using A wire stored in MAB; (f) specimen made using B wire stored in MAB.

Figure 10 shows SEM images of fractures after tensile test. In Figure 10a,b, dimples, characteristic of the ductile microvoid coalescence fracture, are clearly visible. Such a fracture mode predominated in specimens made with wires in delivery condition. An increased share of the brittle fracture (marked with white arrows) was observed in specimens made of wire from the GWS and in the specimen made of A wire from MAB (Figure 10c–e). In this case, the quasi cleavage fracture was found. Three zones can be observed—at the face the fracture was more ductile, dimples appeared larger, in the middle zone between dimples flat cleavage areas appeared and at the root there were dimple clusters and larger areas of cleavage, with large steps. Figure 10f shows the fracture surface of a specimen made using B wire stored in MAB. In this specimen, cleavage fracture dominates. At 1000× magnification, only single dimples are visible, situated between large cleavage areas.

A change in plasticity can also be observed by comparing the mode of fracture of the tensile tested specimens (Figure 10). The most characteristic is the transition from the ductile microvoid coalescence fracture to the almost complete cleavage fracture for the specimen made using B wire stored in MAB. Such a great change is directly related to the results of plasticity indexes (Table 5), which also indicate a very intense degradation of bead-on-plate weld plasticity for this wire and location. In all fracture surfaces, at least some dimples were found and they were all equiaxed, which confirms that tensile loading was the main loading type responsible for breaking of specimens.

4. The mode of the fracture in tensile specimens varied depending on the storage conditions and grade of wire. Under the influence of monthly storage, there was a change from the ductile microvoid coalescence fracture to the almost complete cleavage fracture.
