## Case study

# Restoration and preservation of the reinforced concrete poles of fence at the former Auschwitz concentration and extermination camp

A. Miszczyk\*, M. Szocinski, K. Darowicki

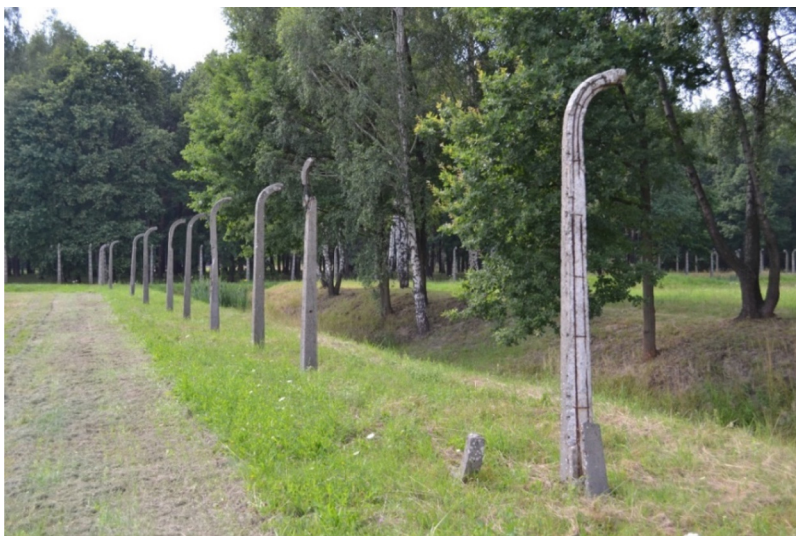
Fig. 2. Some poles need still renovation.

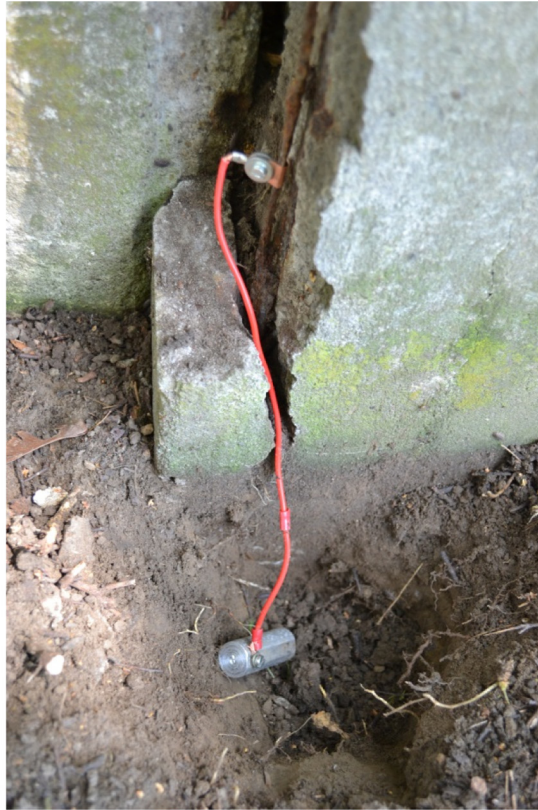
a)

**Fig. 7.** Pillars located in the former Auschwitz camp protected with sacrificial anodes before applying a new repair mortar: variants with protector buried in soil (a), variant with protector placed directly on reinforcement (b).

In order to ensure effective protection of steel reinforced pillar two variants of protection are suggested. The first one consists in placing the protector in ground in vicinity of the reinforced concrete pillar as illustrated in Fig. 6a. Electrical connection between the protector and the steel reinforcement is accomplished in the underground section of the pillar, so the protection system is not visible for the potential visitors, which fulfills the requirements for conservation of historical heritage objects. The same requirement is fulfilled by the second variant of protection, which predicts positioning of the protector directly on the reinforcement (Fig. 6b). In this case the protector is typically in form of small-dimension zinc disc or wire fixed on and electrically connected with the reinforcement bar. Then missing layer of concrete is applied covering the rebar together with the protector. As long as the concrete layer is not penetrated by water, ions and the front of carbonation is away from the reinforcement, steel does not corrode and the protectors play a waiting role. The moment the aforementioned agents reach the rebar the sacrificial anodes start to provide electrochemical protection. The second variant of protection is ideally suited for the degraded pillars calling for restoration where the reinforcement is revealed and exposed to atmospheric conditions. In case of both approaches the effectiveness of applied protection as well as the time instant when the protector has to be replaced can be monitored and determined by measurements of electrochemical potential of the pillar's reinforcement. Both proposed variants of electrochemical protection have already been implemented at separate pillars present on the area of the former Auschwitz camp (Fig. 7a and b).
