Article

Revitalization of Residential Buildings Dating Back to the Late 19th and Early 20th Century on the Example of “Willa Halina” in Sopot (Poland)

Antoni Taraszkievicz

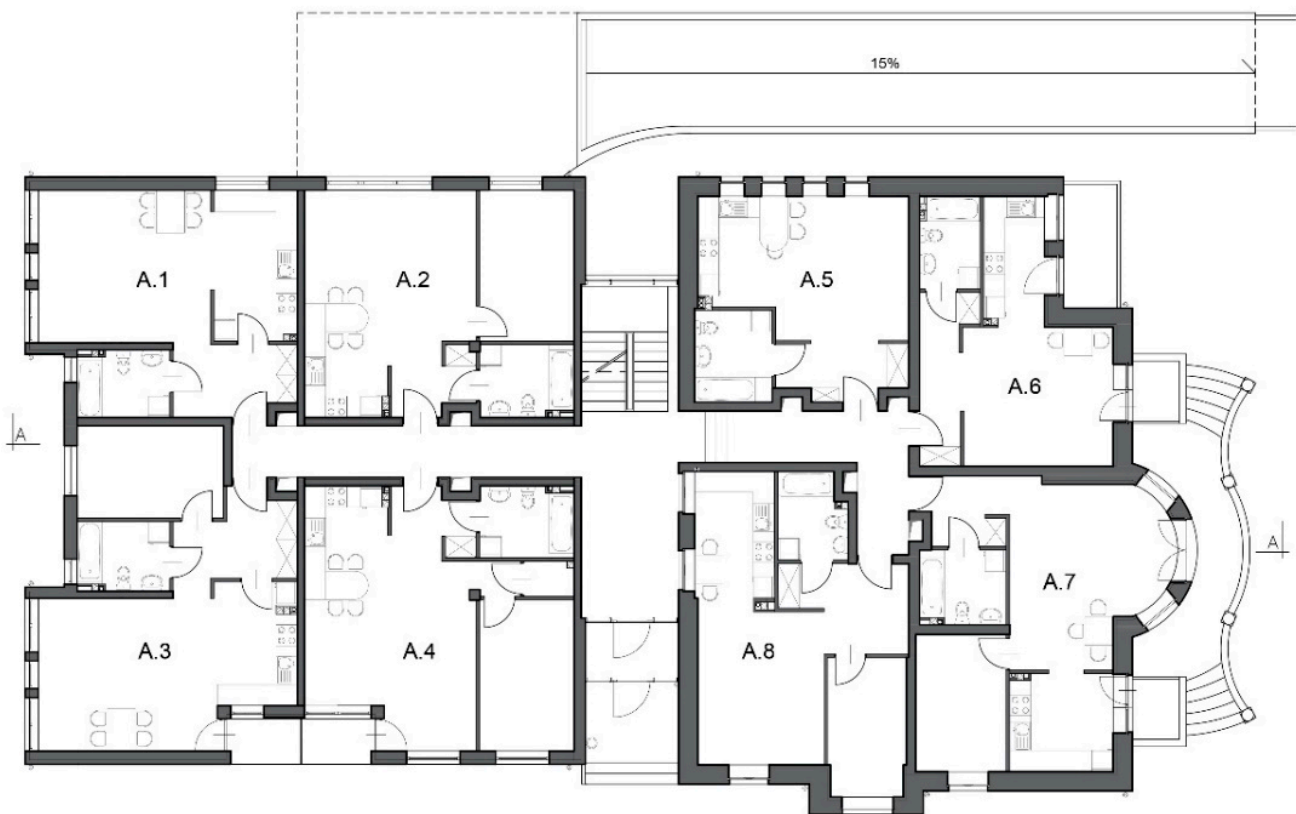
Figure 11. Willa Halina extension design; ground floor plan. Source: A. Taraszkiewicz.

Completely technically degraded, devoid of any historical elements, the interiors of the villa were designed in such a way as to enable the arrangement of six modern apartments. In the extended part 11, additional apartments have been designed. The revitalization and extension of the villa were designed in such a way that made it possible to turn it (according to the investor’s intention) into a multi-family residential building (Figure 11).
